## Technical Memorandum

**To:** Commissioners, Black Dog Watershed Management Organization (BDWMO)  
**From:** Barr Engineering Co.  
**Subject:** 2019 Lac Lavon Habitat Monitoring  
**Date:** March 10, 2020  
**Project:** 23190457

This memorandum presents the results of the BDWMO's 2019 habitat monitoring of Lac Lavon.

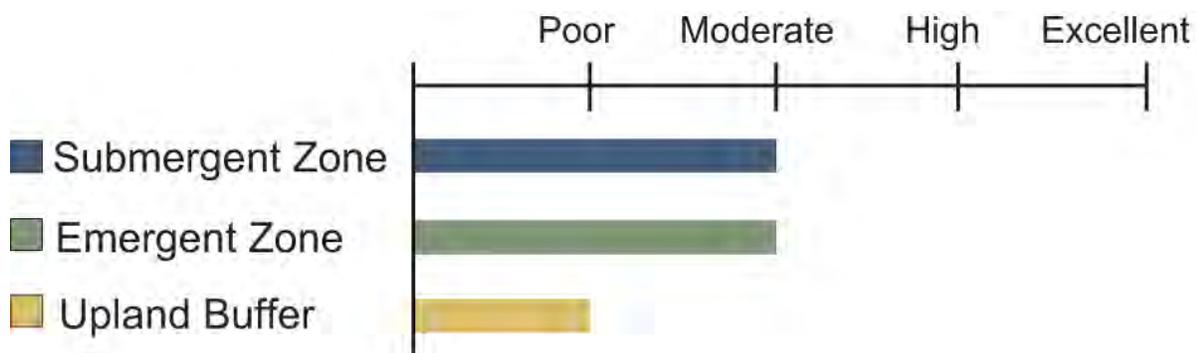
The following schematic diagram shows the overall ratings in 2019 for each vegetation zone within and adjacent to Lac Lavon:

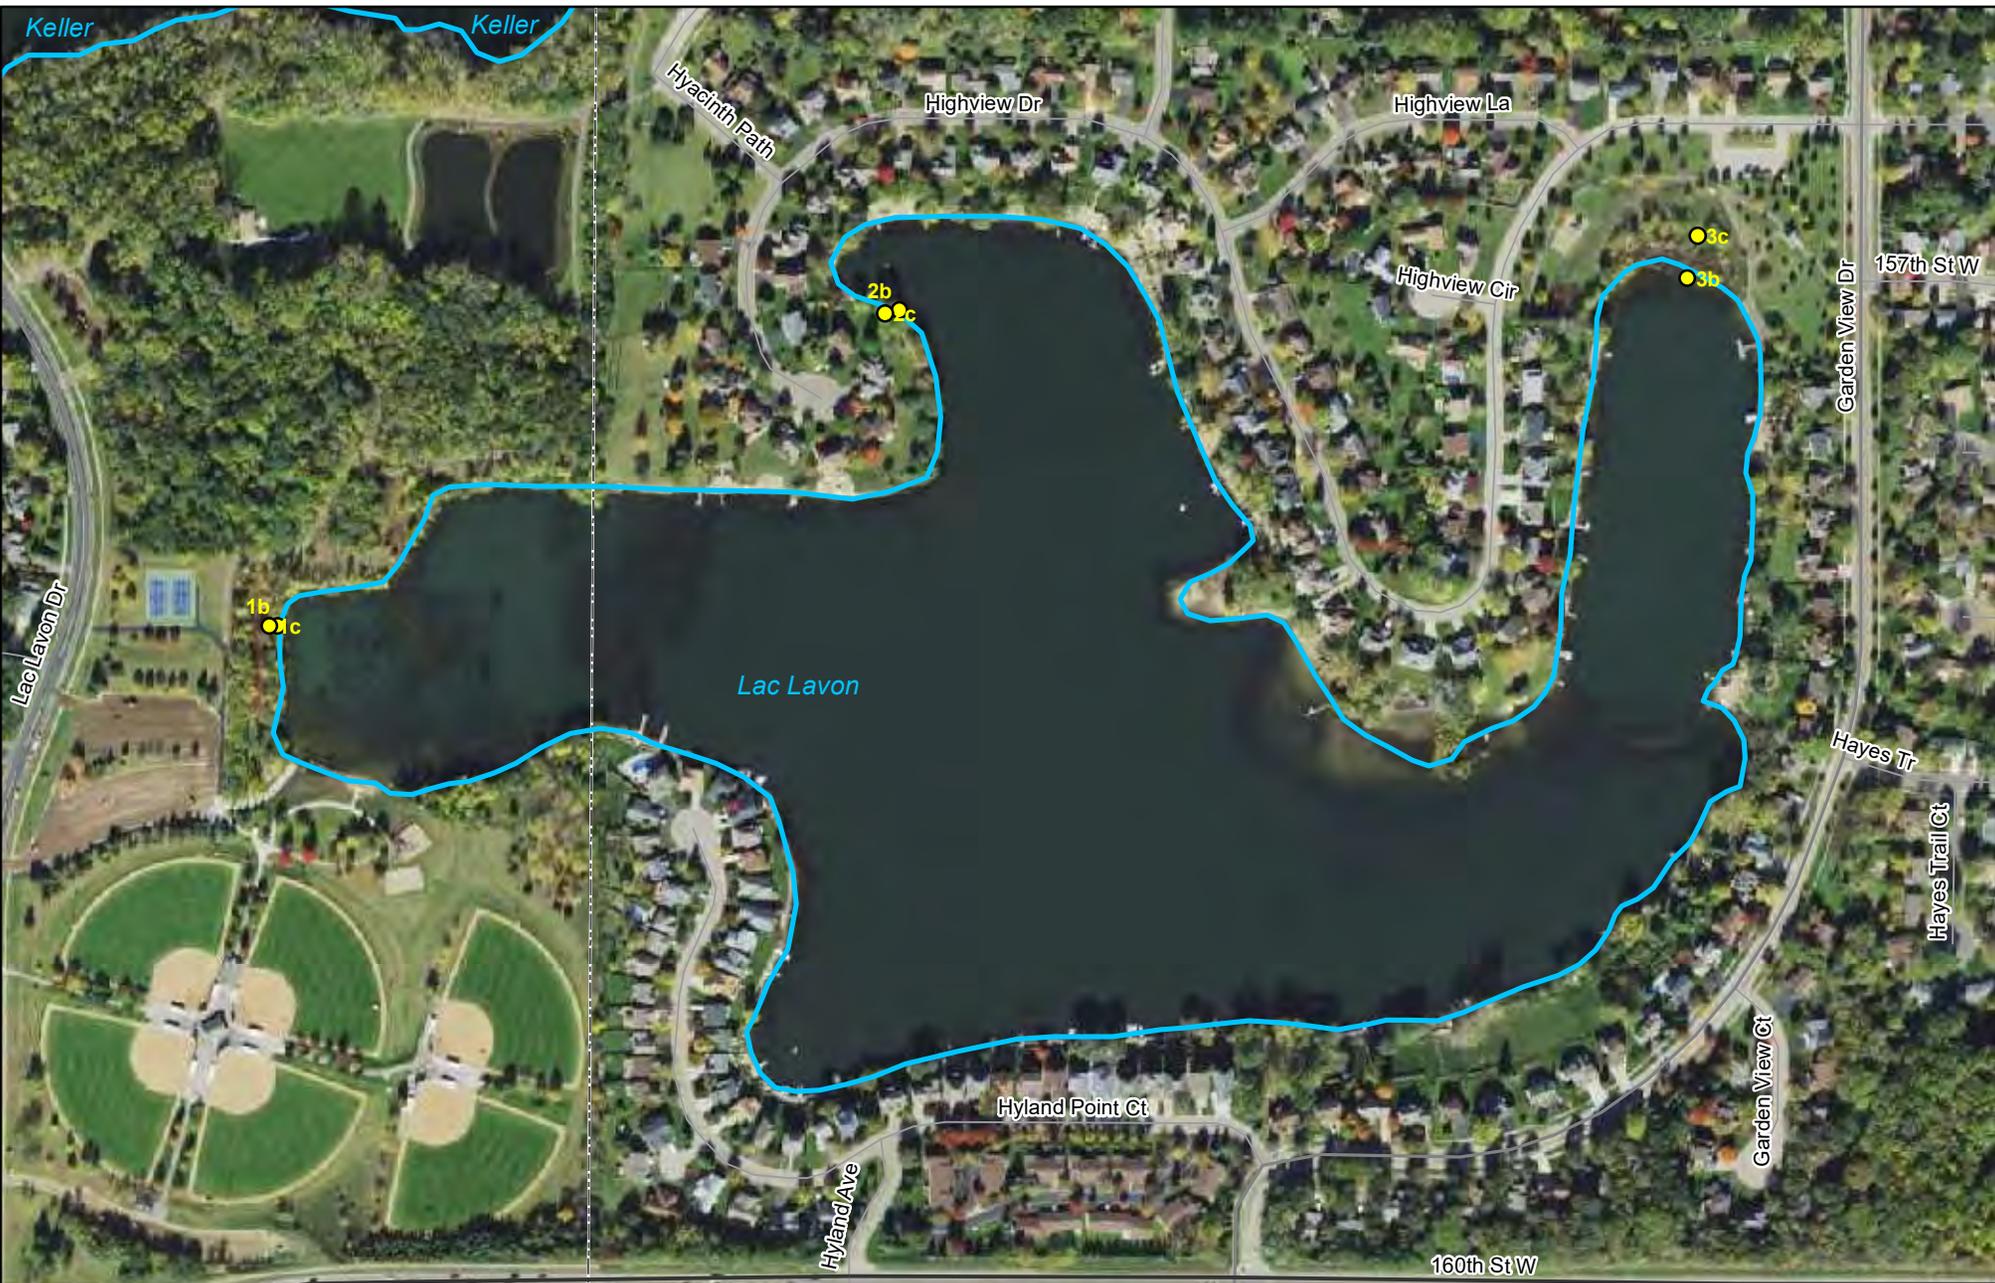
**Figure 2**  
**LAC LAVON**  
**SAMPLE PLOT LOCATIONS**  
**Black Dog WMO**  
**Burnsville and Apple Valley, MN**

**Figure 2** shows the 2017 aerial imagery of Lac Lavon.

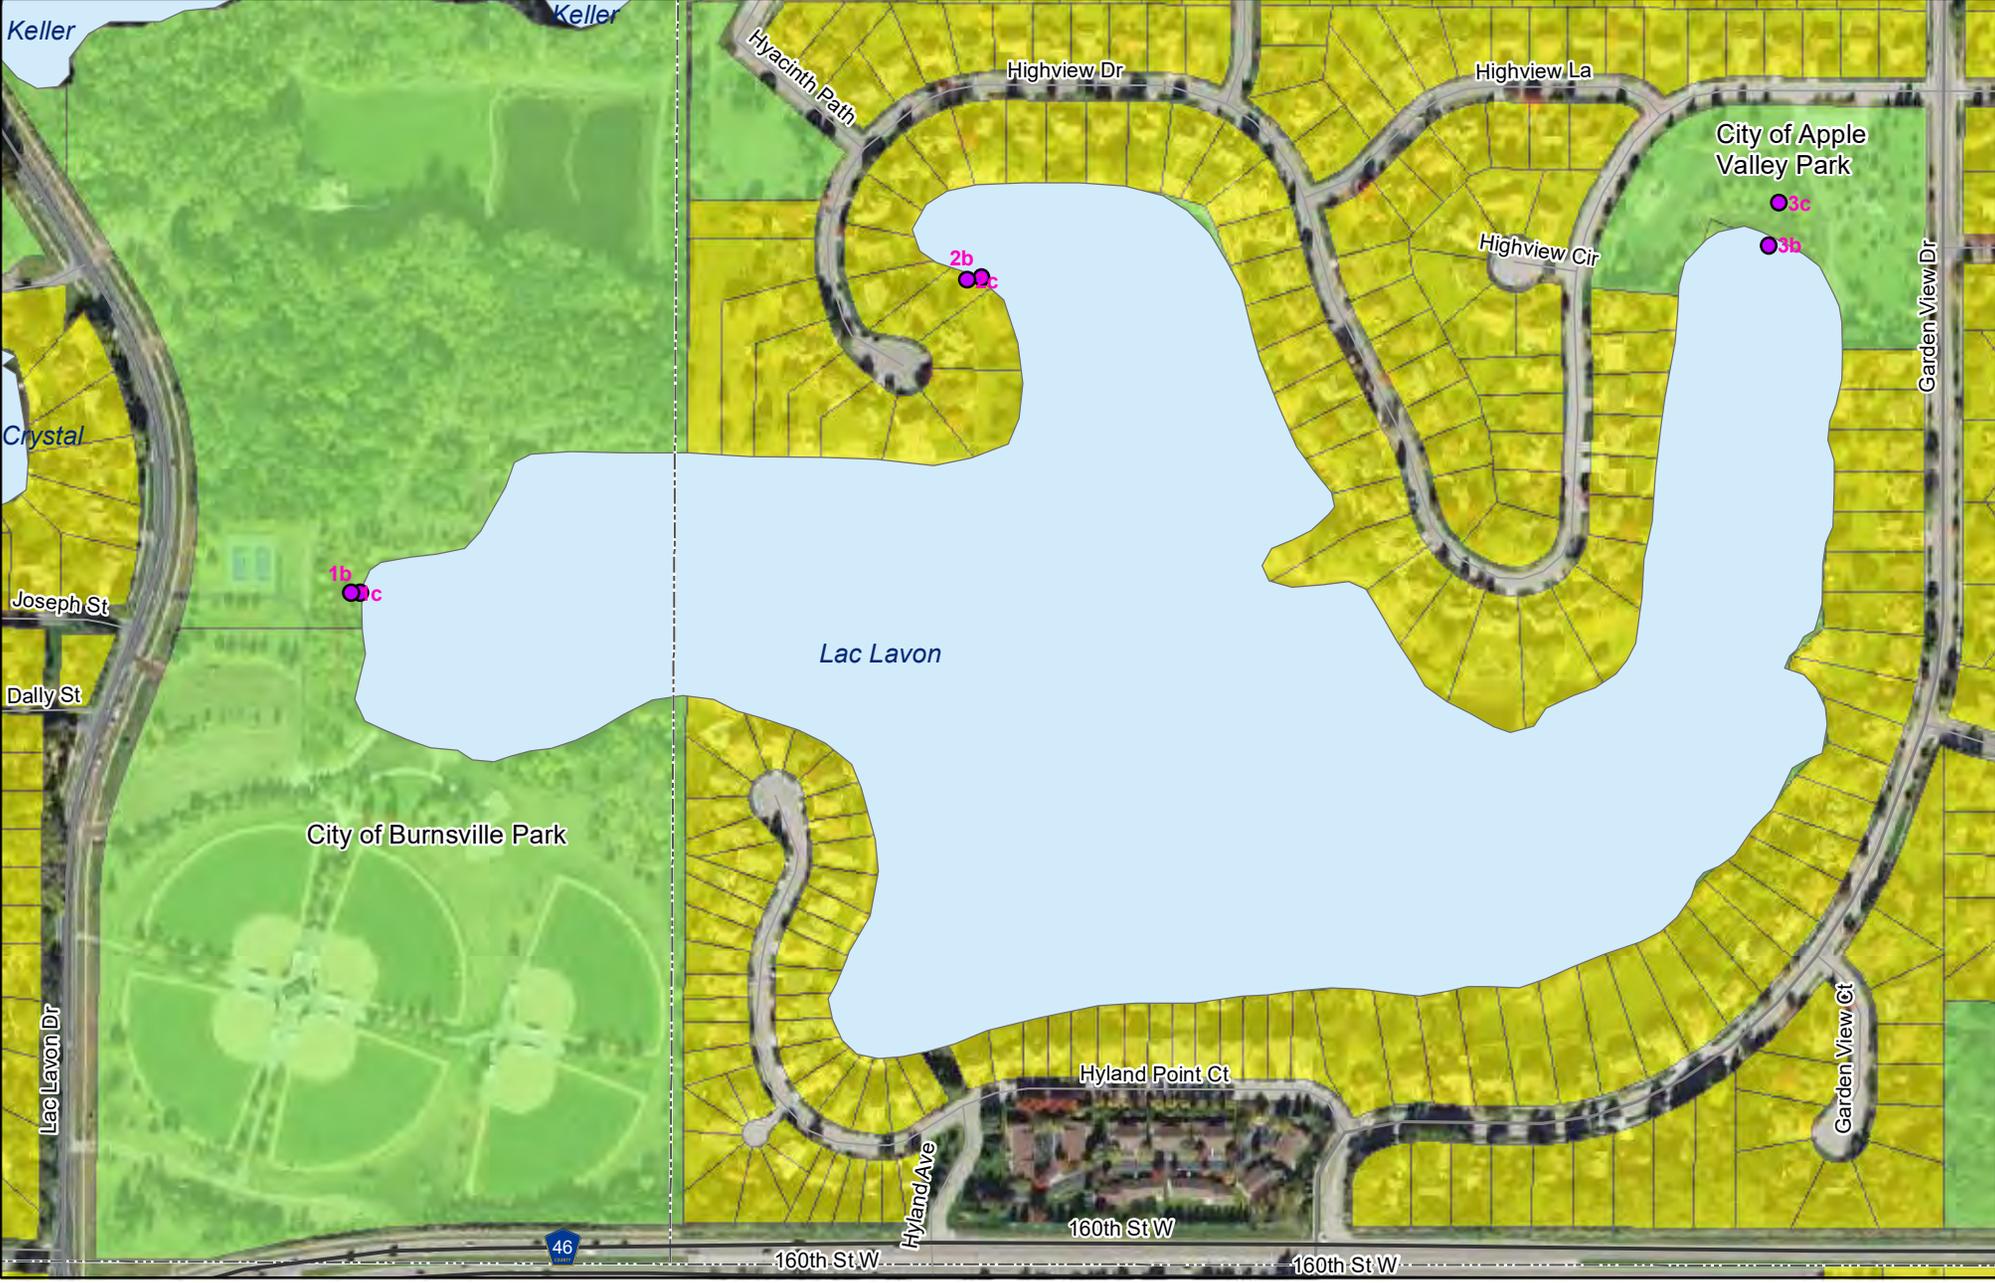
**Figure 3**  
**LAC LAVON**  
**SHORELINE PARCEL OWNERSHIP**  
**Black Dog WMO**  
**Burnsville and Apple Valley, MN**

The shoreline property ownership around Lac Lavon is about 80% residential and 20% city ownership.

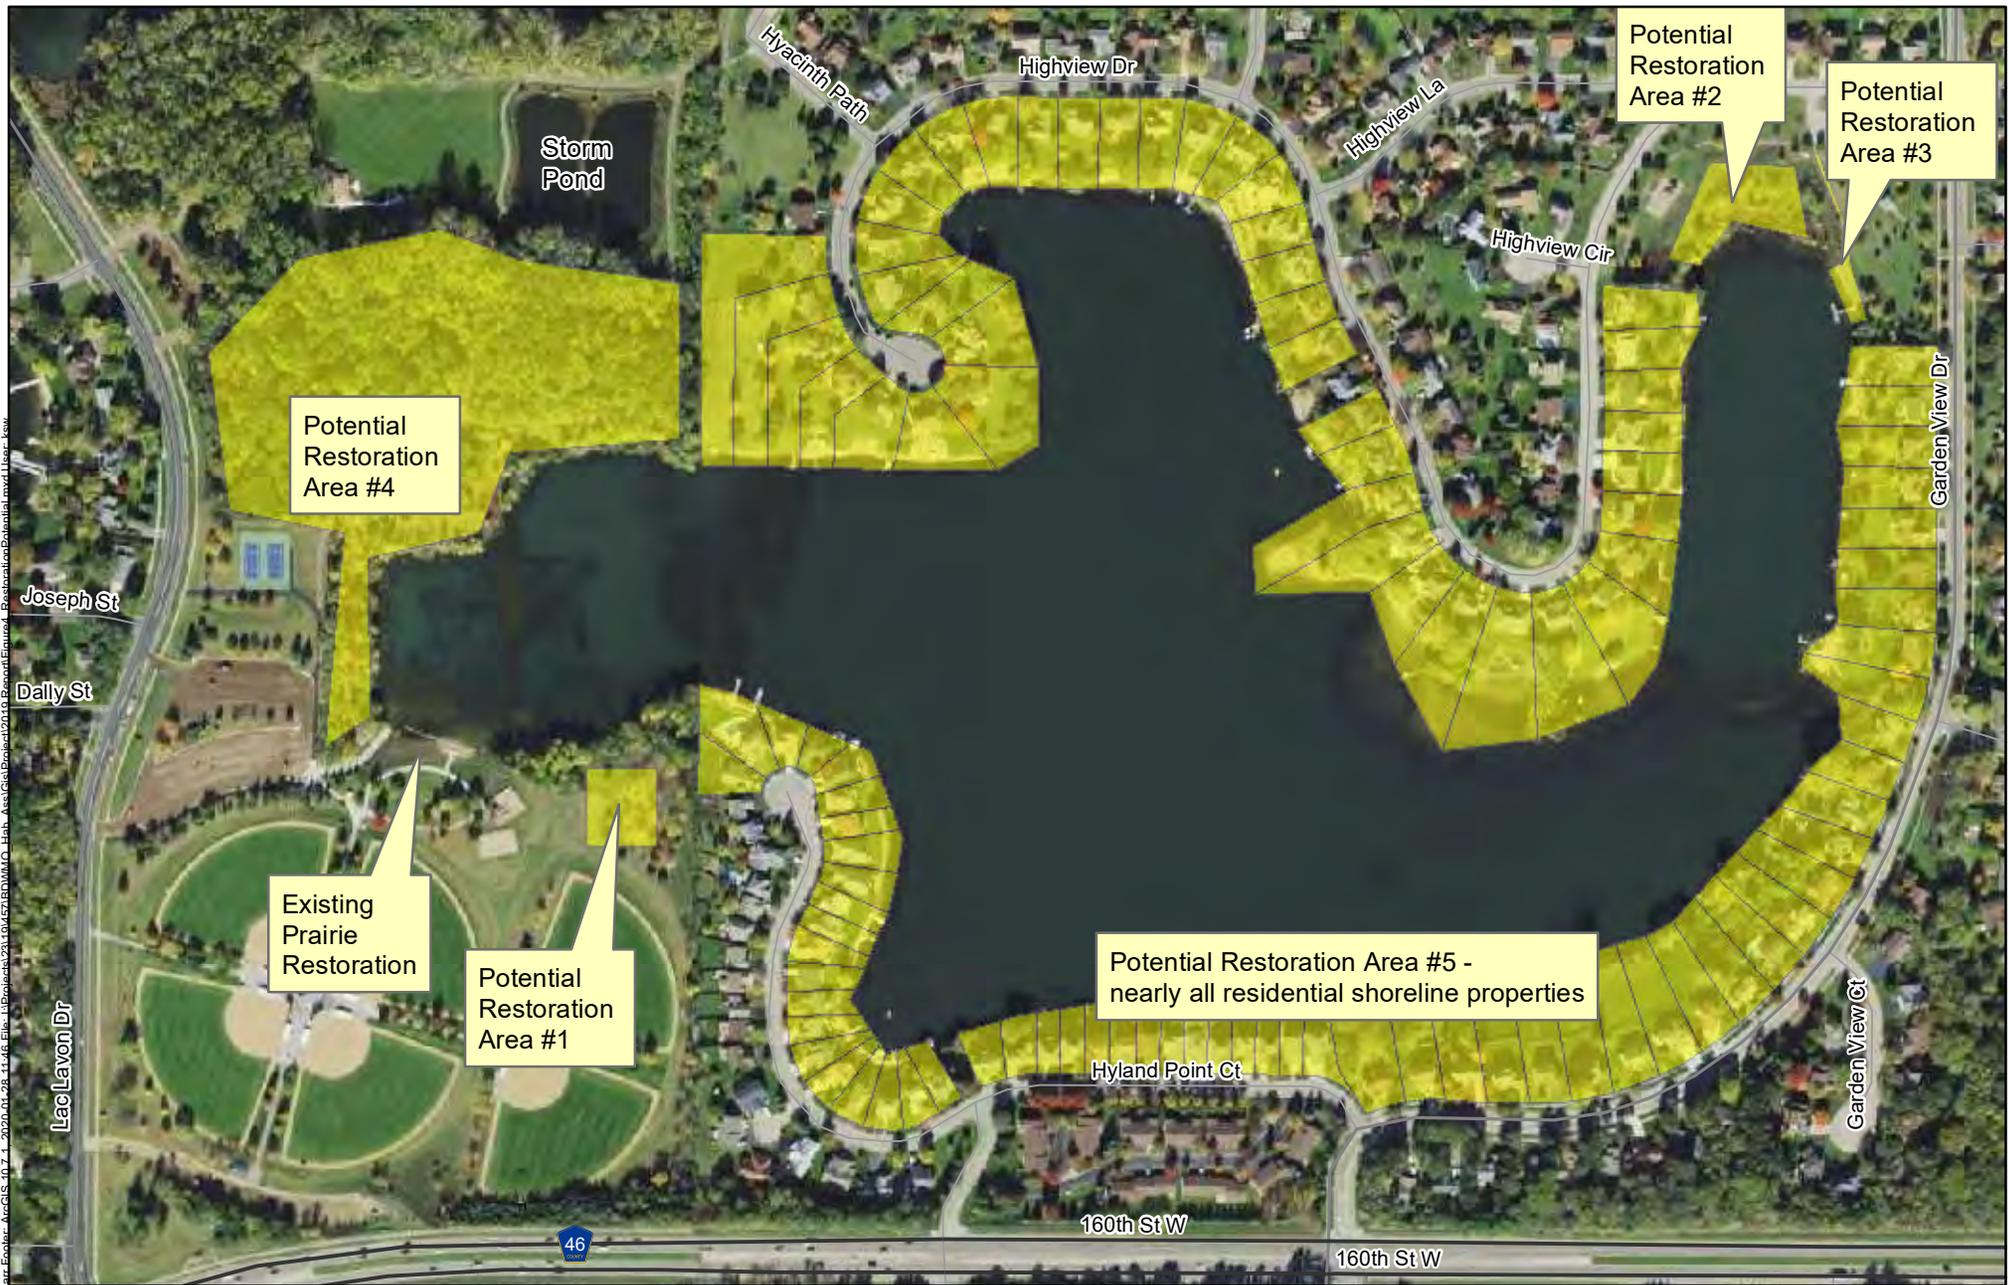
**LAC LAVON  
Potential Restoration Areas  
Black Dog WMO  
Burnsville and Apple Valley, MN**

Potential Restoration Areas

2. Continue to control and manage non-native invasive vegetation including purple loosestrife, buckthorn, Siberian elm, leafy spurge, and spotted knapweed. The prairie restoration area in the southwest portion of the lakeshore could be extended to the east along a hillside in an area that does not appear to be used for any activities. This area is currently dominated by non-native knapweed. This project could potentially receive funding assistance from the Dakota SWCD Landscaping for Clean Water program. (**Potential Restoration Areas #1, 2, and 4, as shown in Figure 4 and photos**)

Landscaping for Clean Water program. (**Potential Restoration Area #3, as shown in Figure 4 and photos**)

4. Improve the residential shorelines with a wider naturalized emergent zone and upland buffer. Rather than manicured turf grass, sand, and bare soil, the shoreline could be vegetated with native grasses and wildflowers. A wider buffer of native vegetation could help protect water quality, prevent erosion, and improve wildlife habitat, vegetative diversity, and aesthetics. Lakeshore residents and cities could receive assistance to create shoreline restoration projects through the Dakota County SWCD Landscaping for Clean Water program. One lakeshore owner in Apple Valley has completed a shoreline restoration project and received technical assistance from the Dakota County SWCD (See **Appendix G** for examples of shoreline restorations). As more lakeshore residents restore their shoreline to naturalized vegetation, the benefits of improved wildlife habitat, vegetation diversity, water quality, aesthetics, and recreation will be realized (**Potential Restoration Area #5, as shown in Figure 4 and photos**).

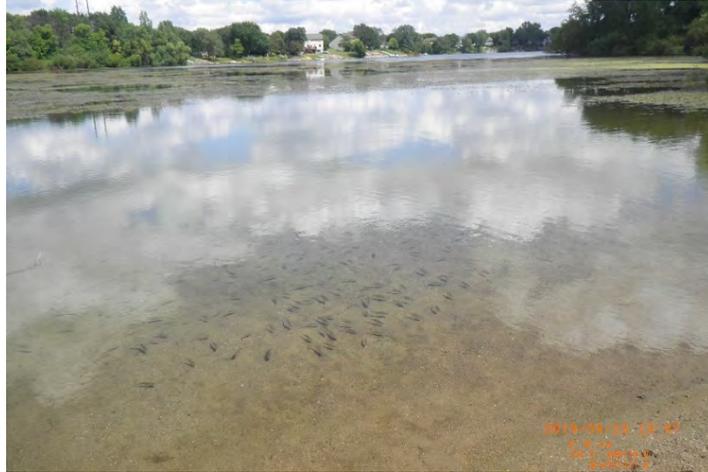
Submergent Zone –west portion of Lac Lavon

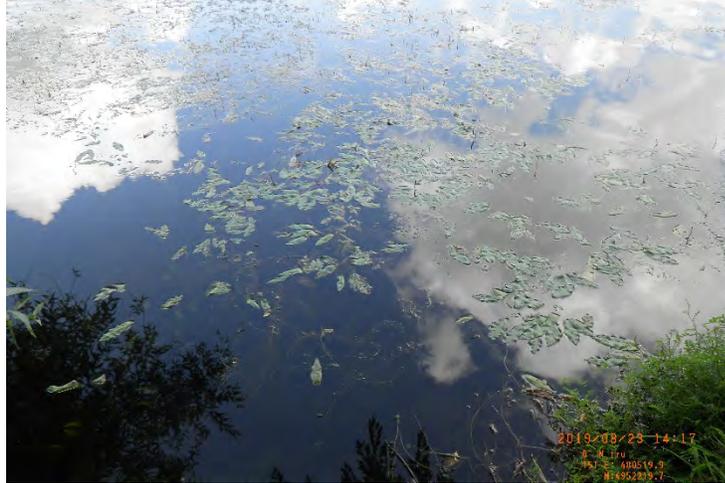
Submergent Zone – north portion of Lac Lavon

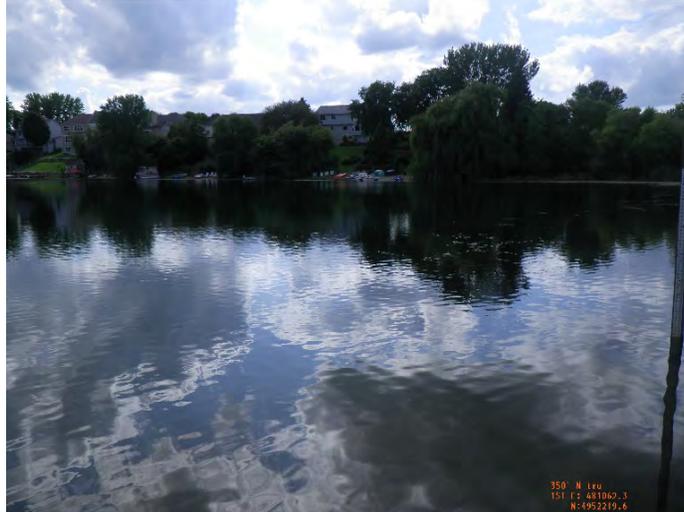
Submergent Zone – northeast portion of Lac Lavon

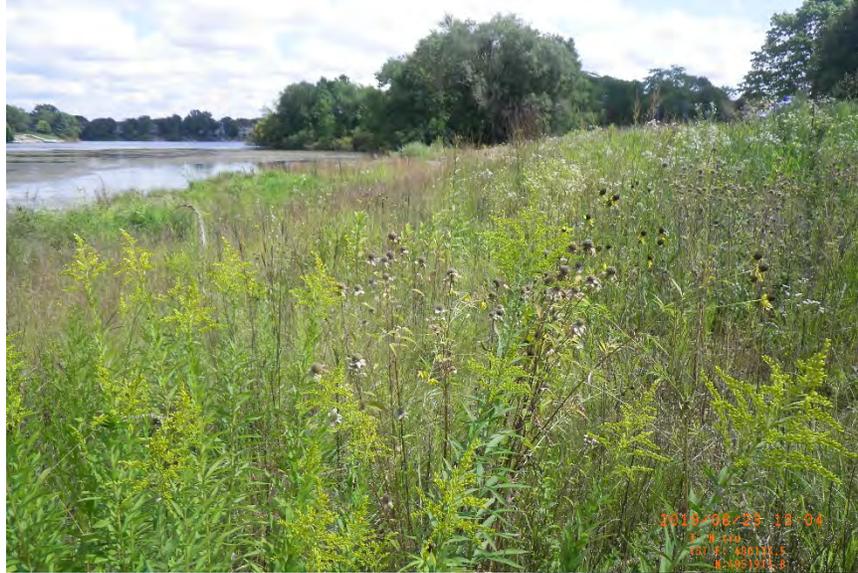
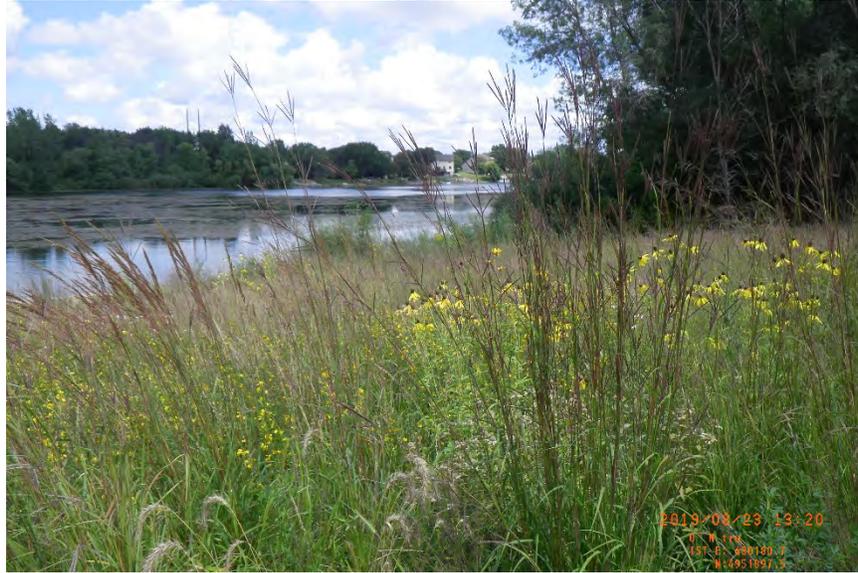
City of Burnsville prairie restoration area

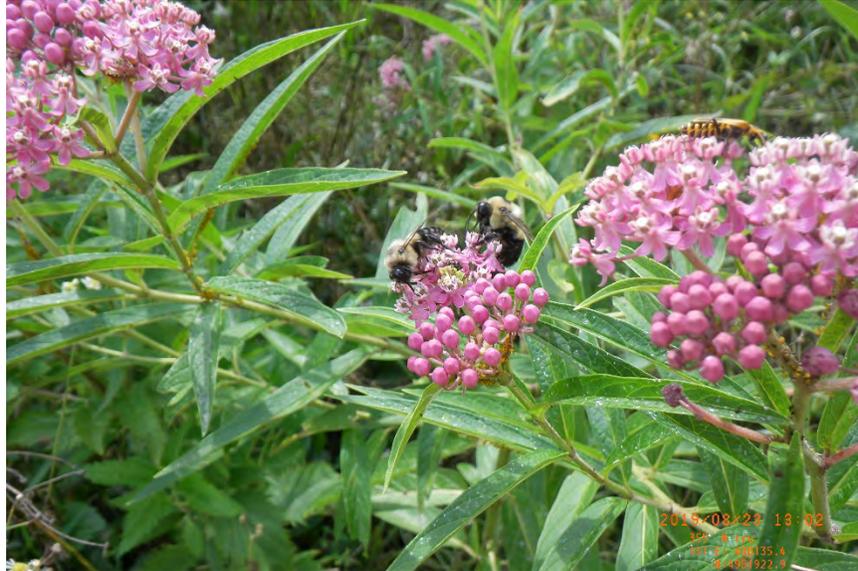
The City of Burnsville prairie restoration area provides habitat for pollinators

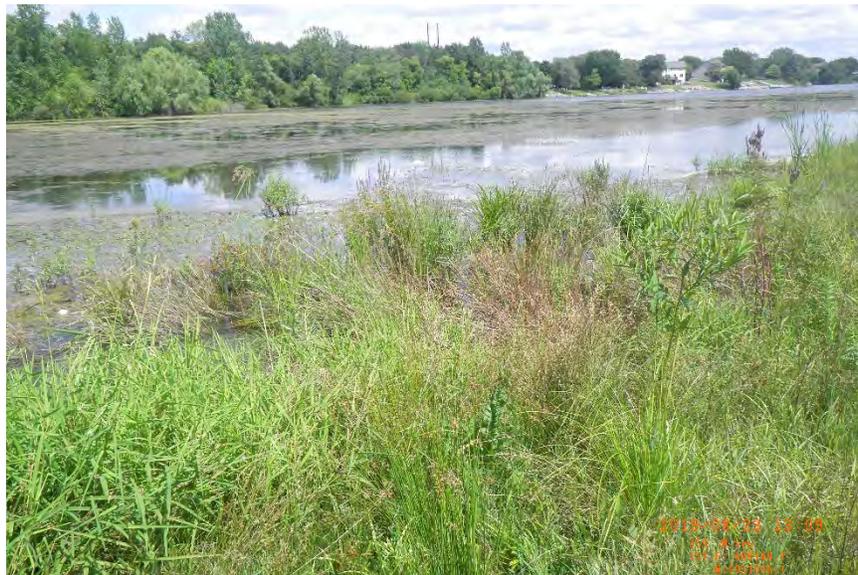
Emergent shoreline adjacent to City prairie restoration was also seeded with native vegetation.

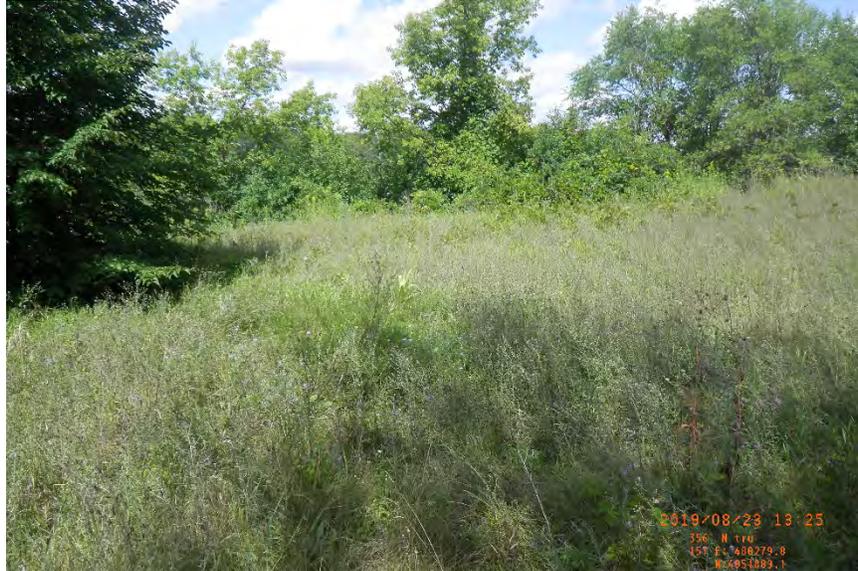
Potential restoration area #1 - The City of Burnsville prairie restoration area could be extended to include this area currently dominated by knapweed. Remove knapweed and restore with tall grass prairie.

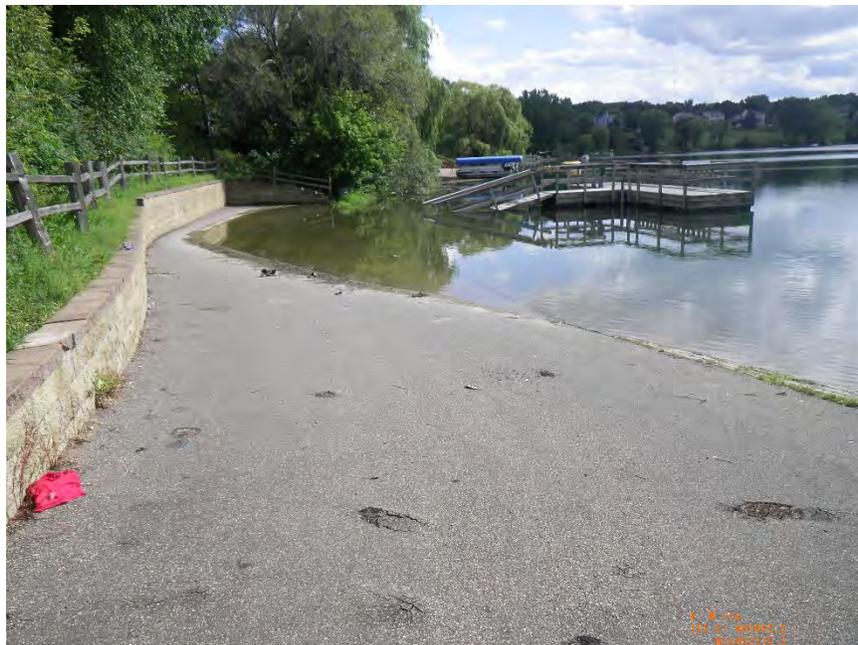
Flooded conditions in 2019 prevented access to fishing dock in City of Apple Valley Park

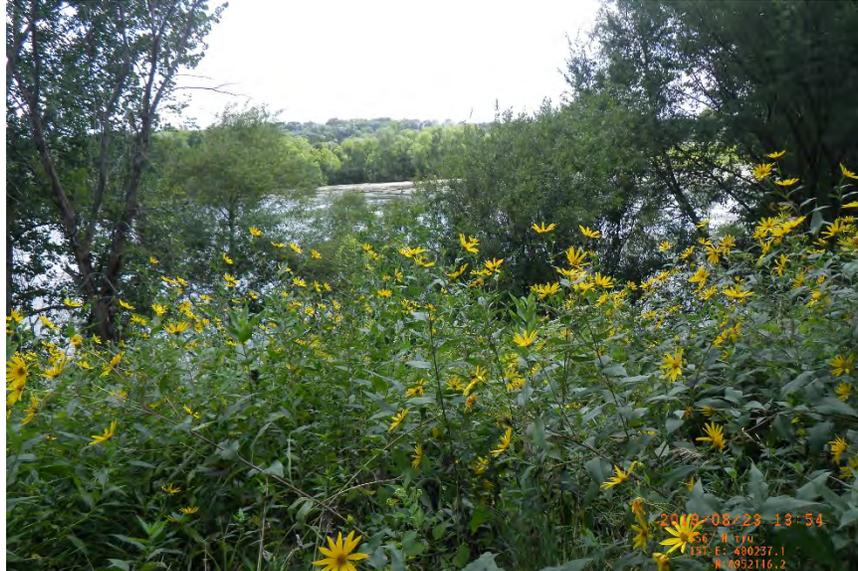
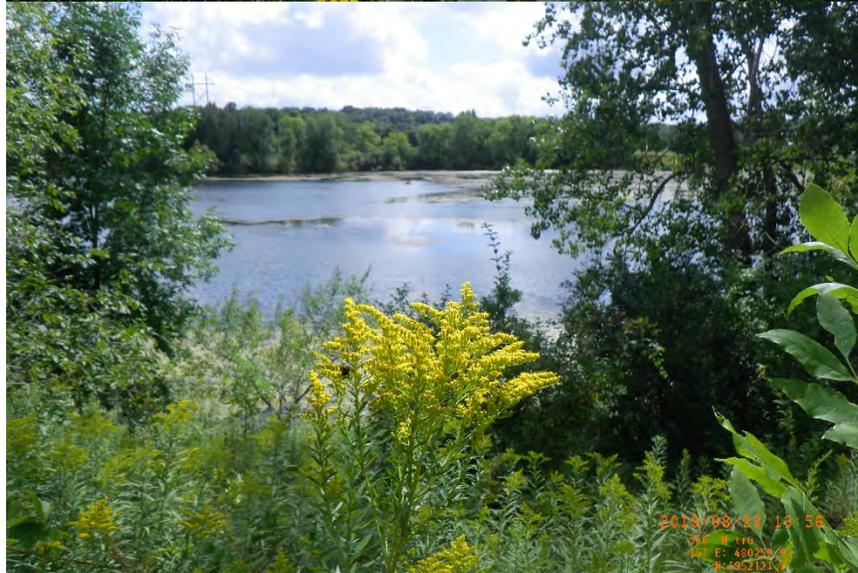
Typical shoreline along City owned property with wide naturalized buffer helps prevent shoreline erosion and provides wildlife habitat.

Potential Restoration Areas #2 and #4 – Continue to control non-native invasive vegetation with the naturalized upland buffer areas in the city parks, including control of buckthorn, Siberian elm, leafy spurge, and spotted knapweed.

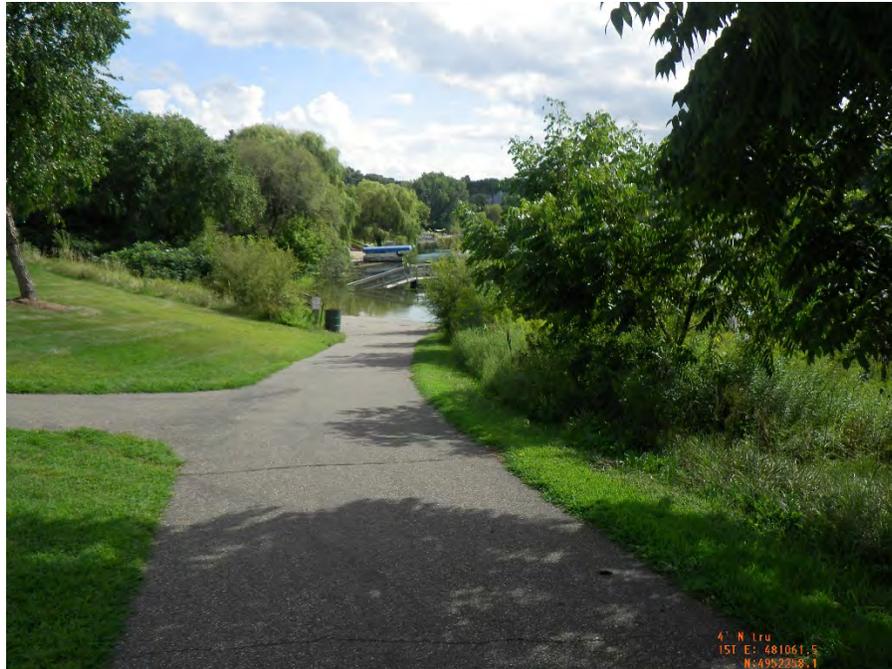
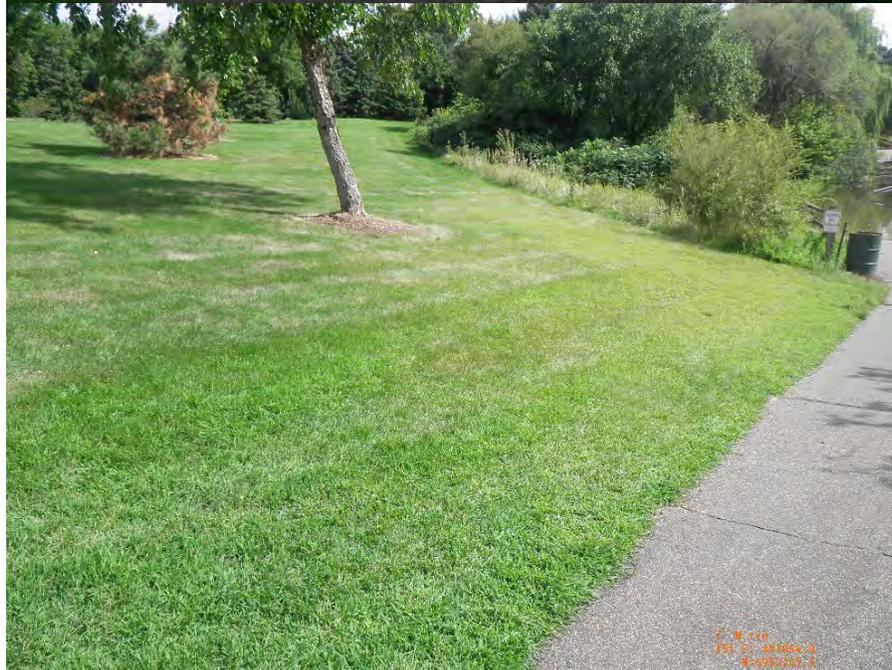
Potential Restoration Area #3 – Stormwater flows directly to the lake along impervious surfaces and turf grass where it can collect pollutants and decrease water quality. Create buffer strips of naturalized vegetation adjacent to the bituminous lake access pathway to slow down and pretreat stormwater prior to entering the lake.

3. Strategically create buffer strips of naturalized vegetation adjacent to the bituminous lake access pathway to slow down and pretreat stormwater prior to entering the lake in the Apple Valley Park near the fishing pier. This project could potentially receive funding assistance from the Dakota SWCD

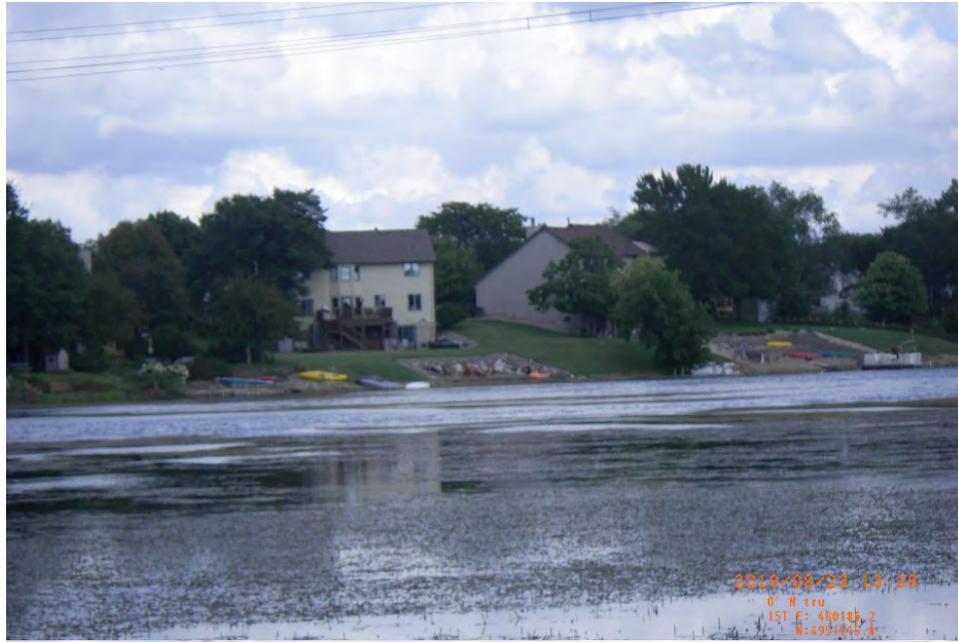
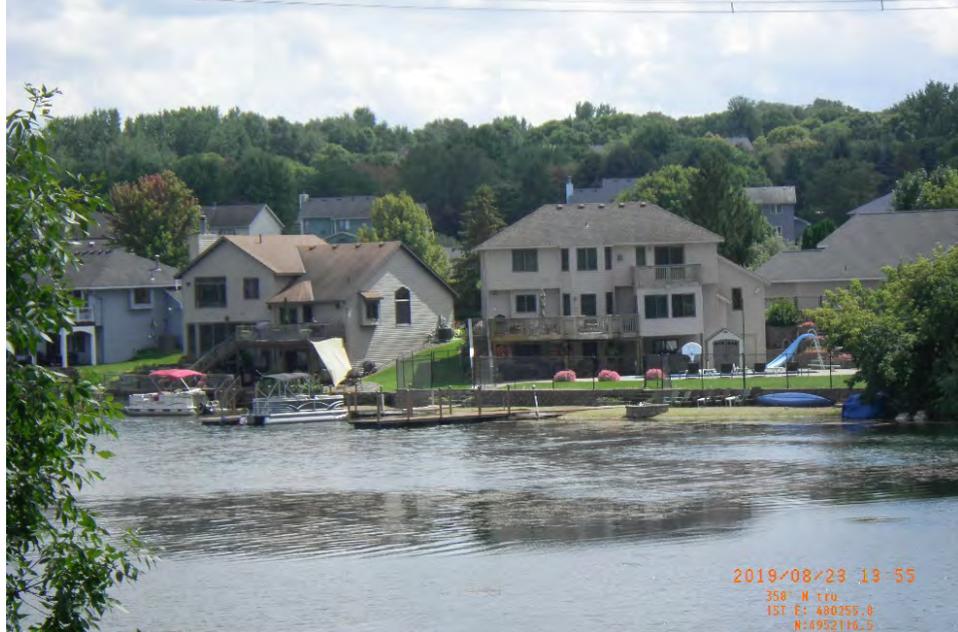
Typical residential shoreline – mowed turf grass or sand beach to edge of water, lacking protective vegetation.

Potential Restoration Area #5 - Sturdy native vegetation in the emergent zone and upland buffer of residential properties could provide more shoreline stability.

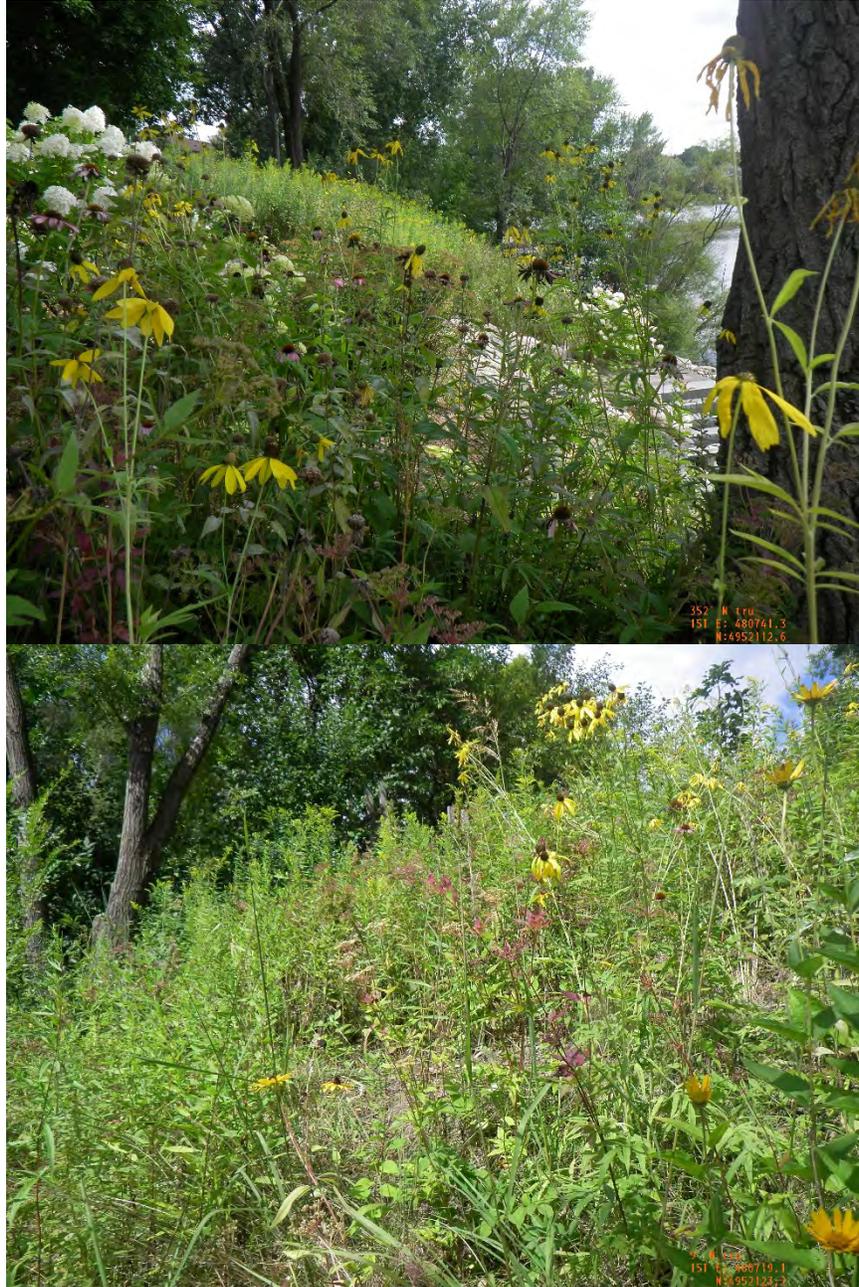
A successful existing residential shoreline restoration
