Black Dog Watershed Management Commission

AGENDA

Wednesday, March 17, 2021

Technical Memorandum

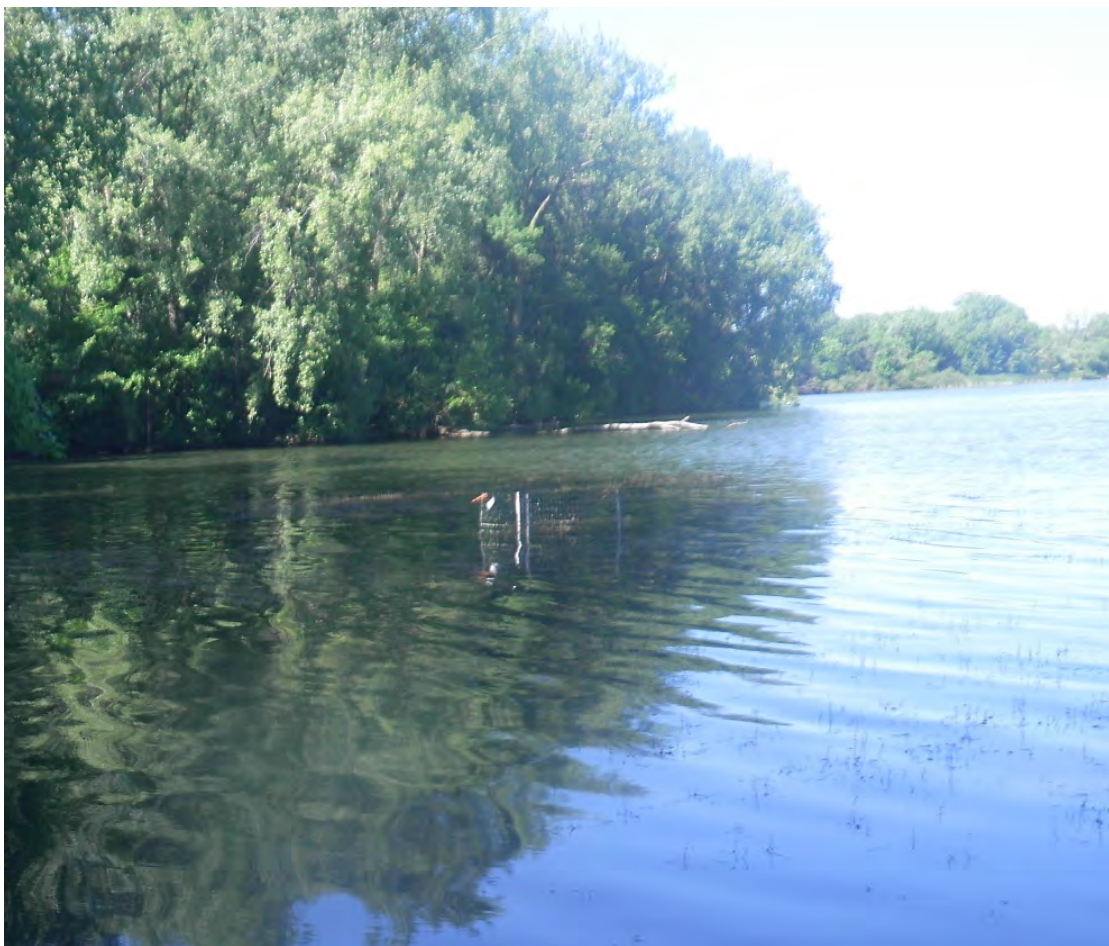
One of ten fenced plots including transplanted native aquatic plants.

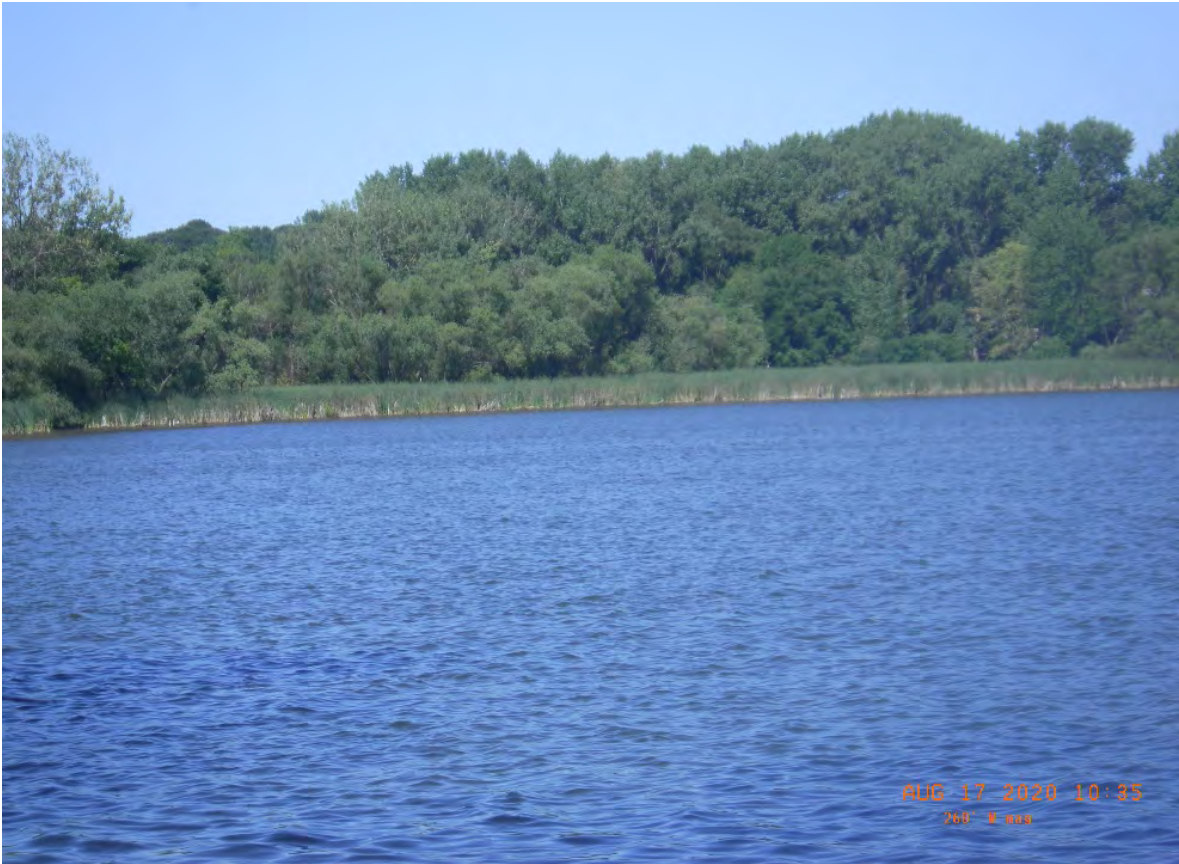
Shoreline along City owned property with wide naturalized emergent zone and upland buffer, which helps prevent shoreline erosion and provide wildlife habitat.

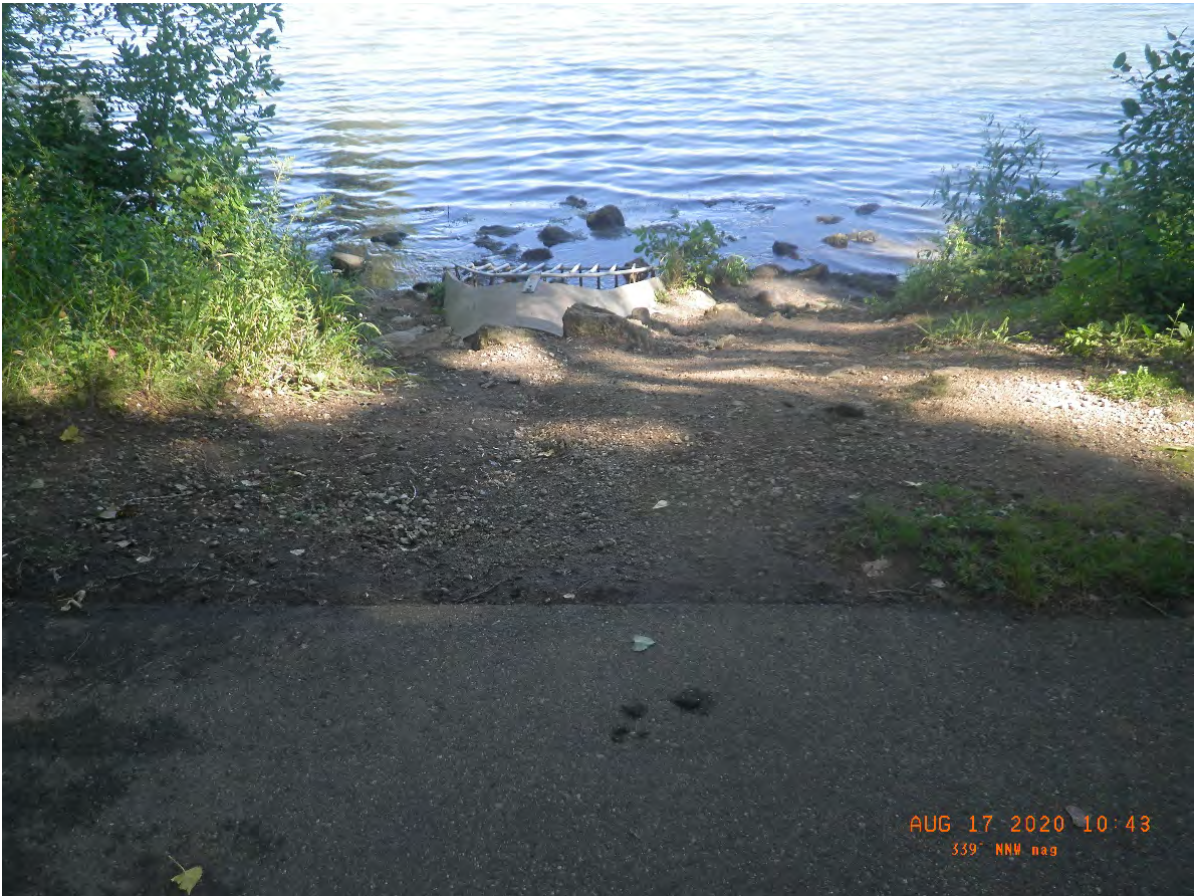
Potential Restoration Area #1 – Seed or plant vegetation in area surrounding the inlet from storm pond

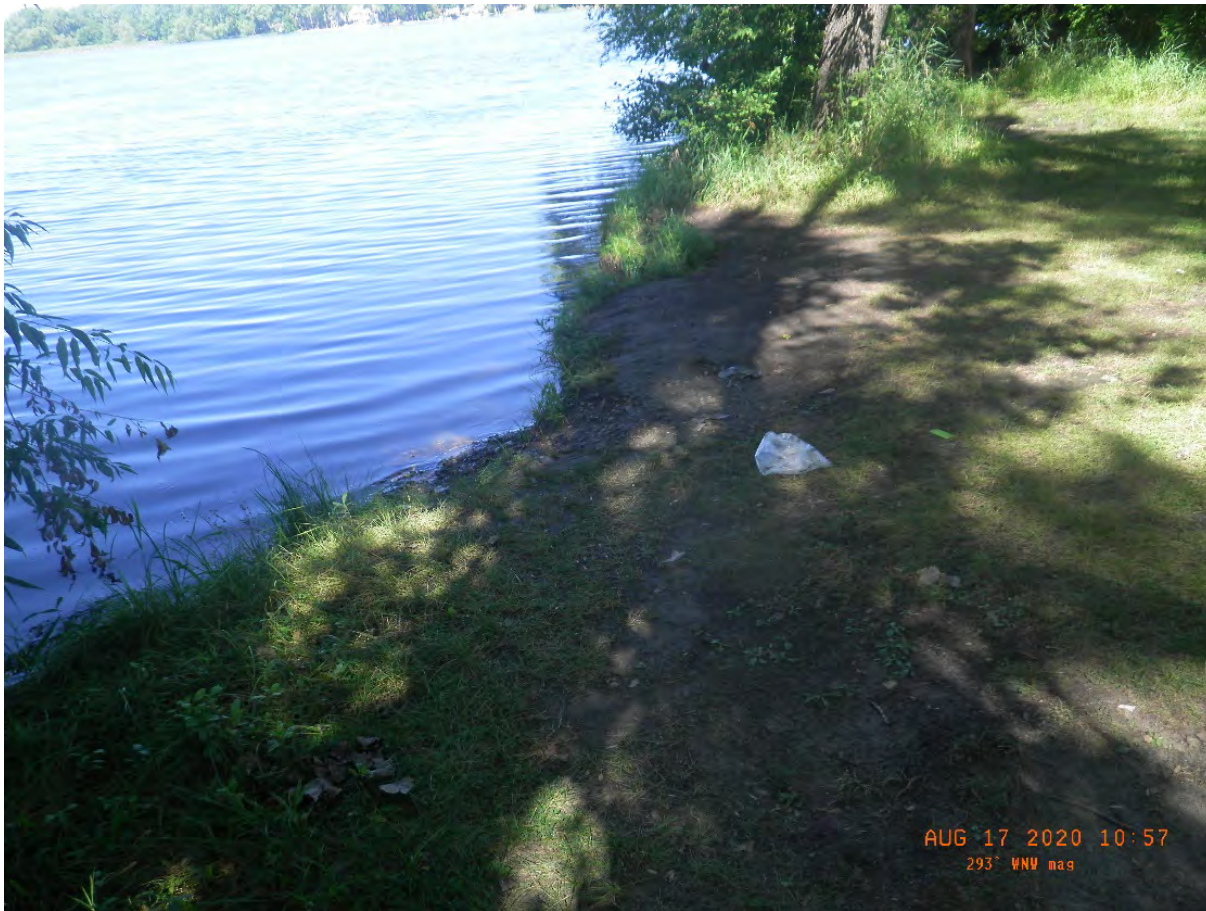
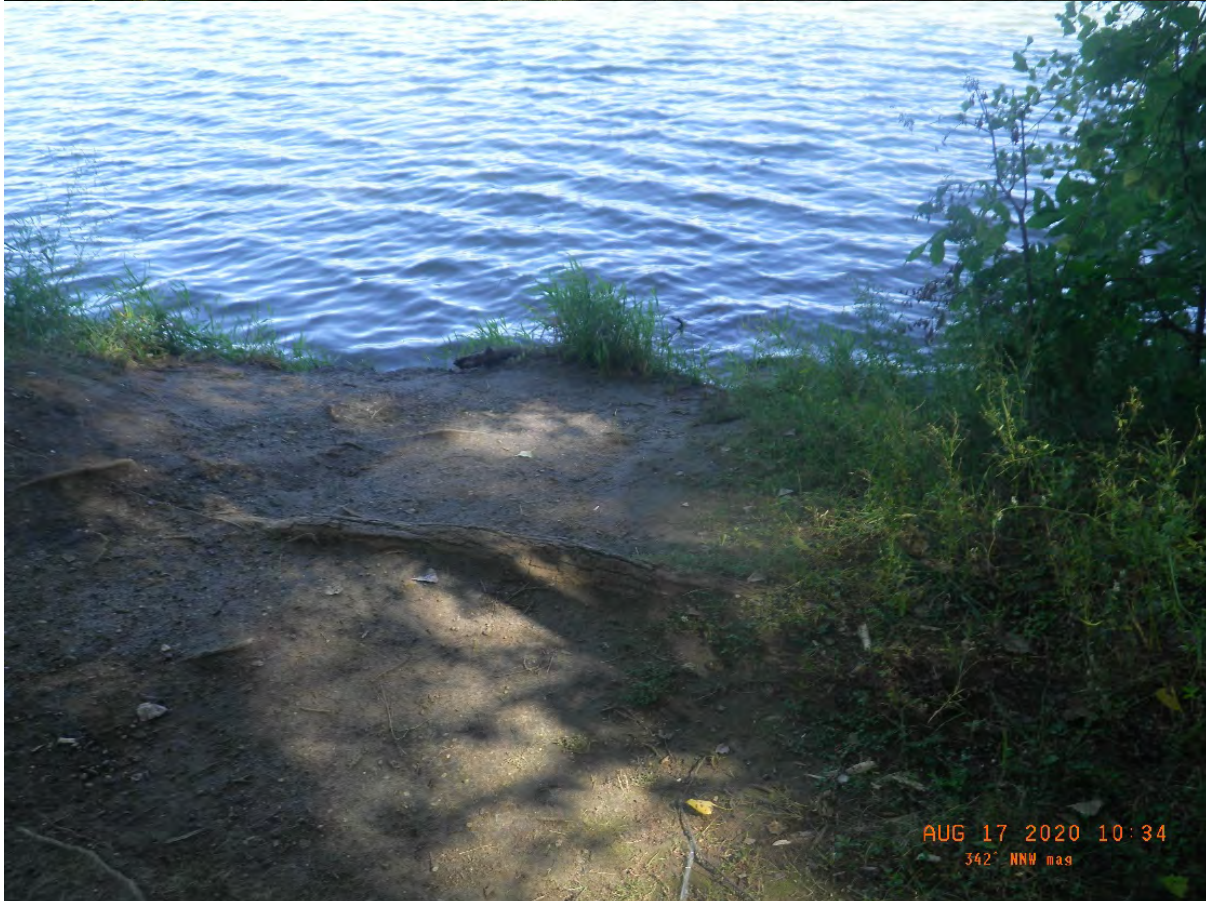
Potential restoration area #2 – Place designated stone walkways in popular shoreline fishing and observational locations to minimize bare soil exposure.

Potential restoration area #3 – Organize a neighborhood cleanup project to pick up trash.

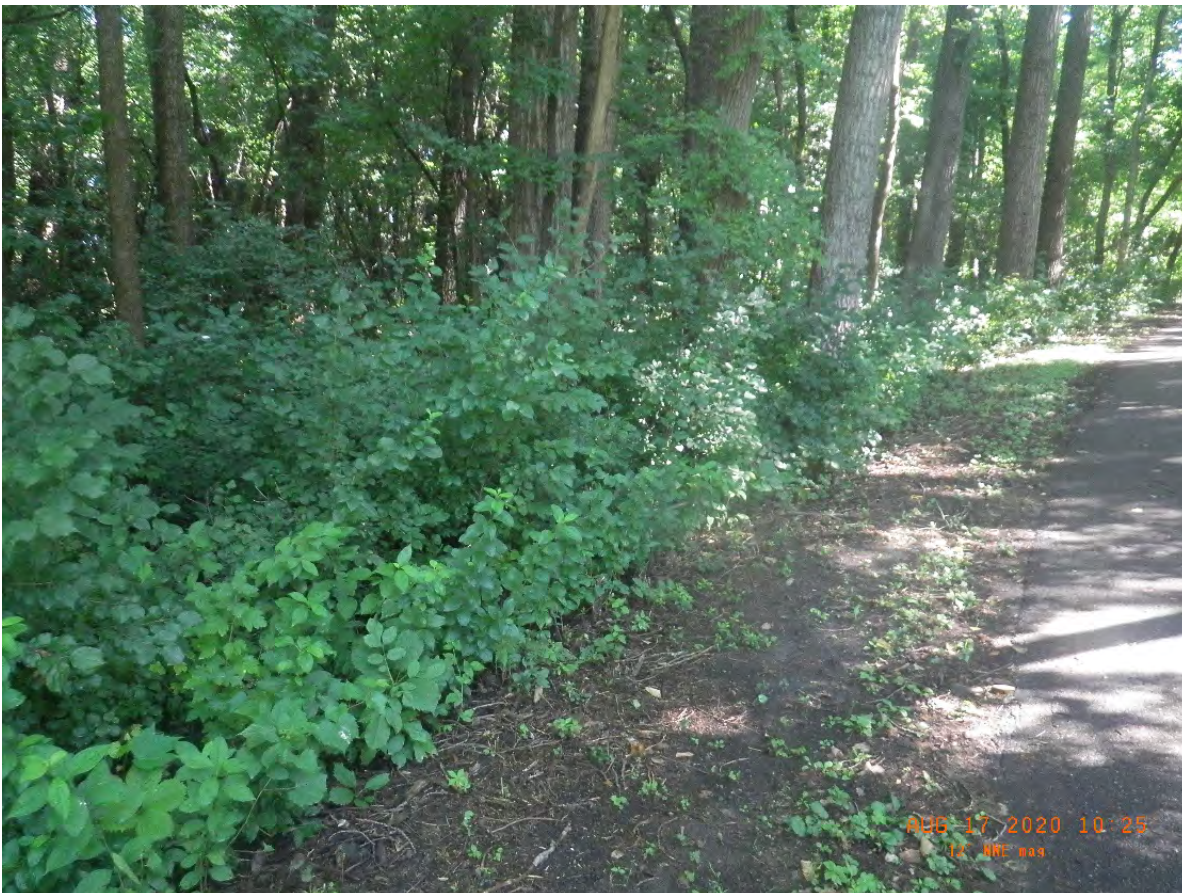
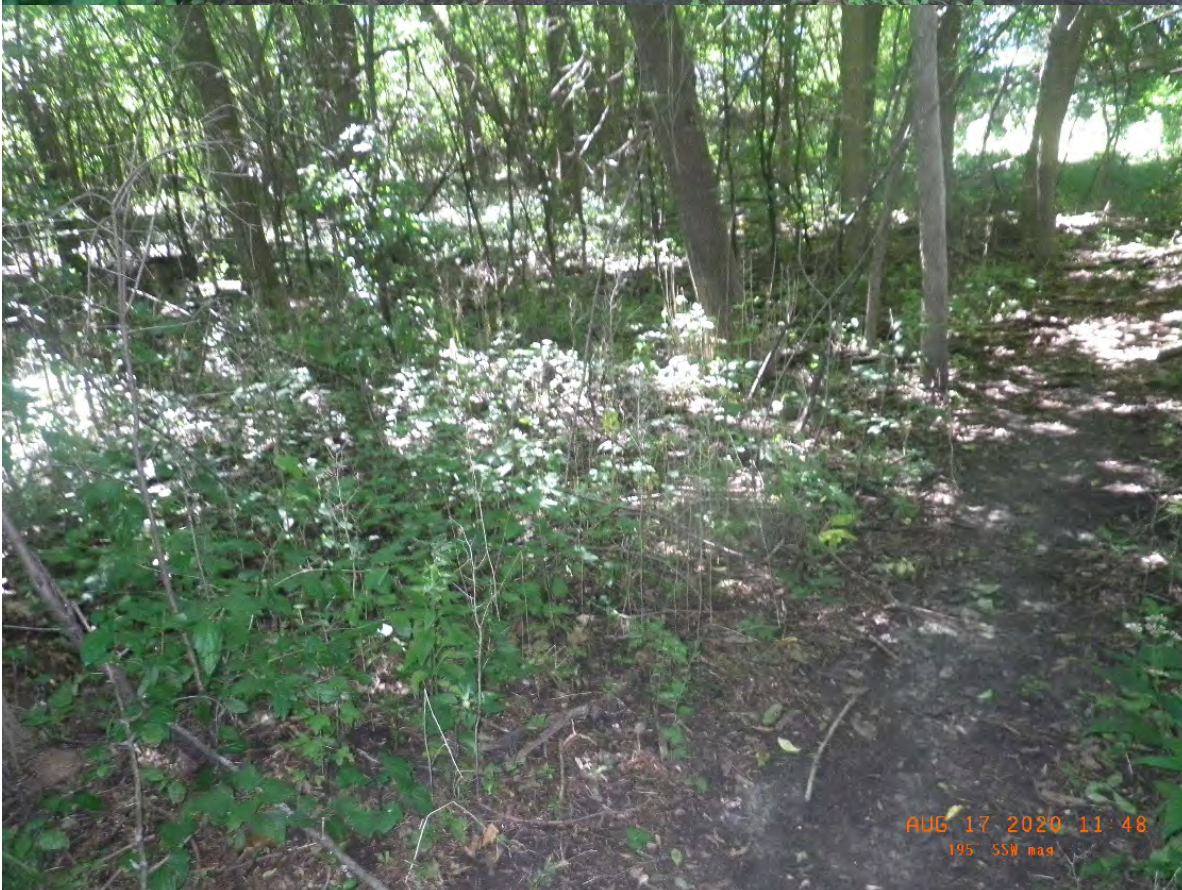
Potential Restoration Area #4 – Continue to control non-native invasive vegetation with the naturalized upland buffer areas in the city parks, including control of buckthorn and garlic mustard.

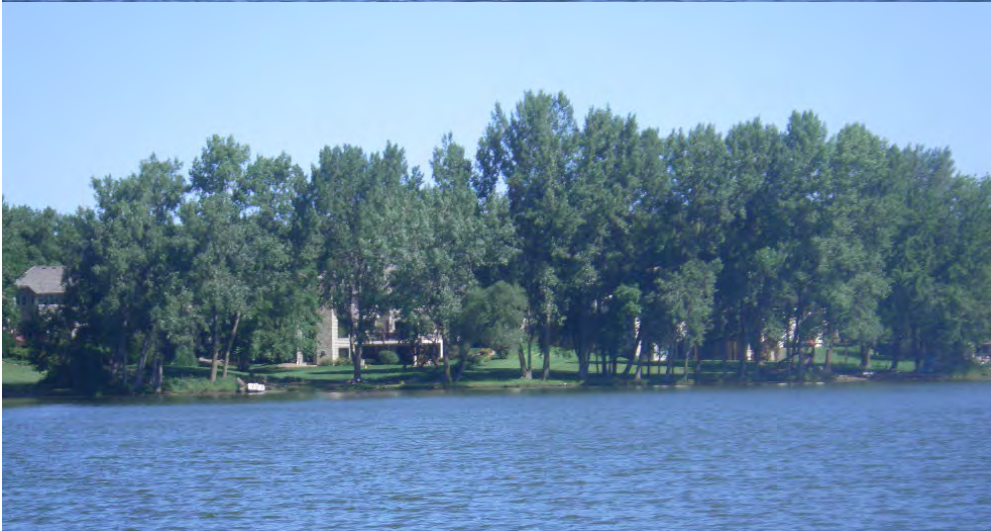
Potential restoration area #5 – Residential properties are mowed to the lakeshore edge. A wider buffer of native vegetation in the emergent zone and upland buffer of residential properties could provide more shoreline stability and wildlife habitat.

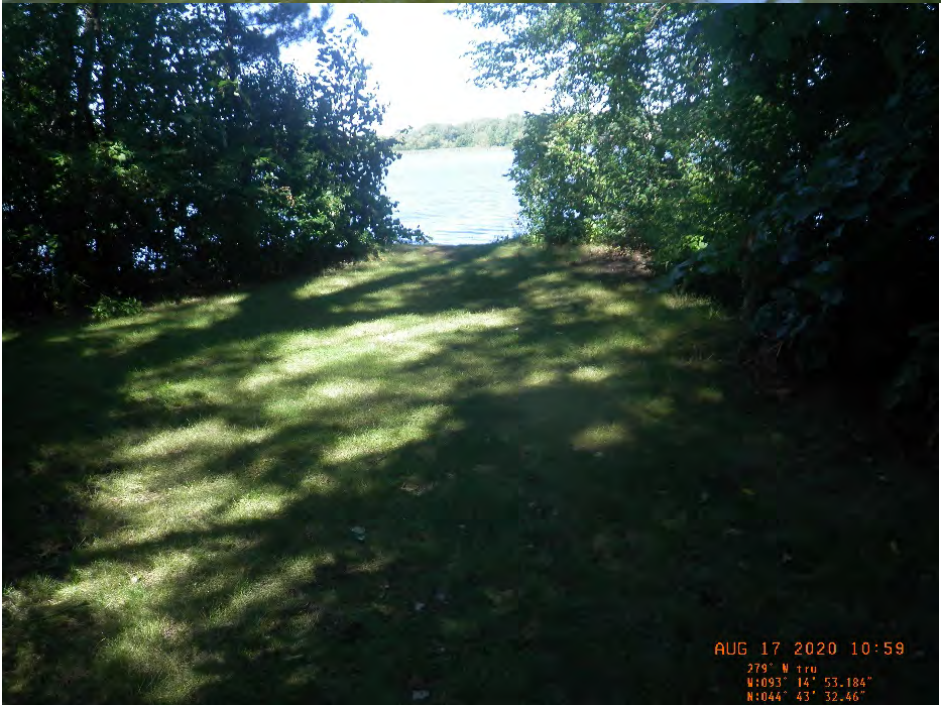
Potential Restoration Area #6 – Adjust mowing distance away from shoreline in Apple Valley’s Keller Park

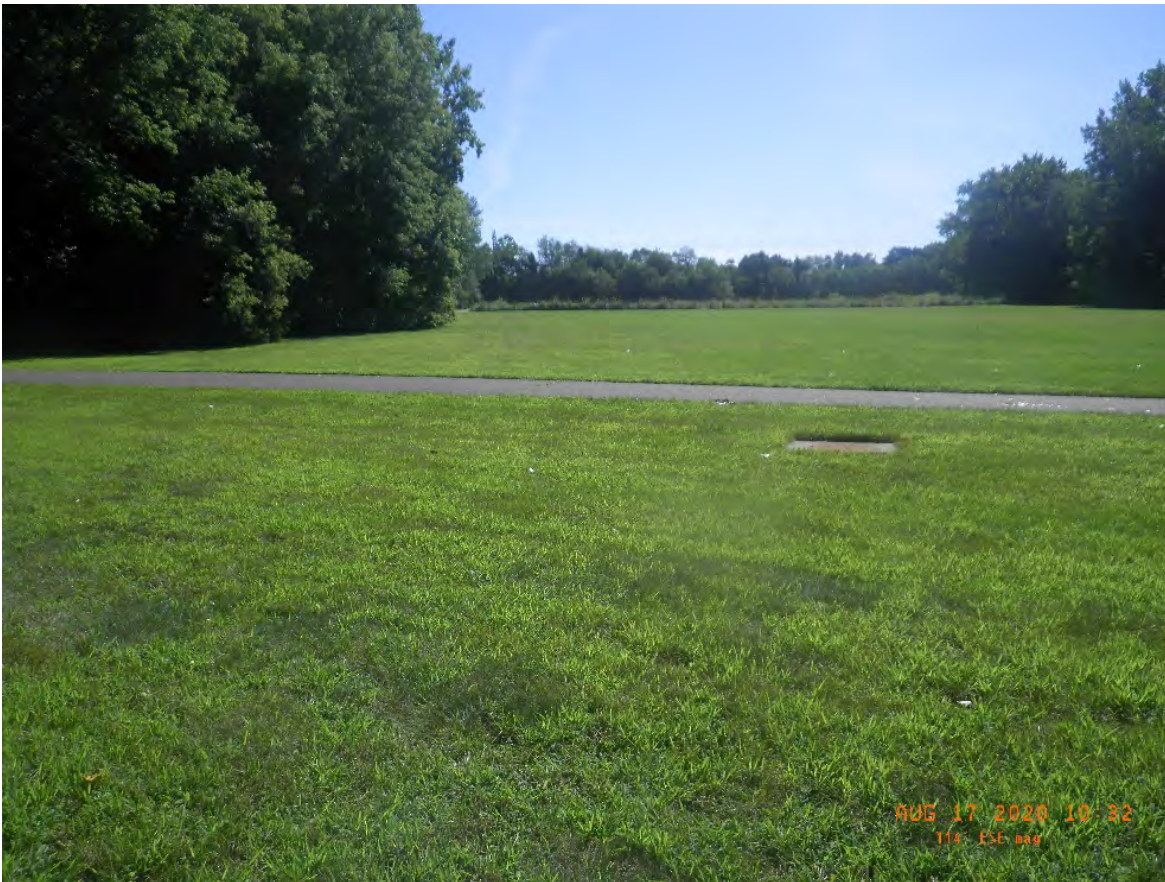
Large area of mowed grass in Lac Lavon Park south of Keller Lake. Potential Restoration Area #7 – Consider using the area for a native prairie restoration with meandering trails and educational signs.

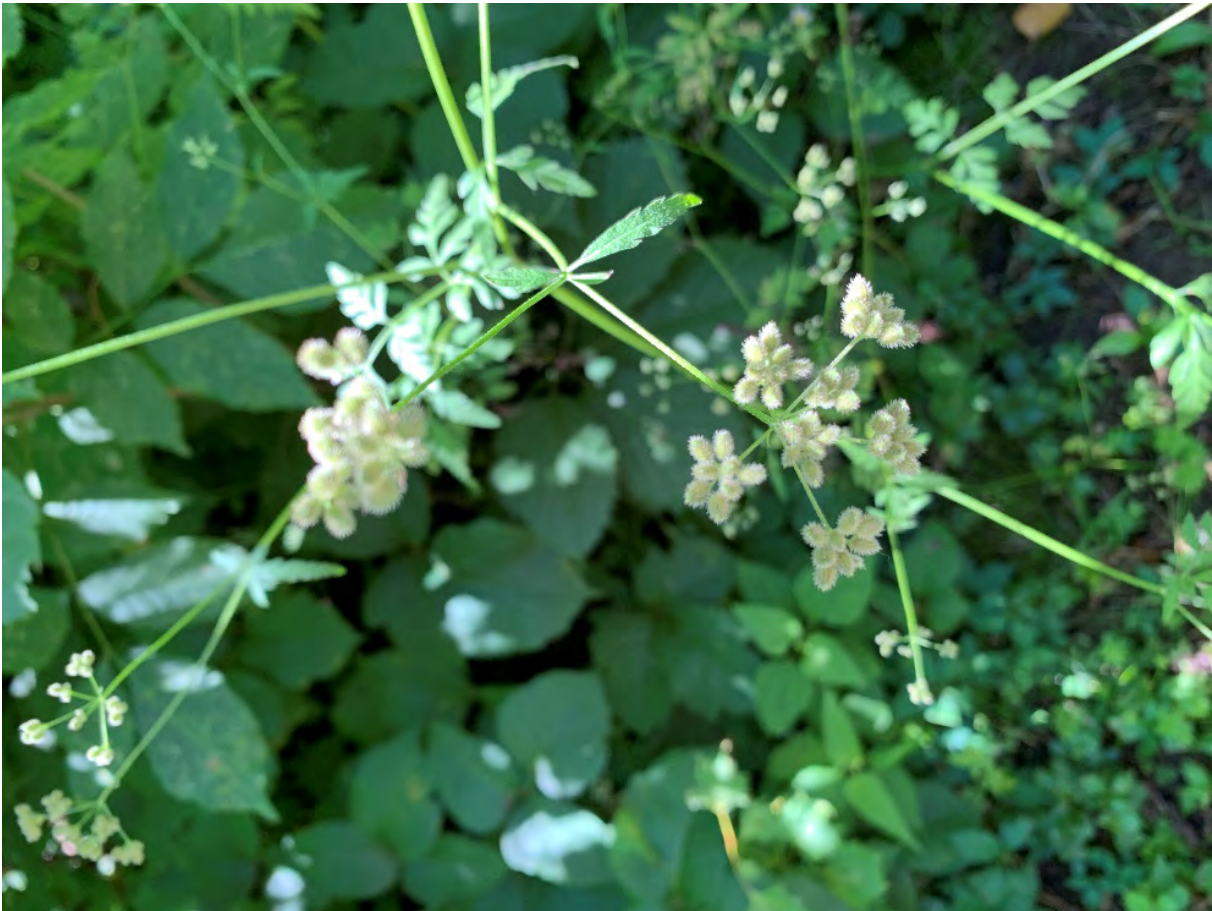
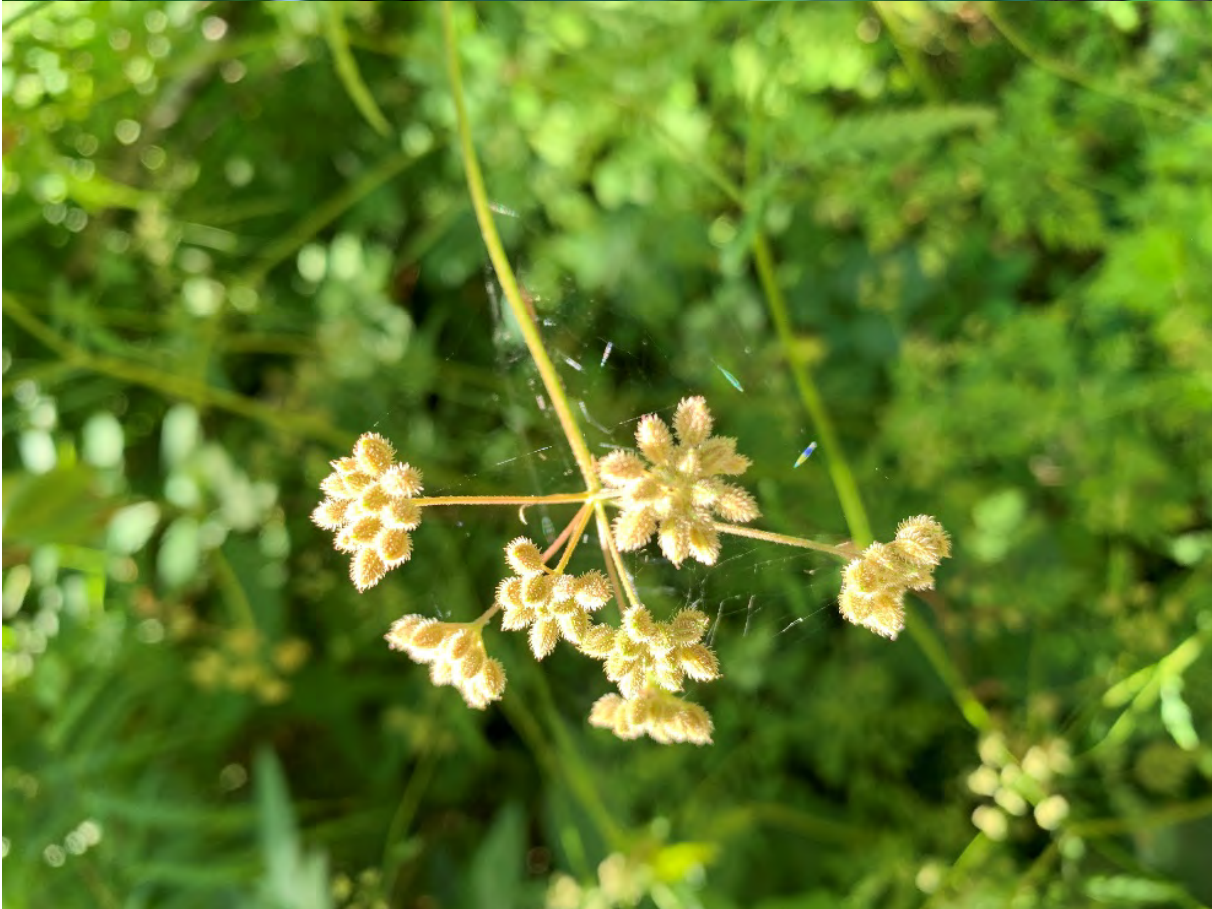
Sediment from the Lac Lavon Park parking lot is directed into the floodplain forest. Potential Restoration Area #8 – Install a pre-treatment system such as a rain garden or sediment trap to collect sediment for protection of the floodplain forest along the southern shoreline of Keller Lake.

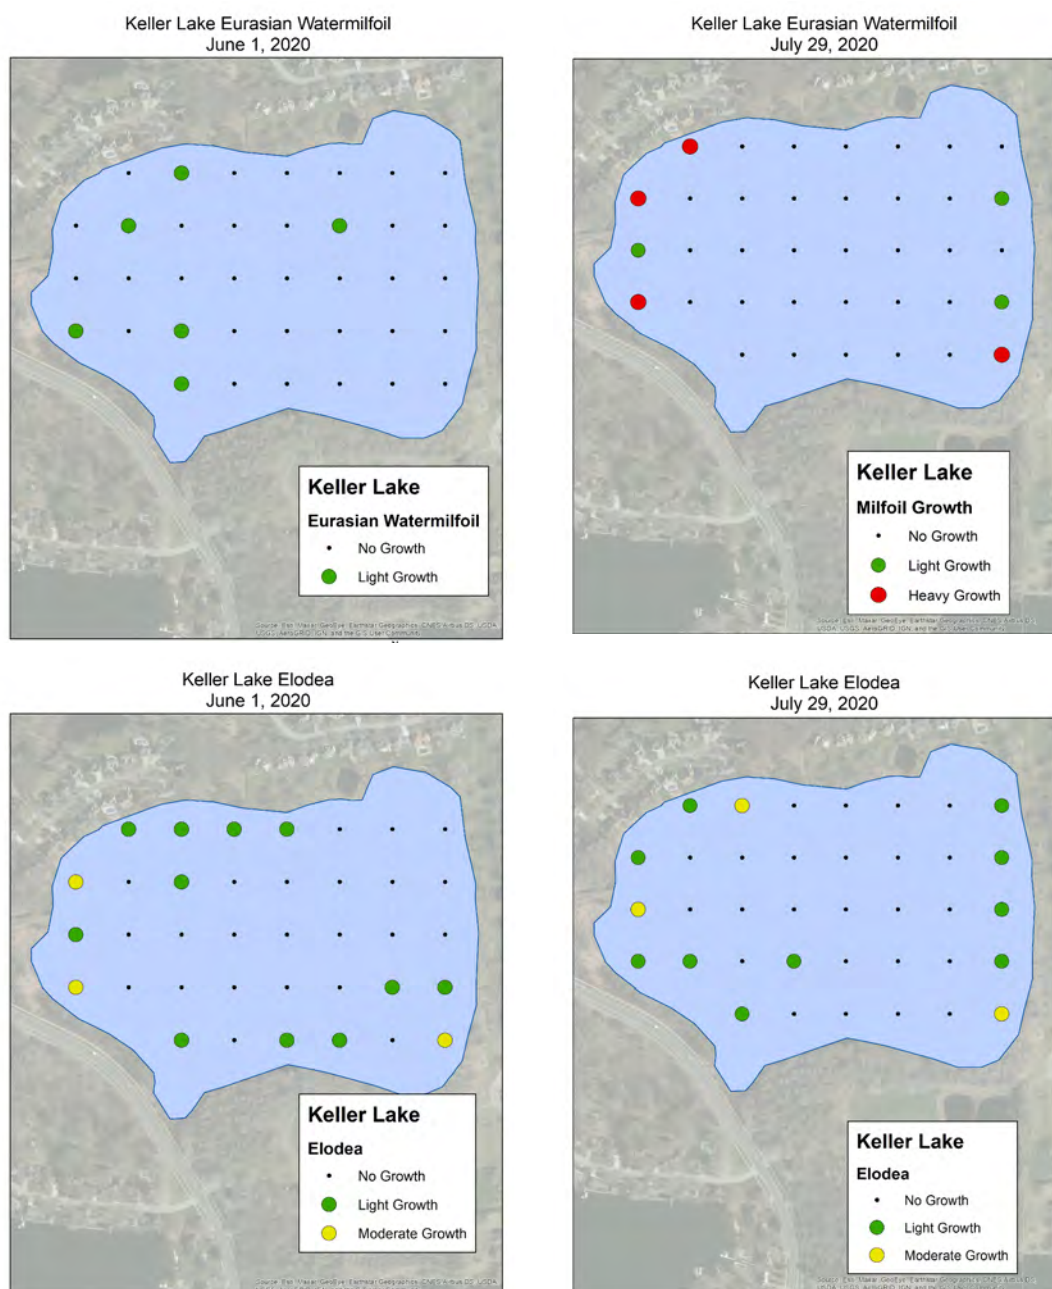
Figure S2. [top-left] EWM June 1, 2020. [top-right] EWM July 29, 2020. [bottom-left] Elodea June 1, 2020. [bottom-right] Elodea July 29, 2020. Key: green dot = light growth, yellow dot = moderate growth, red dot = heavy growth, and black dot = no growth.

Results of the EWM check (July 29, 2020) using an aquatic plant point intercept survey found that EWM along with 2 other submerged aquatic plant species were present in the lake and coontail was the dominant plant. Several areas of scattered heavy growth of EWM were observed on the July 29, 2020 point intercept survey. However, coontail and elodea had light to moderate growth at several sites as well (Figure 5).

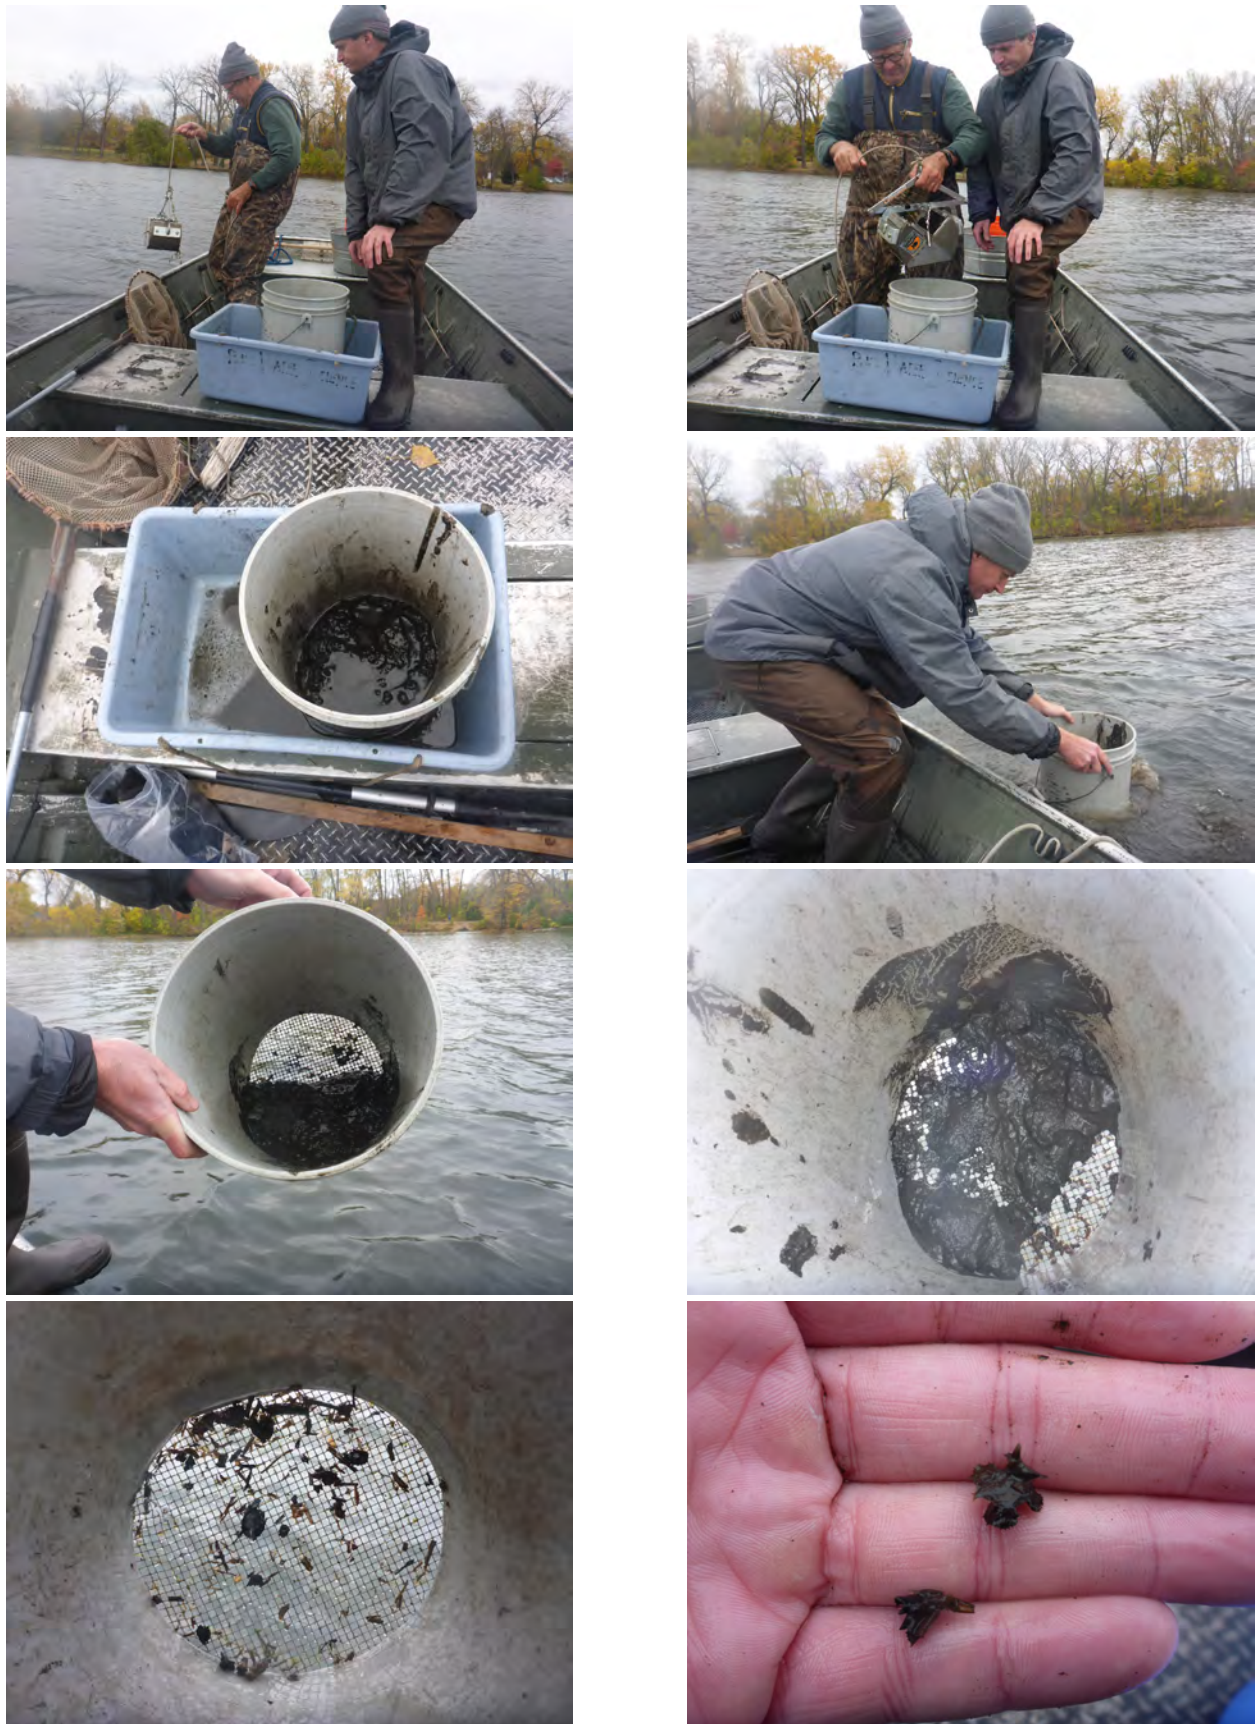
Figure 3. Turion collection methods for Keller Lake using a ponar dredge and filtering the sediments through a bucket with a wire mesh bottom.
