Technical Memorandum

To: Commissioners, Black Dog Watershed Management Organization (BDWMO)
From: Barr Engineering Co.
Subject: 2021 Kingsley Lake Habitat Monitoring
Date: April 13, 2022
Project: 23190457

This memorandum presents the results of the BDWMO's 2021 habitat monitoring of Kingsley Lake.

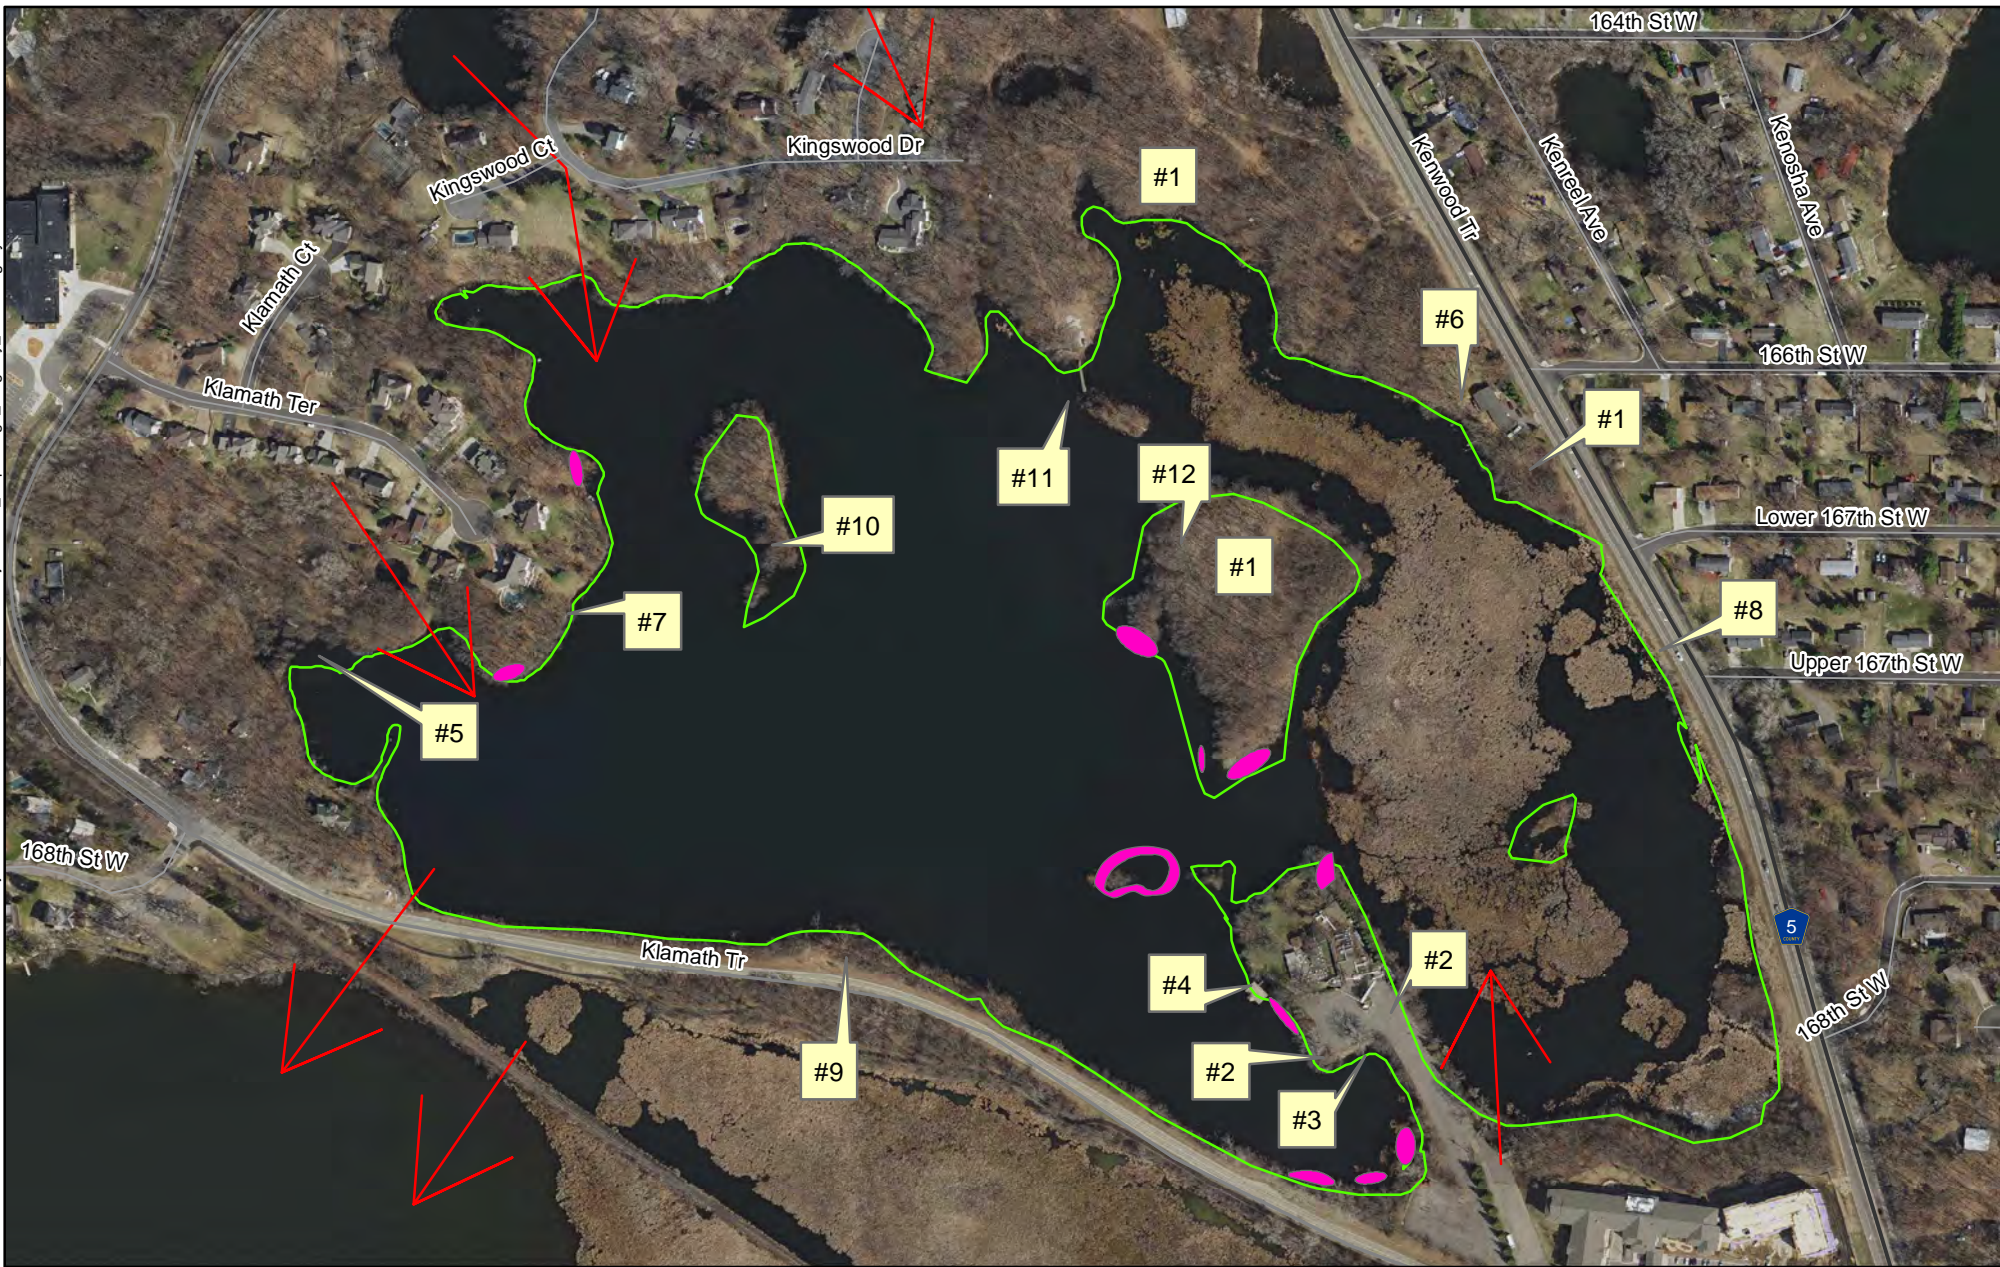
Figure 4
RESTORATION POTENTIAL
KINGSLEY LAKE
Black Dog WMO
Lakeville, MN

- Flow Direction
- Purple loosestrife Location
- Kingsley Lake

Potential Restoration Areas

3. Install a pre-treatment system such as a rain garden, pervious pavement, or sediment trap to collect sediment from the Chart House Restaurant parking lot prior to discharge into the lake. A pre-treatment system combined with routine maintenance of sediment clean-out could help to improve lake water quality and prevent algae blooms and degradation of the vegetation community in this area. This project could potentially receive funding assistance from the Dakota County SWCD's Community Conservation Partnership Incentives program (see **Potential Restoration Area #2, as shown in Figure 4 and photos**).

4. Improve the shoreline by increasing the width and continuity of the naturalized upland buffer. Rather than manicured turf grass, gravel, and managed plantings with bare soil, the shoreline and adjacent upland buffer could be vegetated with native grasses and wildflowers. Adjust mowing distance further away from the shoreline on the City of Lakeville properties next to Klamath Trail and Kenwood Trail. Providing a wider buffer of native vegetation could help protect water quality, prevent erosion, and improve wildlife habitat, vegetative diversity, and aesthetics, potentially through funding assistance from the Dakota County SWCD Conservation Initiative Funding Program Guidance, assistance and potential funding may be available through the Xerces Society ([Pollinator Conservation Program | Xerces Society](#)) and the Minnesota Board of Water and Soil Resources Pollinator Initiative and Lawns to Legumes Program ([Pollinator Habitat | MN Board of Water, Soil Resources \(state.mn.us\)](#)) (see **Figure 4, Potential Restoration Areas #4, 6, 8, and 9 and site photos**. See **Appendix G** for examples of improvements.

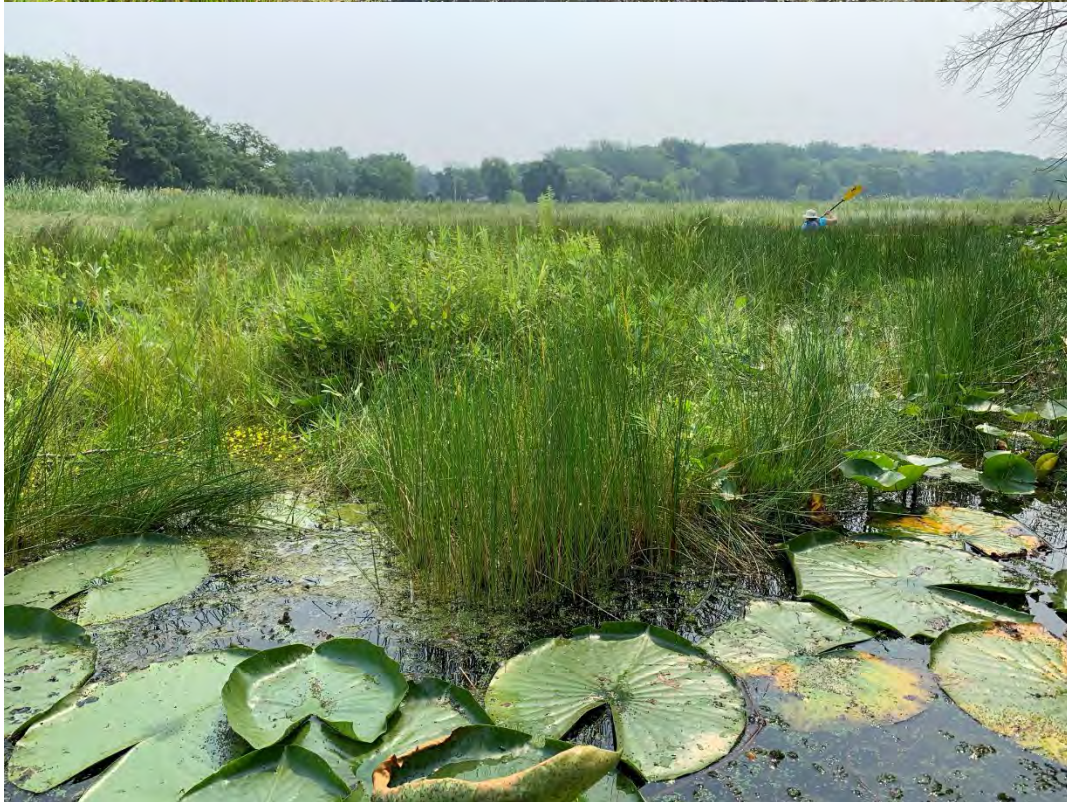
Deep marsh northeast area with floating mats, which support diverse native vegetation

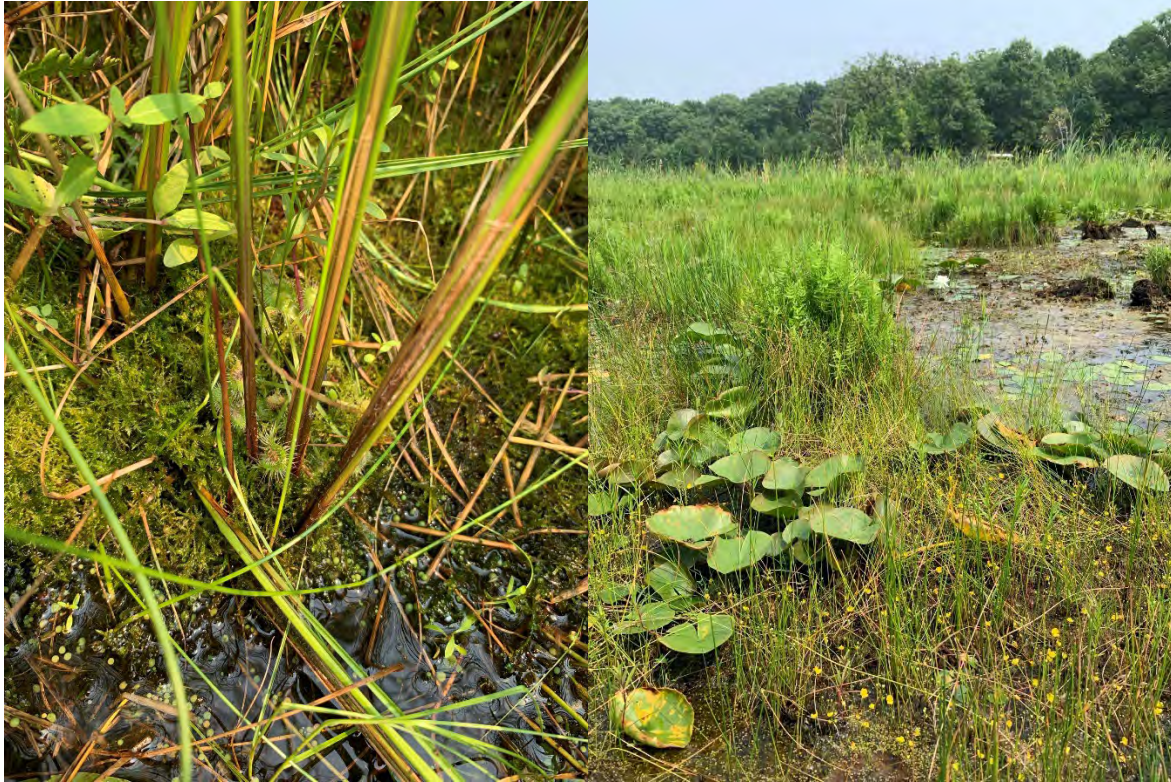
Floating mats in northeast portion of lake supporting diverse native vegetation including sundew

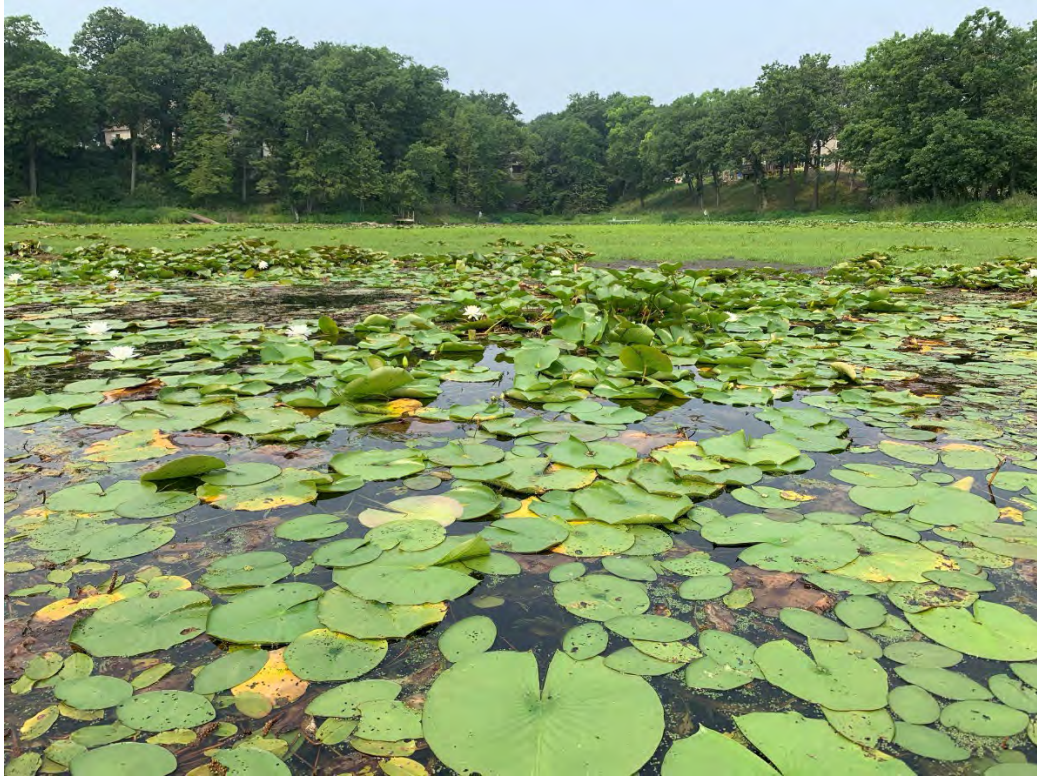
Floating leaved vegetation in northwest portion of the lake

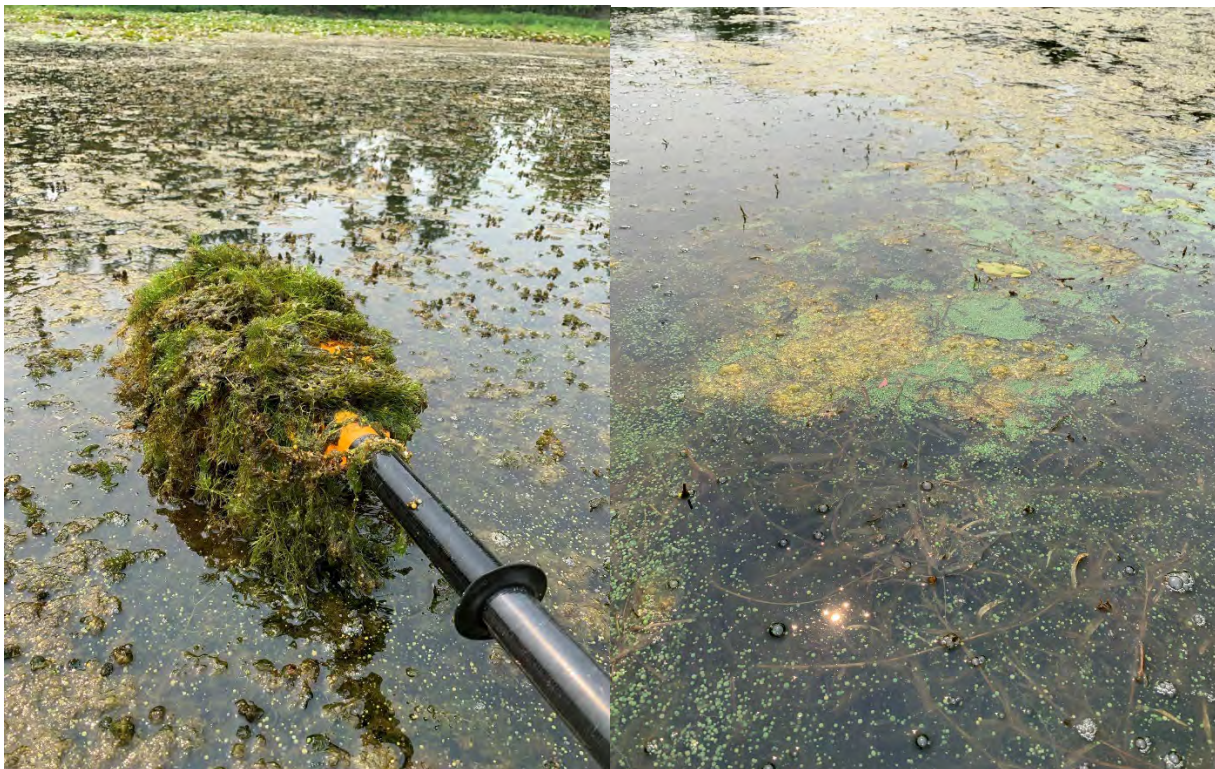
Submergent vegetation and algae in southeast bay

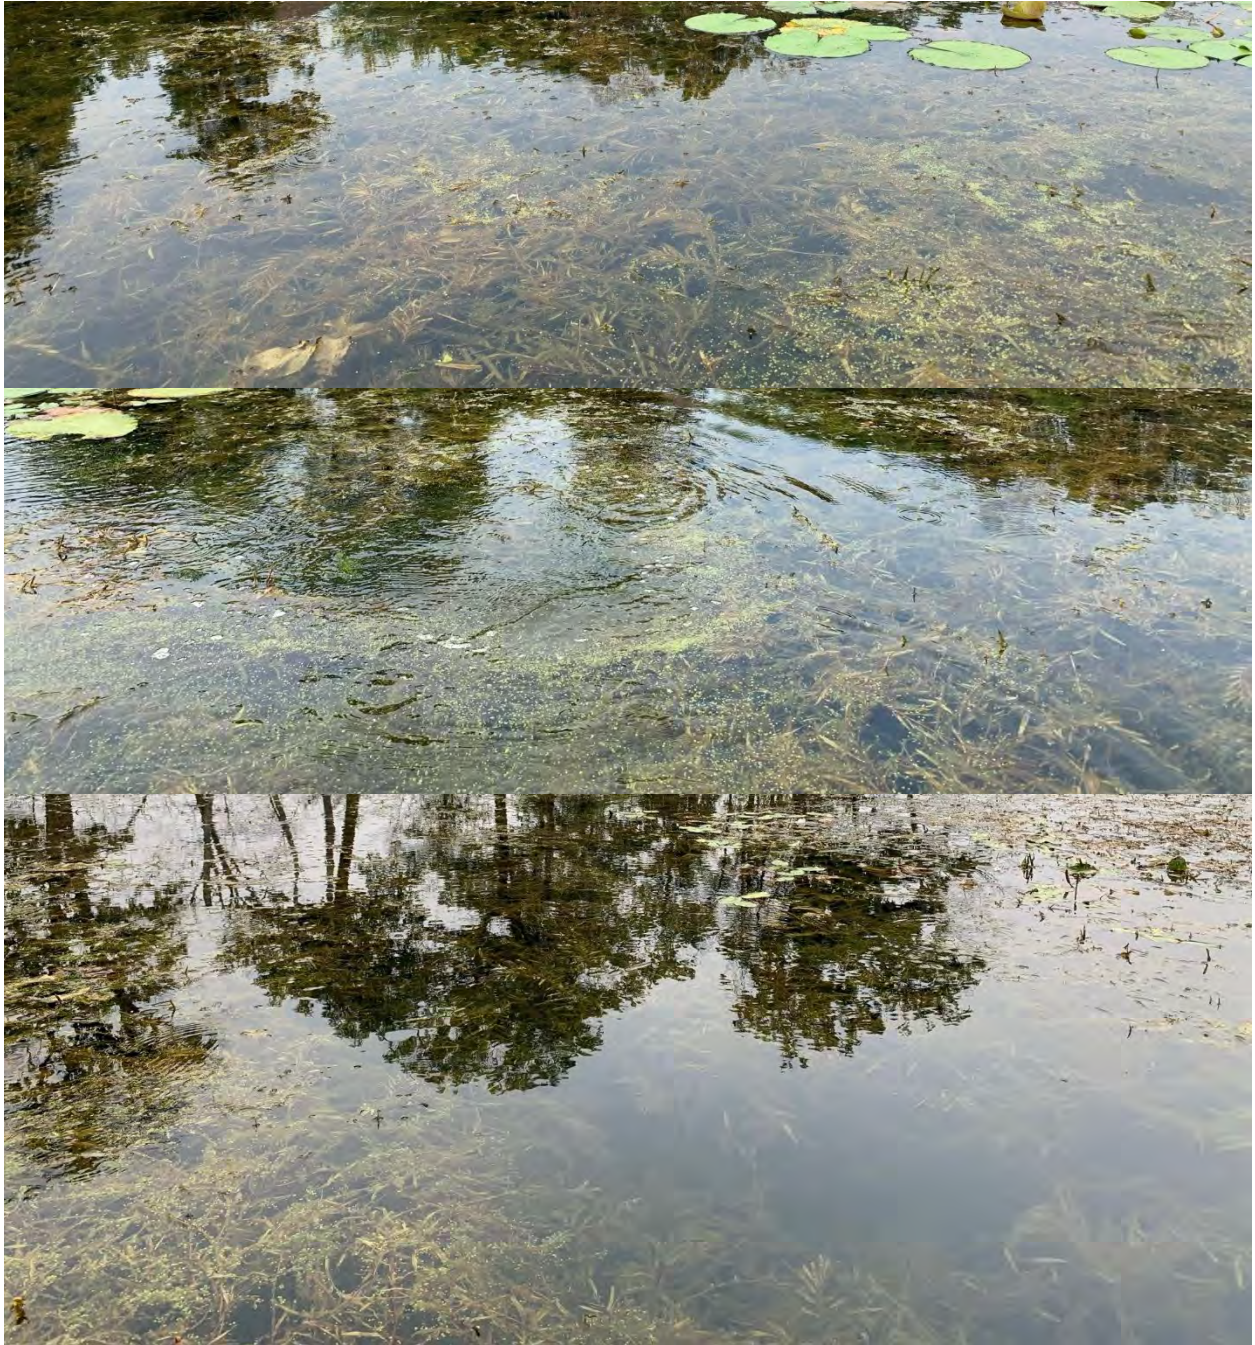
Submergent vegetation in western portion of lake

Recommendation #1 – Continue to monitor for curly-leaf pondweed and consider control measures if densities and locations increase to an extent of concern. See Appendix A for curly-leaf pondweed location and locations of other submergent vegetation.

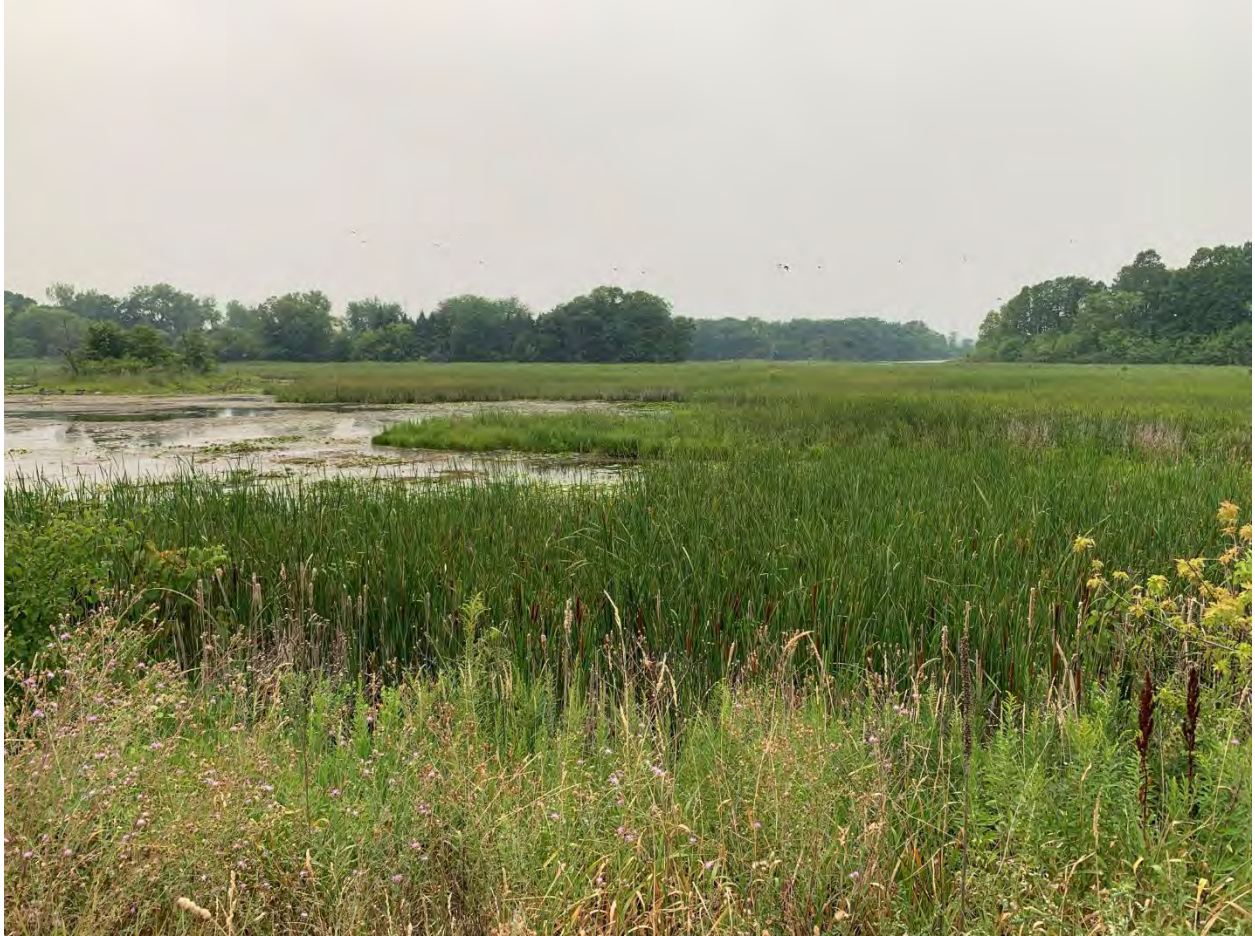
Upland buffer adjacent to Kenwood Trail dominated by non-native and invasive species and invasive cattail in emergent zone. Consider control of invasive cattail to prevent degradation of deep marsh floating mat areas with diverse native emergent species (Figure 4 Potential Restoration Area #8). Additional areas with non-native and invasive species in the emergent zone and upland buffer include purple loosestrife and yellow iris (locations shown in Appendix A), Figure 4 Potential Restoration Areas #1 (common buckthorn), #3 (Chinese silver grass), #5 (reed canary grass), #9 (Russian olive and Siberian elm).

Recommendation #2 – Continue to control and manage non-native invasive vegetation along the shoreline and in the upland buffer.

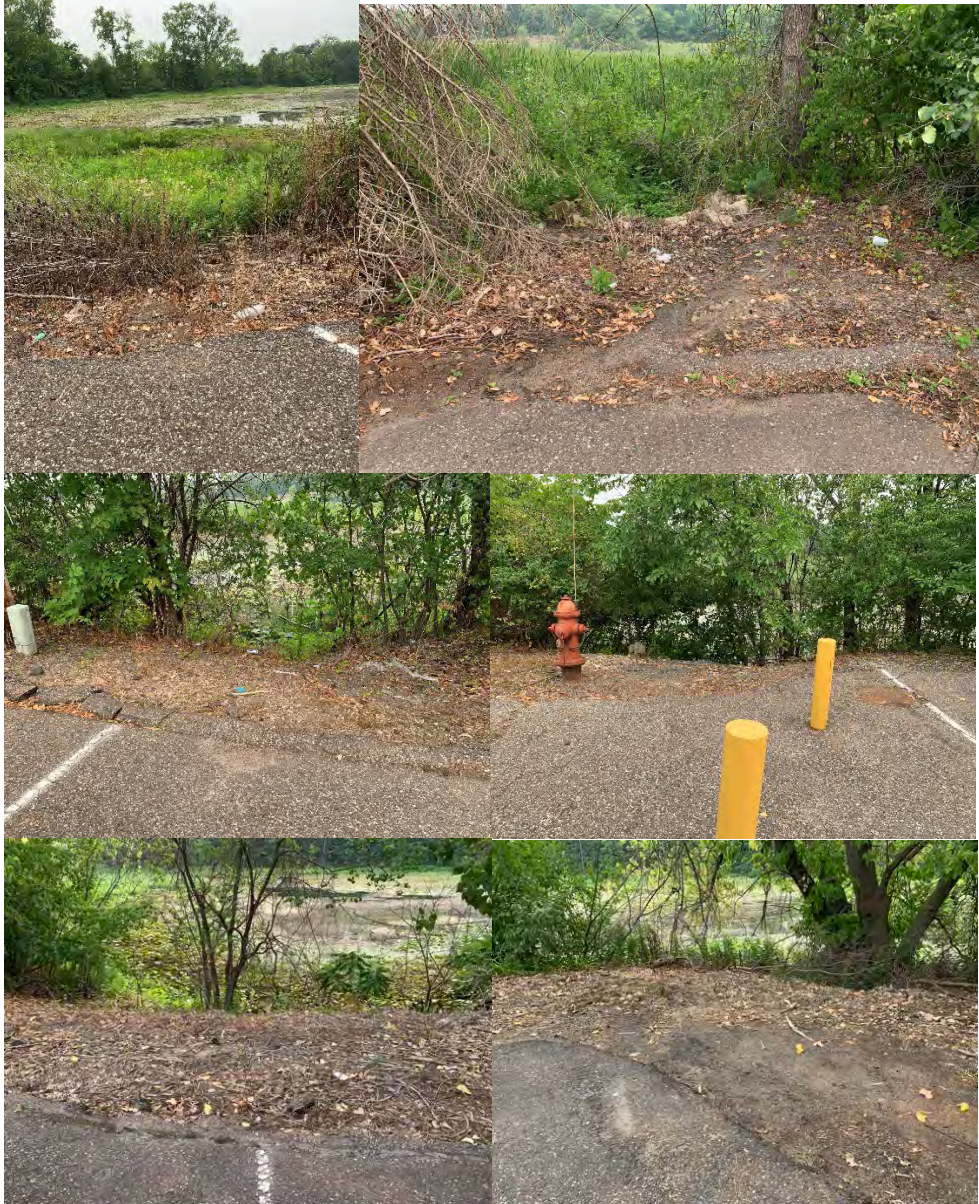
Potential Restoration Area #2 – Prevent direct drainage from impervious surfaces into the lake
Recommendation #3 – Install a pre-treatment system such as a rain garden, pervious pavement, or sediment trap to collect sediment from the restaurant parking lot prior to discharge into the lake.

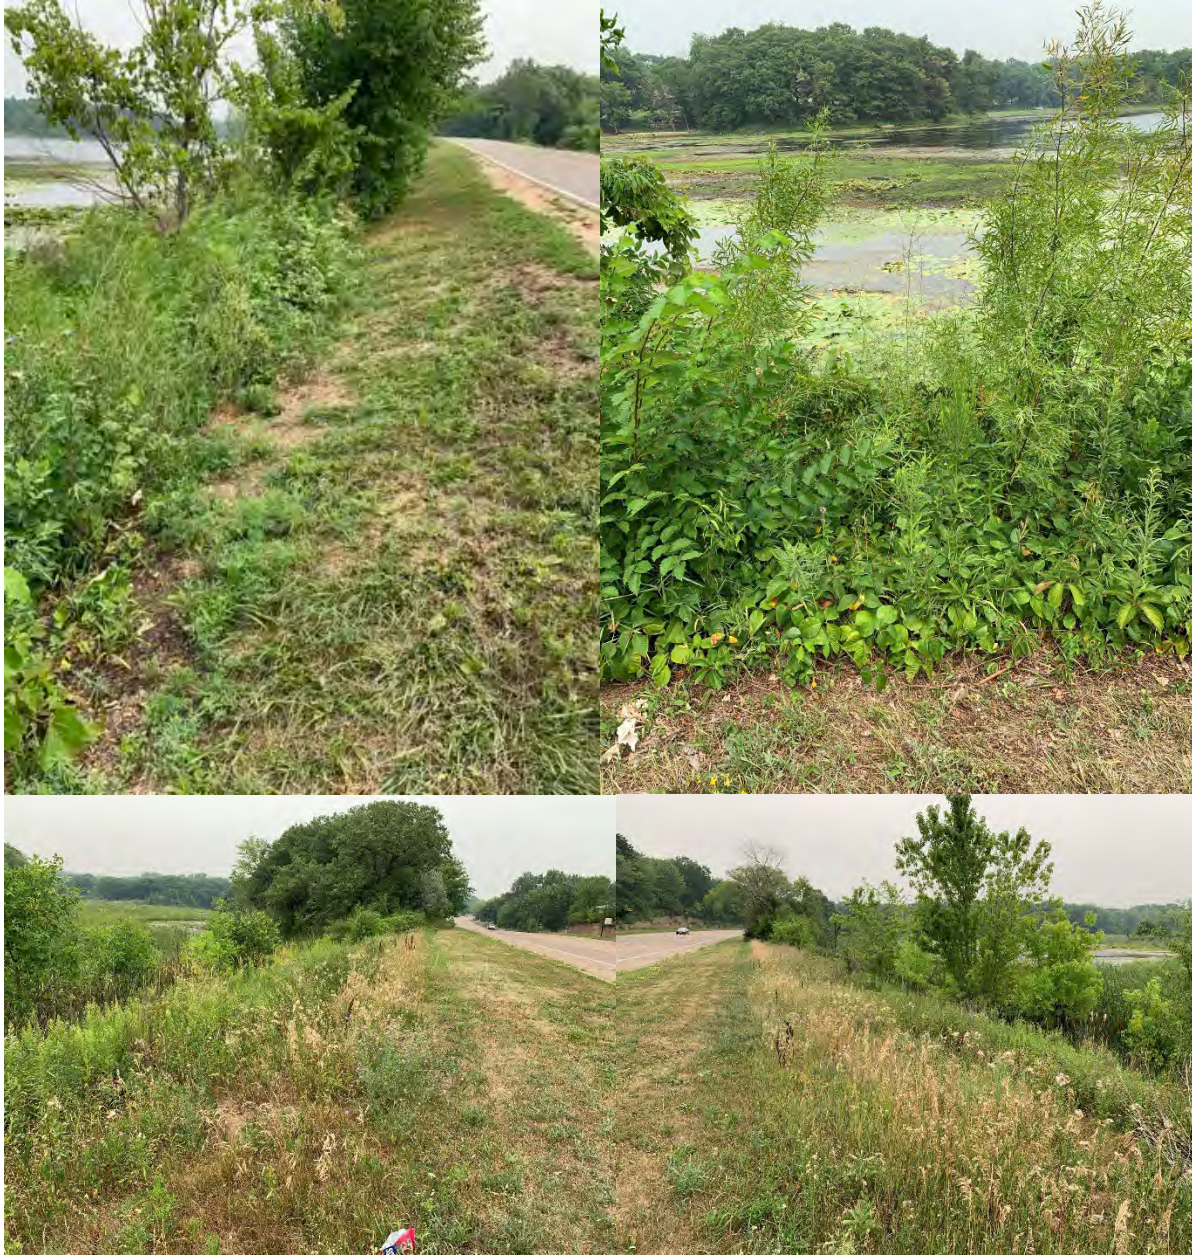
Recommendation #4 - Adjust mowing distance further away from the shoreline in the City of Lakeville properties next to Klamath Trail and Kenwood Trail to increase the width of the naturalized upland buffer (Potential Restoration Areas #8 and 9). Note of caution that the upland buffer along Klamath Trail includes poison ivy.

A wider naturalized upland buffer is also recommended on restaurant property (Potential Restoration Area #4).

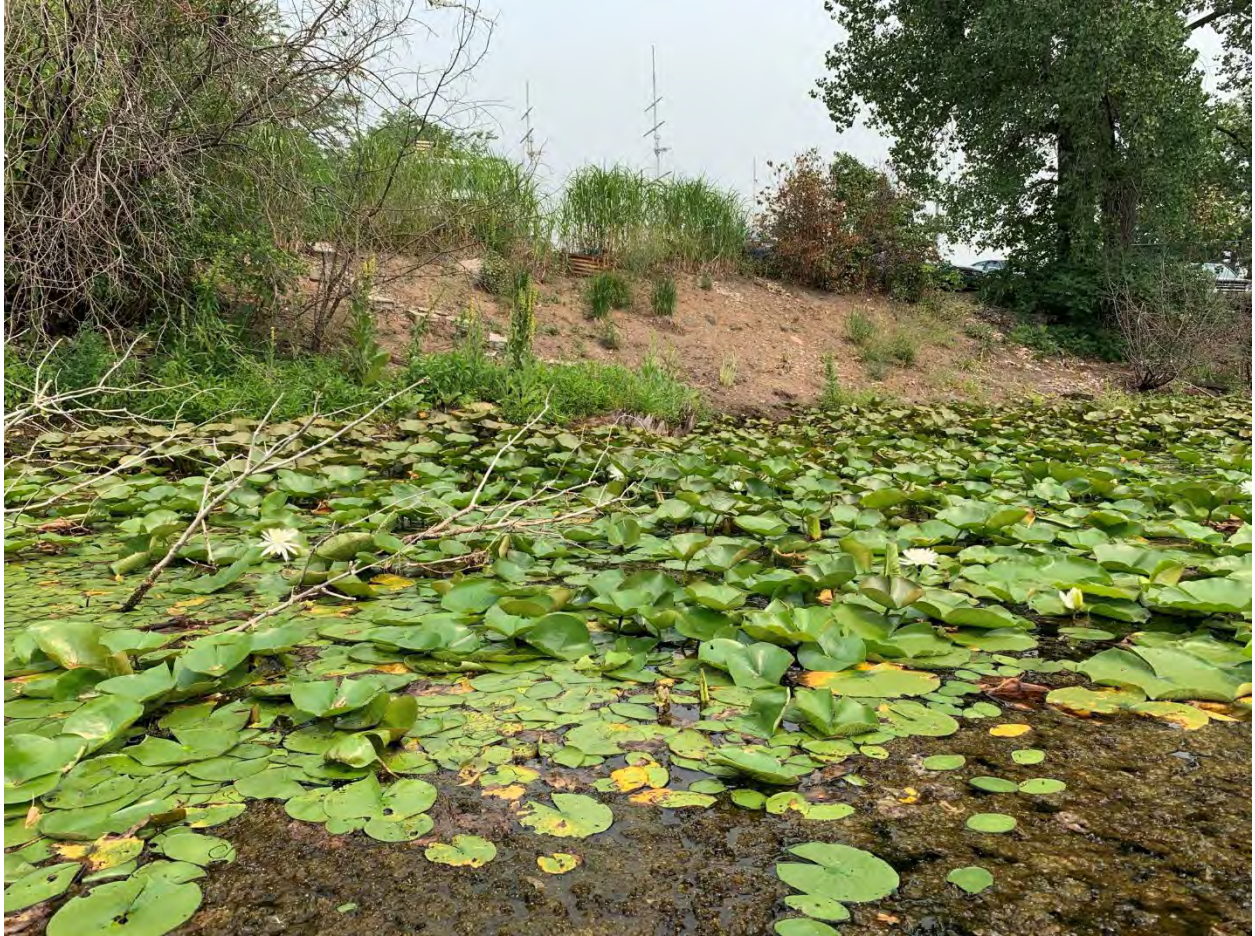
Recommendation #5 – Re-vegetate bare areas to prevent soil erosion on steep slopes (Photo shows Potential Restoration Area #3. Additional bare areas identified at Potential Restoration Areas #7, 10, 11, and 12).

5. Re-vegetate bare areas by establishing native vegetation to prevent soil erosion on steep slopes and to protect water quality, prevent erosion, and improve wildlife habitat, vegetative diversity, and aesthetics. Commercial property owners could potentially receive assistance for erosion and slope stabilization through funding from the Dakota County SWCD's Community Conservation Partnership Incentives program. See **Figure 4, Potential Restoration Areas #3, 7, 10, 11, and 12 (YMCA islands), and site photos (restaurant property)**.
