**To:** Commissioners, Black Dog Watershed Management Organization (BDWMO)  
**From:** Barr Engineering Co.  
**Subject:** 2021 Kingsley Lake Habitat Monitoring  
**Date:** April 13, 2022  
**Project:** 23190457

This memorandum presents the results of the BDWMO's 2021 habitat monitoring of Kingsley Lake.

**KINGSLEY LAKE  
Black Dog WMO  
Lakeville, MN**

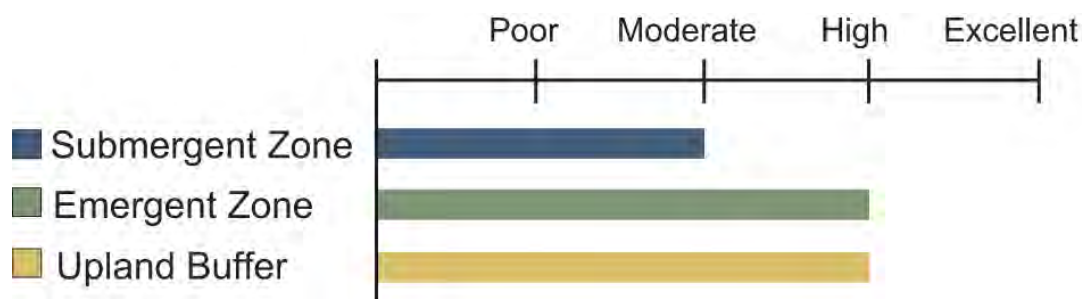
The following schematic diagram shows the overall ratings in 2021 for each vegetation zone within and adjacent to Kingsley Lake:

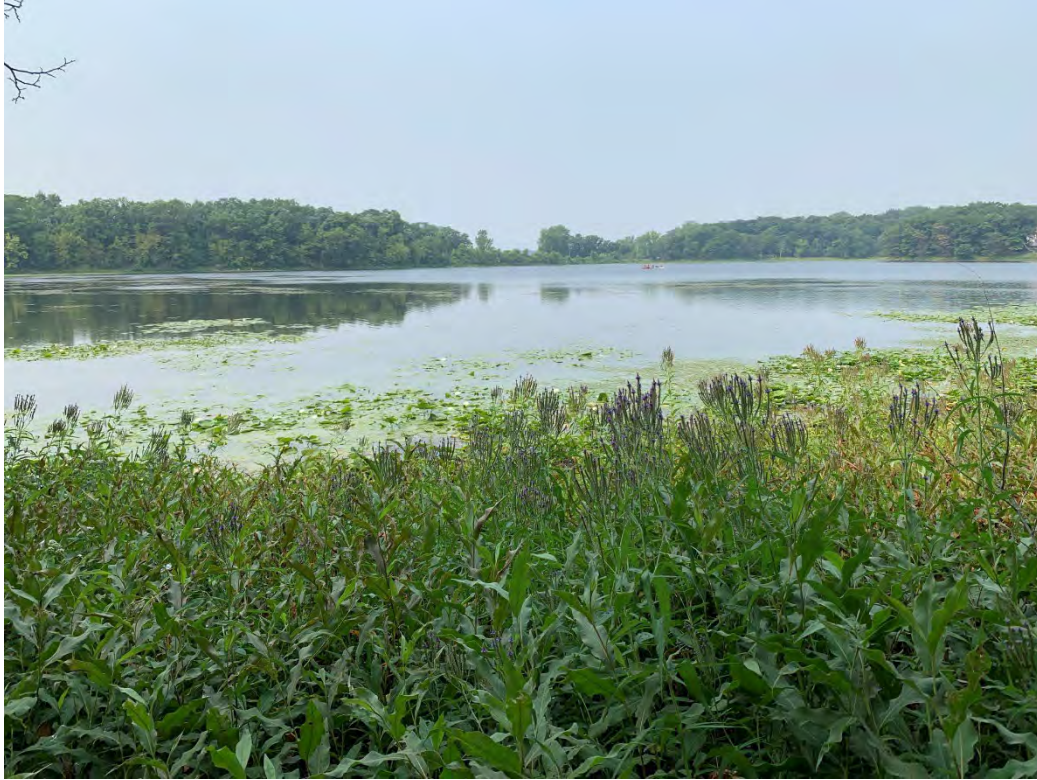
Submergent vegetation in western portion of lake

Recommendation #1 – Continue to monitor for curly-leaf pondweed and consider control measures if densities and locations increase to an extent of concern. See Appendix A for curly-leaf pondweed location and locations of other submergent vegetation.
