# **Black Dog Watershed Management Commission**

## **AGENDA**

**Wednesday, April 19, 2023**

V. Review the 2022 Lac Lavon Water Quality Report

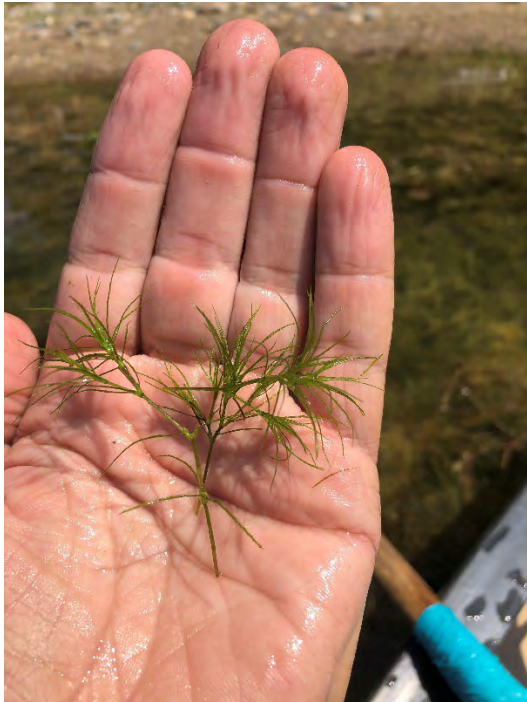
**Photograph 1. Non-native Brittle naiad in Lac Lavon, August 10, 2022**

Brittle naiad was observed at multiple locations in Lac Lavon during the August 2016 survey. Unlike curly-leaf pondweed and Eurasian watermilfoil, which have infested numerous Minnesota lakes, brittle naiad has only been reported in a total of six Minnesota lakes, according to MDNR web page on the invasive plant (<https://www.dnr.state.mn.us/invasives/aquaticplants/brittlenaiad/index.html>). Brittle naiad grows much shorter than curly-leaf pondweed and Eurasian watermilfoil (both of which can create dense surface mats); and does not appear to be growing at nuisance levels in Lac Lavon. Because brittle naiad does not grow very tall, and more easily breaks into small fragments (it truly is "brittle"), it may not show up on the plant rake during surveys even when present, and it's possible its abundance is underreported. It can be transferred to other waterbodies by plant fragments stuck to boats or equipment, or by tiny seeds in mud stuck to boots, anchors, etc.

begins growing much earlier in the spring and dies back earlier in summer than native plants, which can release nutrients and contribute to worse water quality in mid- to late-summer when abundant.

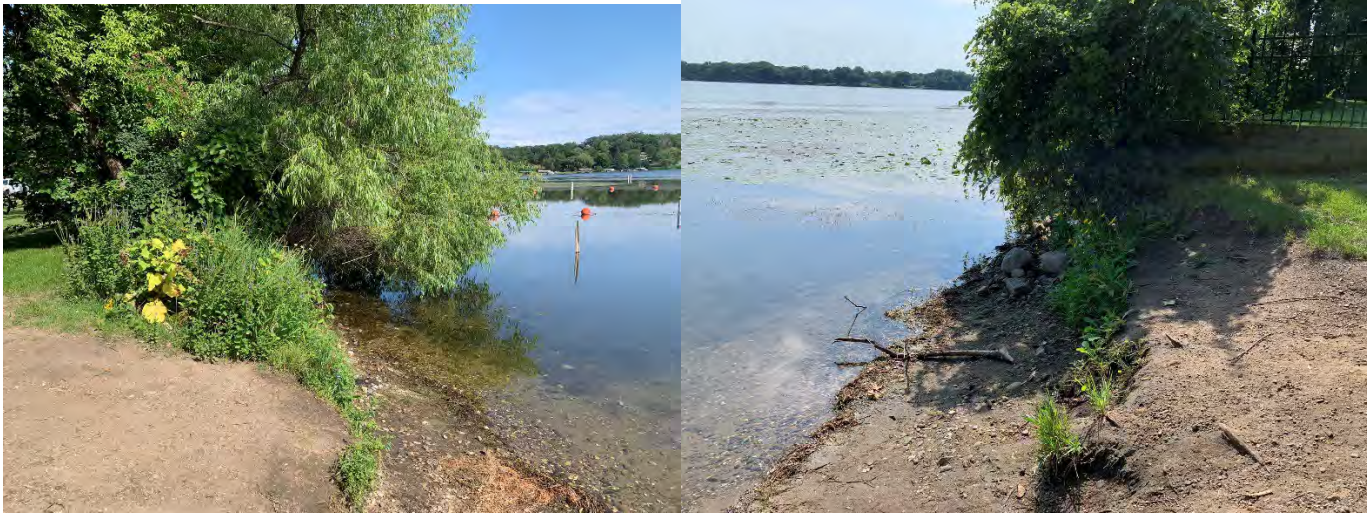
Potential Restoration Area #4 – Beach Area – Dilapidated timber retaining wall was taken out and shoreline restoration attempted but failed. Would need soil improvement to be successful. And/or consider placing stone walkways to establish designated shoreline fishing and viewing areas.

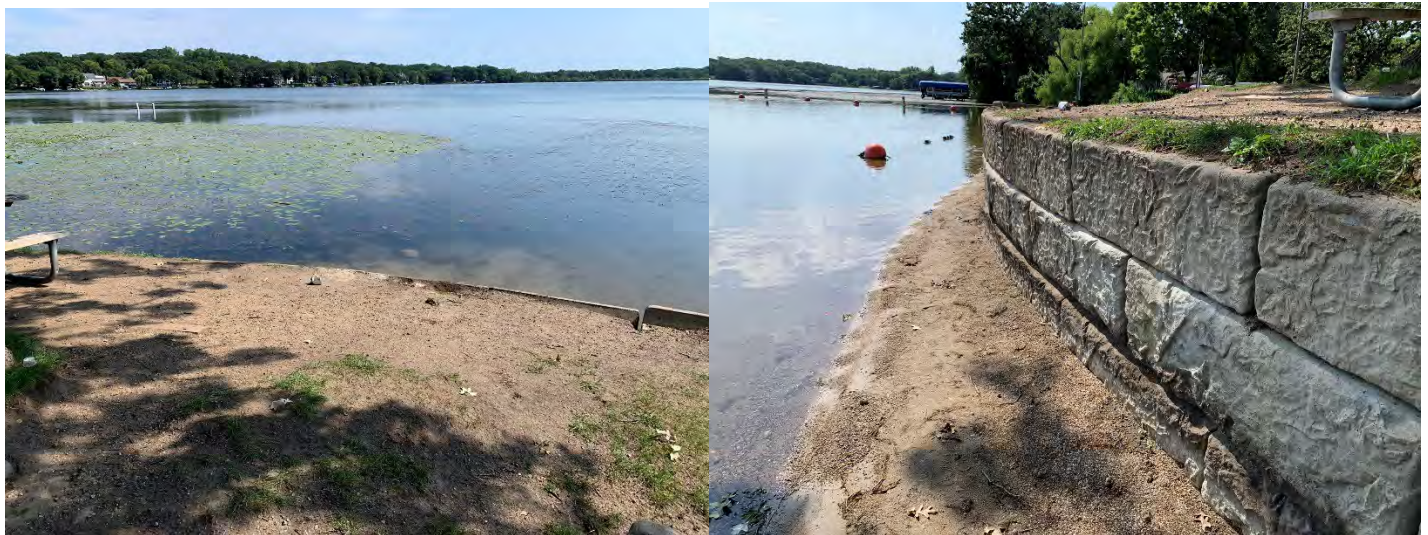
Timber wall was replaced by concrete wall at north end of beach area. Poor vegetation establishment and trash above the concrete.

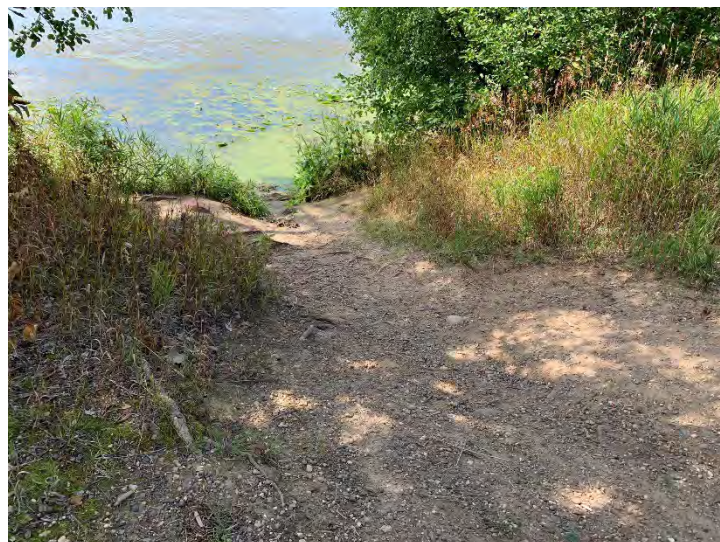
Potential Restoration Area #5 - An established canoe and kayak access at the Wayside Park could help prevent shoreline erosion in this location.

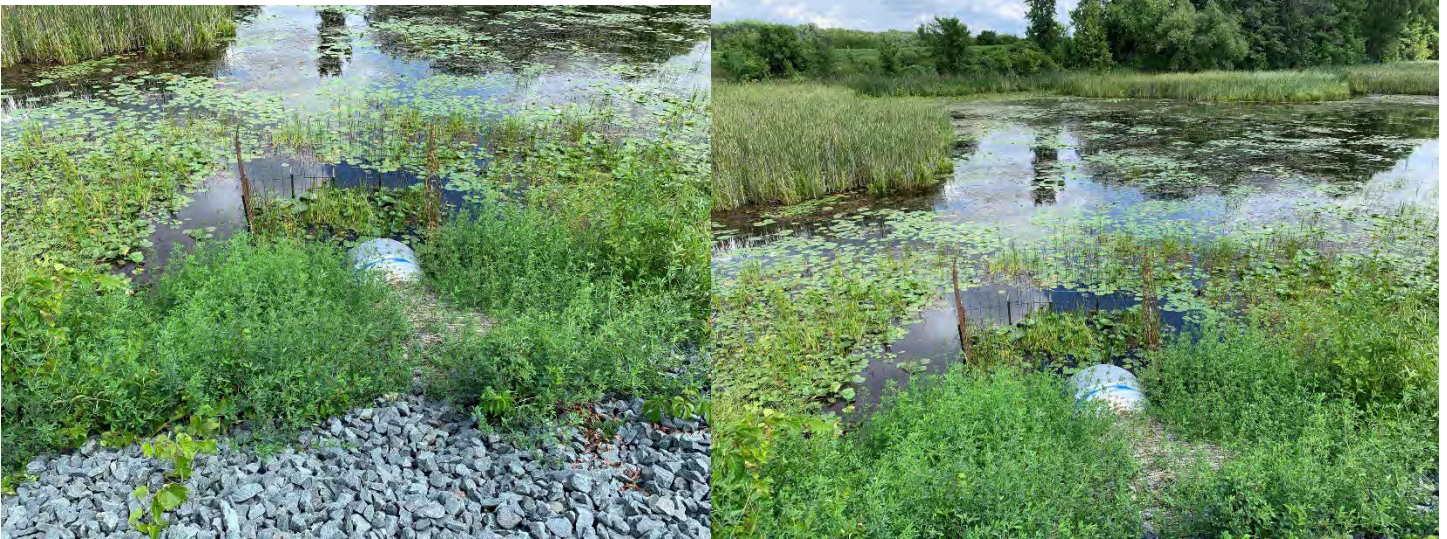
A new culvert under railroad tracks was installed under railroad tracks to maintain flow through of surface hydrology between Areas B and C.

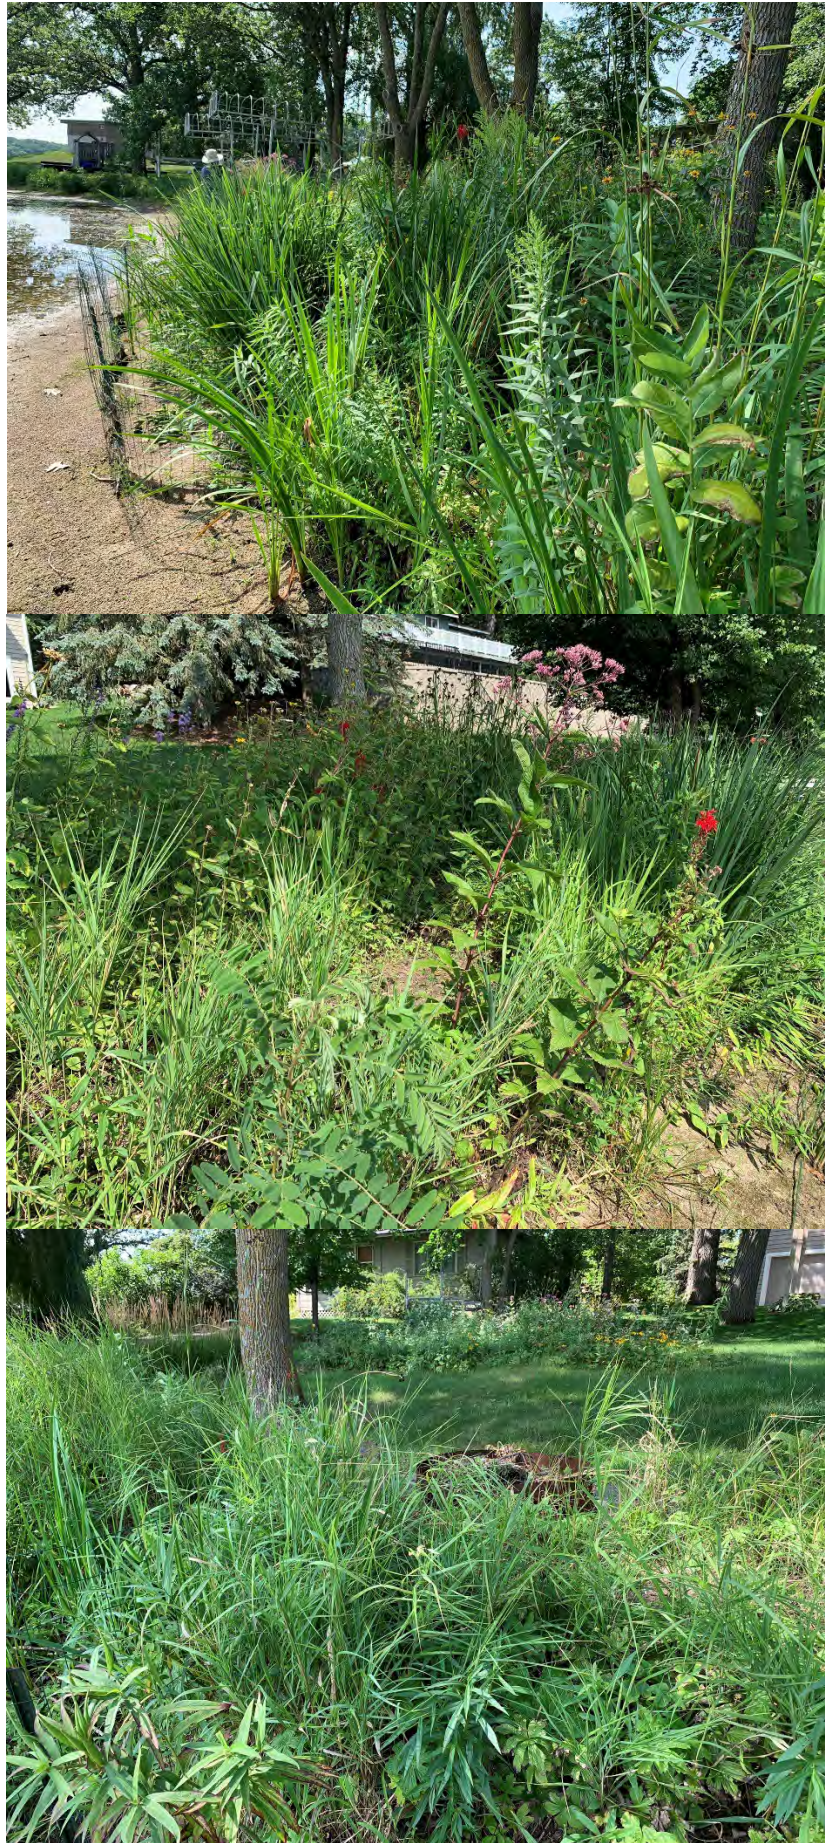
Well maintained successful residential shoreline restoration and raingarden north of beach area
