Technical Memorandum

To:Commissioners, Black Dog Watershed Management Organization (BDWMO)From:Barr Engineering Co.Subject:2017 Orchard Lake Habitat MonitoringDate:February 21, 2018Project:23190457

This memorandum presents the results of the BDWMO's 2017 habitat monitoring of Orchard Lake.

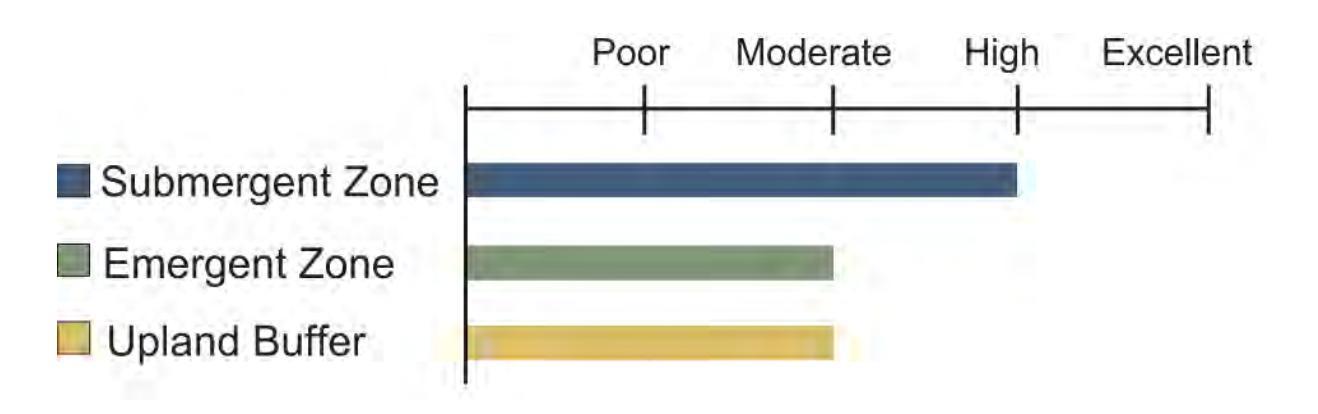
The overall ratings in 2017 for each vegetation zone within and adjacent to Orchard Lake are shown on the following schematic diagram:

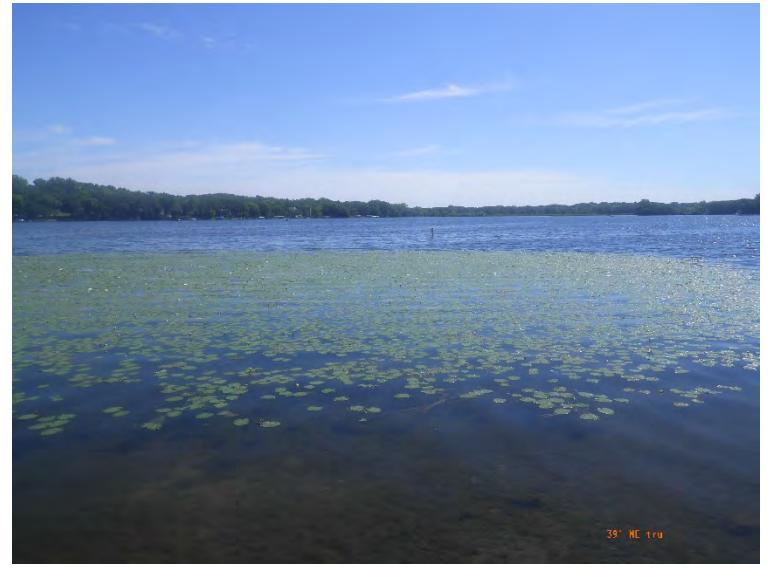
Submergent Zone – beach area

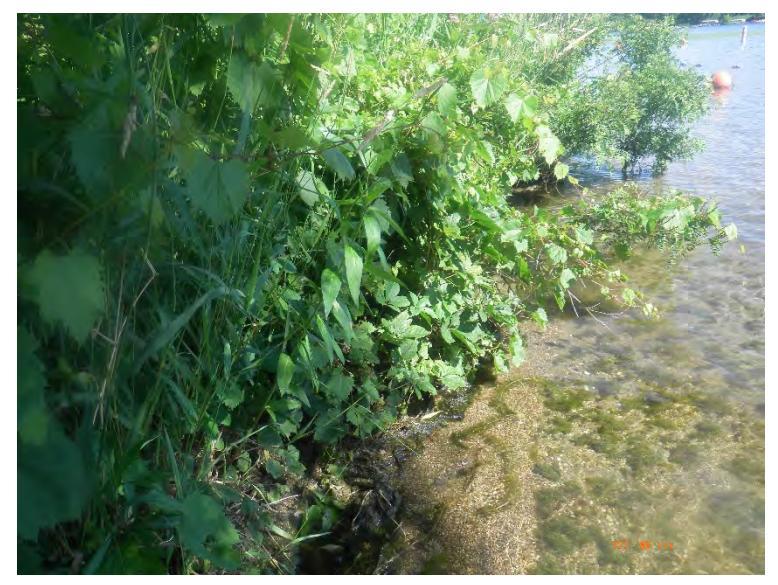
Plot 1B Emergent Zone – beach area

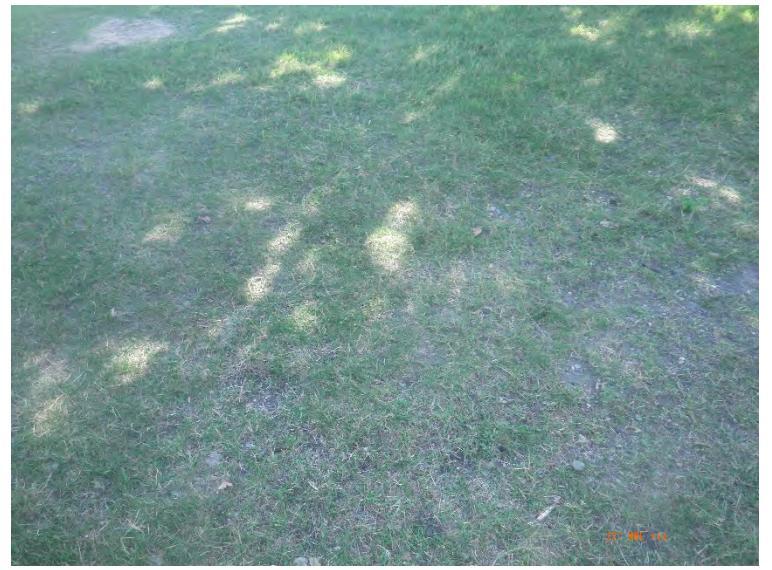
Plot 1C Upland Buffer – beach area - Potential Restoration Area #1

- Prevent erosion of bare soil by establishing vegetation, potentially through funding assistance from the Dakota County SWCD Landscaping for Clean Water program. See Figure 4, Potential Restoration Areas #4 and #5, and site photos.
- 6. Improve the shoreline with a wider naturalized upland buffer. Rather than manicured turf grass, the emergent zone and upland buffer could be vegetated with native grasses and wildflowers. A wider buffer of native vegetation could help protect water quality, prevent erosion, and improve wildlife habitat, vegetative diversity, and aesthetics. Lakeshore residents could receive assistance to create shoreline restoration projects through the Dakota County SWCD Landscaping for Clean Water program. See **Figure 4**, **Potential Restoration Areas #1 through 3**, **7 and 8**, **and site photos**. See **Appendix G** for examples of improvements.

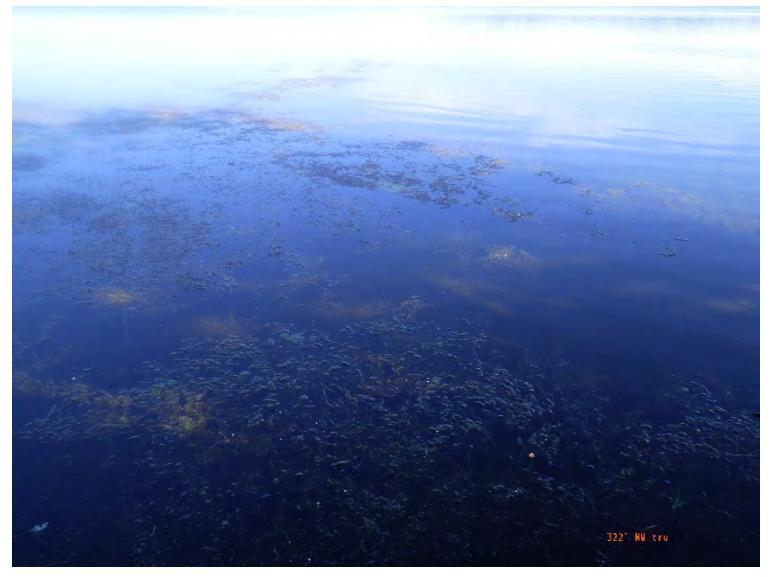
Submergent Zone – boat launch area

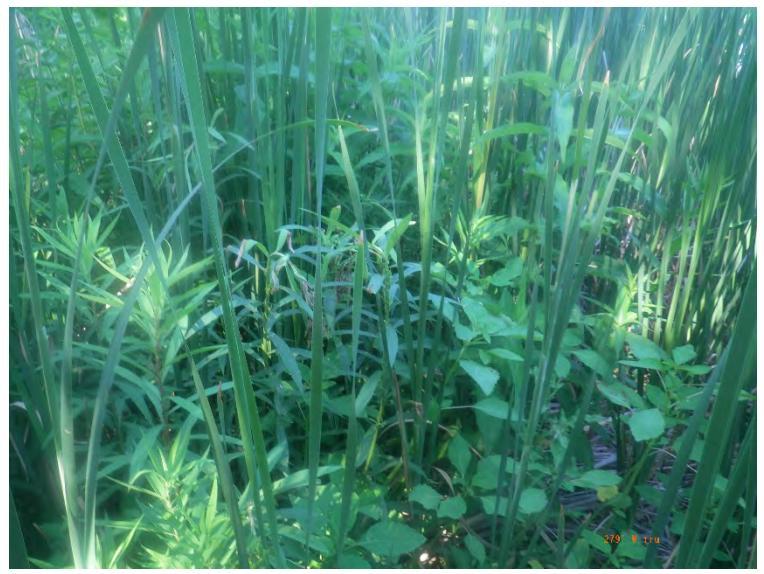
Plot 2B Emergent Zone – boat launch area

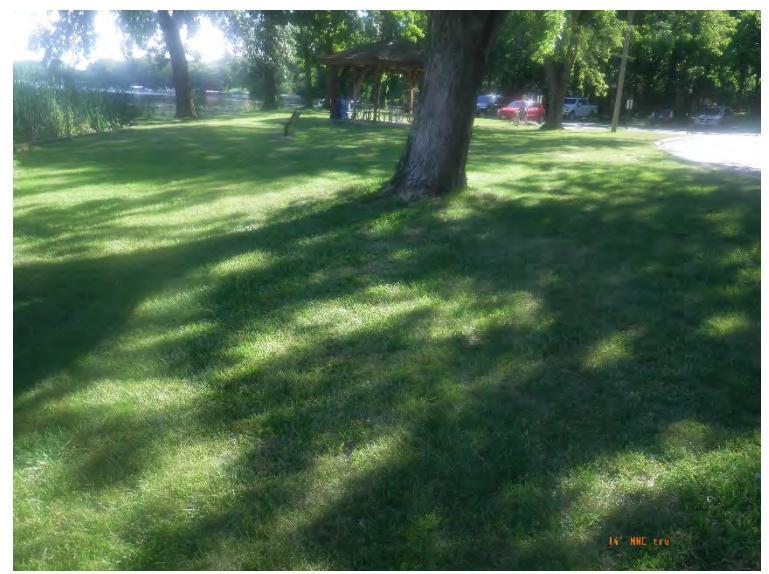
- The City owned property in the boat launch area currently has a 5-foot wide naturalized buffer, but could have a naturalized upland buffer ranging from 25 feet at the west side to 200 feet at the east side.

Plot 2C Upland Buffer – boat launch area – Potential Restoration Area #2

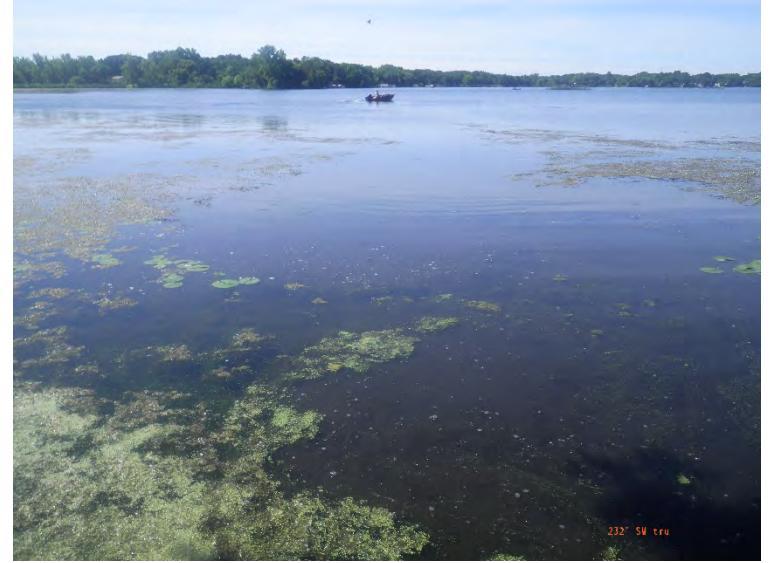
Submergent Zone – Wayside Park Area

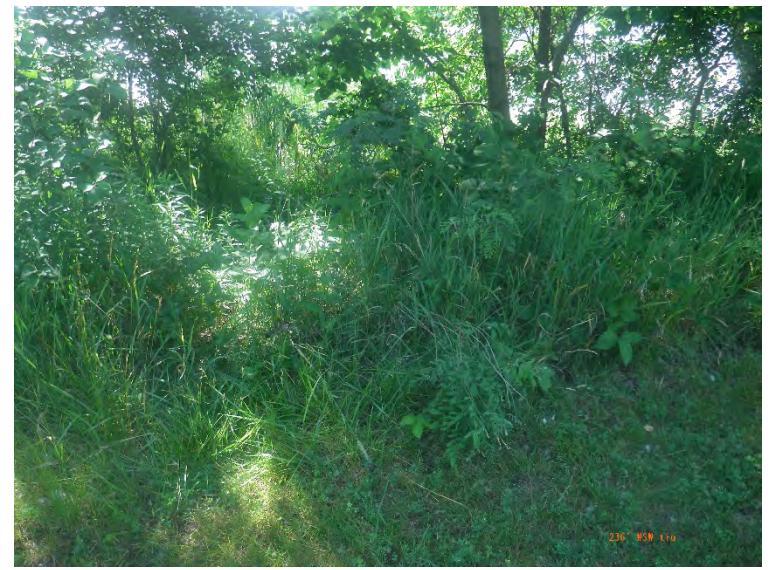
Plot 3B – Emergent Zone – Wayside Park area

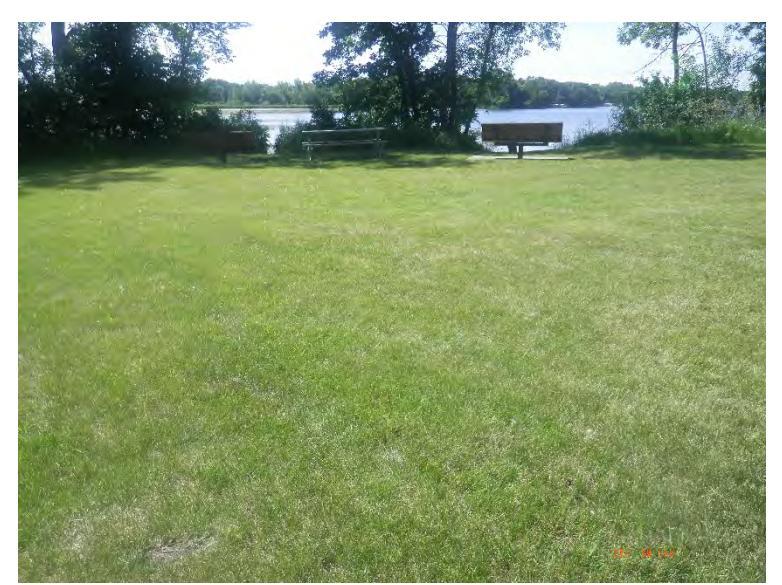
- The Wayside Park area currently has a 20-foot wide naturalized buffer, with the potential for a 200-foot wide naturalized buffer.

Plot 3C – Upland Buffer – Wayside Park area – Potential Restoration Area #3

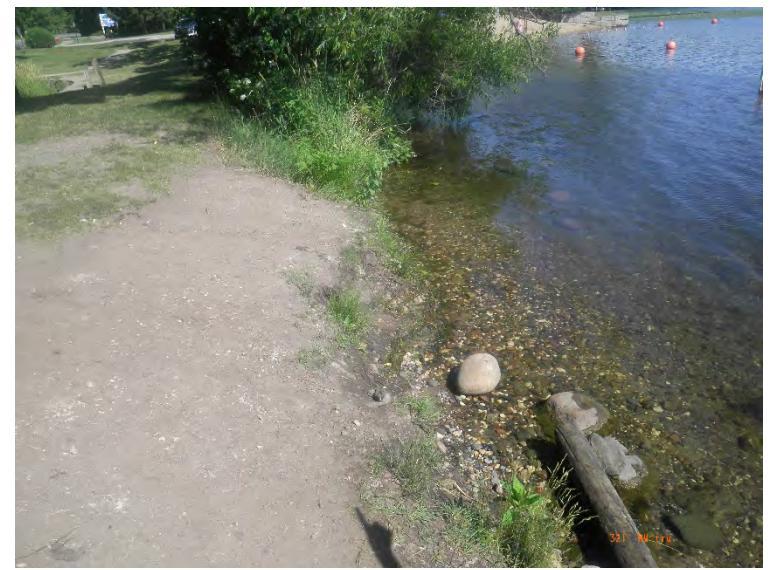
Potential Restoration Area #4 – Beach Area – Dilapidated timber retaining wall was taken out and shoreline restoration attempted, but failed. Would need soil improvement to be successful.

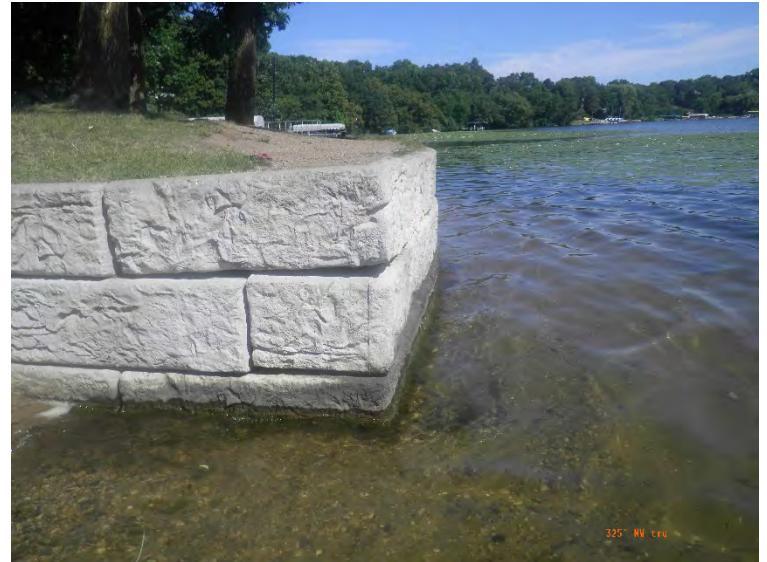
- At the beach area, there is a concrete retaining wall north of the beach, which extends to the edge of the water. South of the beach, the current 5-foot wide naturalized buffer has the potential for a naturalized buffer ranging from 20 feet to as much as 100 feet wide.

Timber wall was replaced by concrete wall at north end of beach area. Poor vegetation establishment above the concrete.

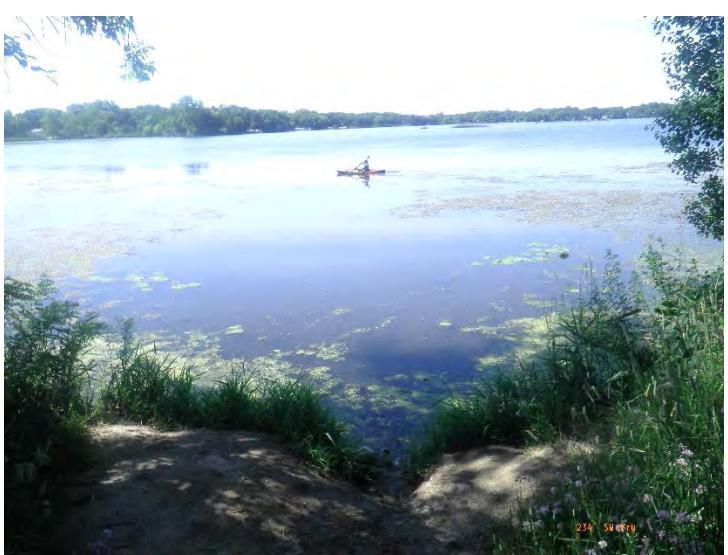
Potential Restoration Area #5 - An established canoe and kayak access at the Wayside Park could help prevent shoreline erosion in this location.

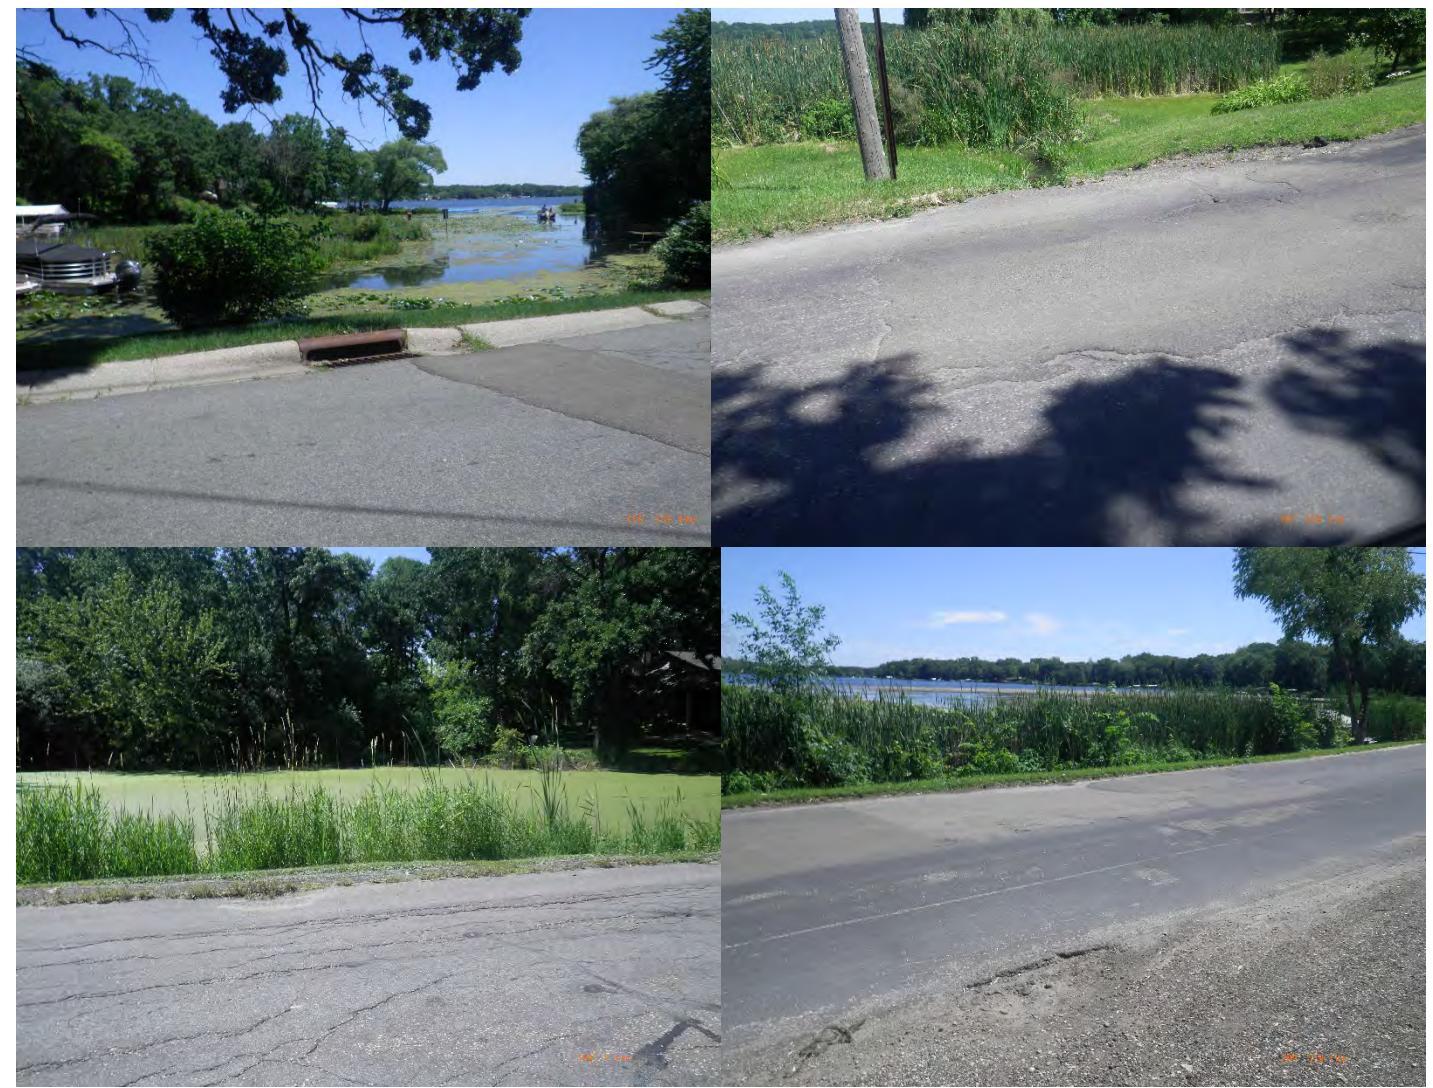
Potential Restoration Area #6 - Stormwater drainage from the road is directed into the lake. A barrier, pre-treatment, and/or naturalized upland buffer could help improve water quality.

- 1. Continue to monitor, control, and manage curlyleaf pondweed. See **Appendix A** for the 2017 aquatic plant survey, which provides more details of actions and recommendations.
- 2. Continue to control common buckthorn (see Appendix H for buckthorn management guidelines).
- 3. Continue to control purple loosestrife. See Figure 4 for purple loosestrife locations.
- 4. Prevent runoff from impervious surfaces from entering the lake by directing stormwater into a rainwater garden, using pervious pavement, or other appropriate infiltration device prior to discharge into the lake, potentially through funding assistance from the Dakota County SWCD Landscaping for Clean Water program. See **Figure 4**, **Potential Restoration Area #6**, and site photos.

Stormwater drainage from impervious surfaces is directed into the lake.	Redirect stormwater for infiltration prior to discharge.	Install a rainwater garden, pervious pavement, or other suitable method for infiltration and establish a naturalized upland buffer. See Figure 4 and Site Photos, Potential Restoration Area #6.	Improve water quality	Open	Two raingardens were completed on 175th St W. In 2010, adjacent to the southwest end of the lake, an aeration system was installed in Orchard Pond to precipitate out phosphorus and improve water quality flowing into Orchard Lake.
Bare soil along shoreline could cause erosion and sedimentation into lake.	Re-vegetate bare areas to prevent soil erosion into Orchard Lake.	Improve soil and plant vegetation along shoreline to prevent erosion. Establish a canoe and kayak access at Wayside Park. See Figure 4 and Site Photos, Potential Restoration Area #4 and #5.	Improve water quality	Spring - Fall	The City of Lakeville removed a dilapidated timber wall and attempted a shoreline restoration south of the beach, however, the soil was too poor for the plantings to become established. North of the beach, a concrete wall was built to prevent shoreline erosion.

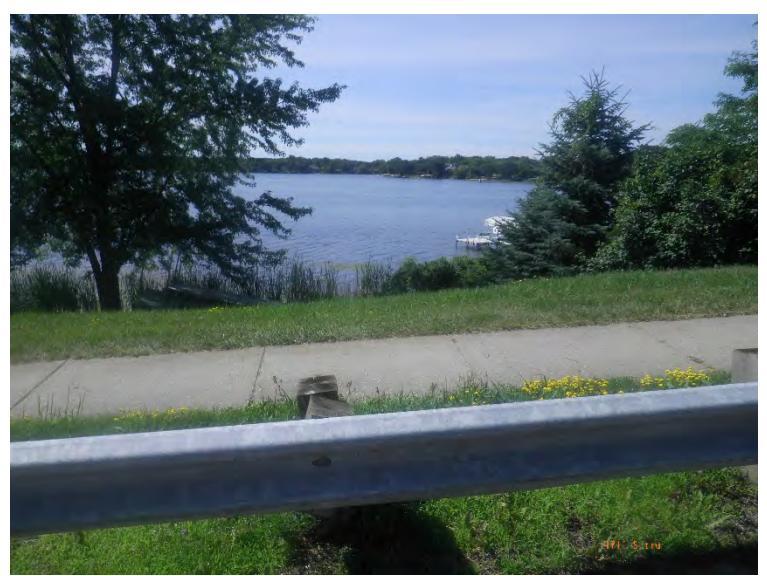
Potential Restoration Area #7 – This property is owned by the City of Lakeville and is adjacent to residential shorelines. A shoreline and upland buffer restoration here could provide an example for adjacent residential landowners.

Upland buffer areas lacking naturalized vegetation.	Increase width and continuity of native upland buffer.	Rather than manicured turf grass the shoreline could be vegetated with native grasses and wildflowers. See Figure 4 and Site Photos, Potential Restoration Areas #1-3, 7 and 8 . See Appendix G for examples of improvements.	Improve water quality, increase wildlife habitat. Improve vegetative diversity and aesthetics.	Spring - Fall	2004 through 2012: The City of Lakeville annually provides lakeshore owners with shoreline restoration information and encourages homeowners to take advantage of the Blue Thumb restoration program. Two residential shoreline restoration projects have been completed. One is located north of the beach area and one is on 175th St. W. 2007: A small area of lakeshore, near the boat launch, was restored using native plants.

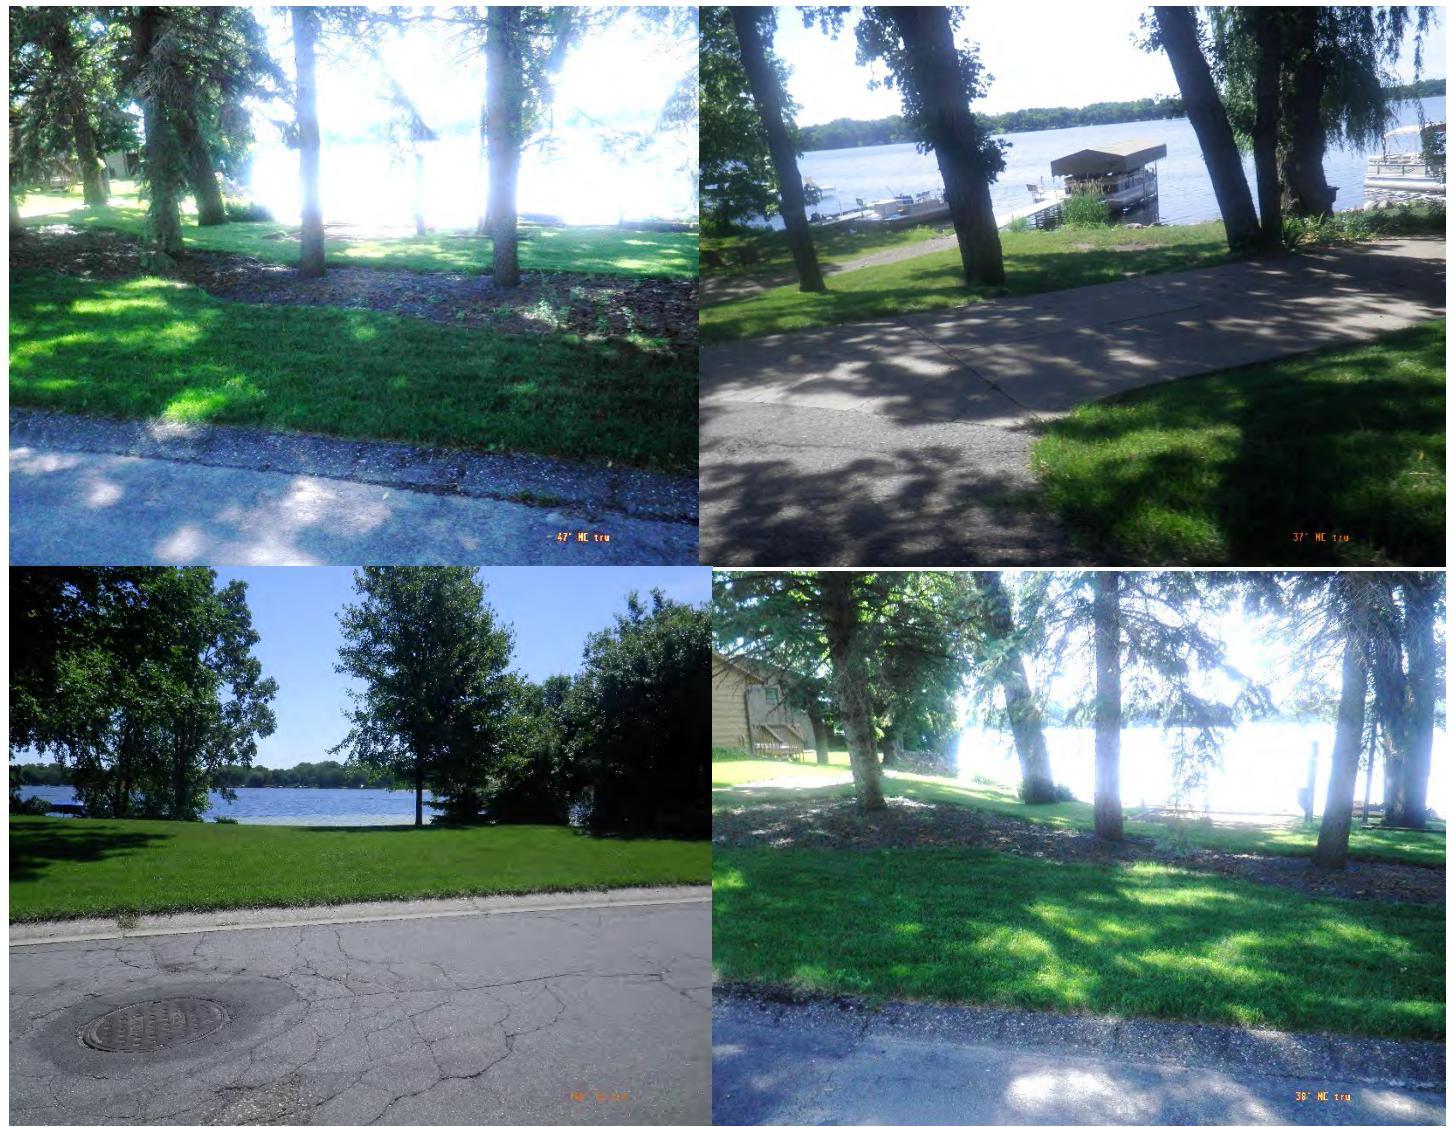
Typical residential shorelines lacking naturalized vegetation in the emergent zone and upland buffer Potential Restoration Area #8 – Nearly All Residential Shoreline properties

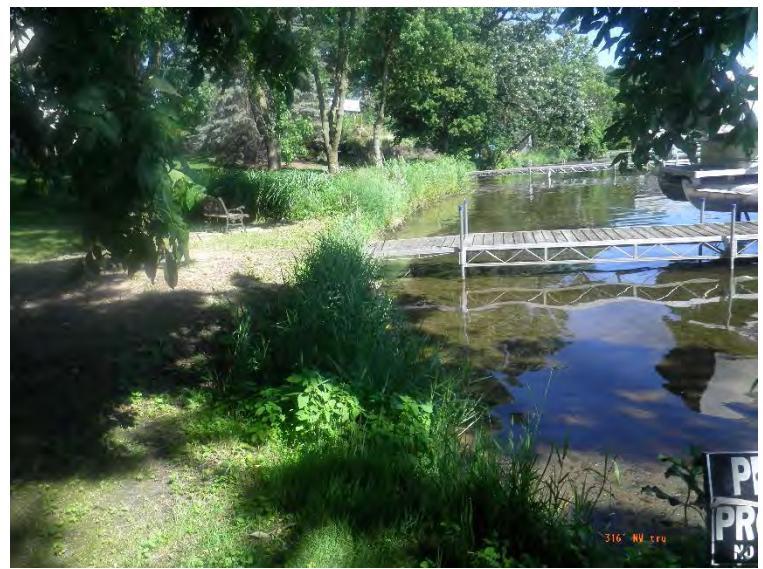
A shoreline restoration was established in 2012 in lot shown here beyond the bench. Vegetation has become well established.

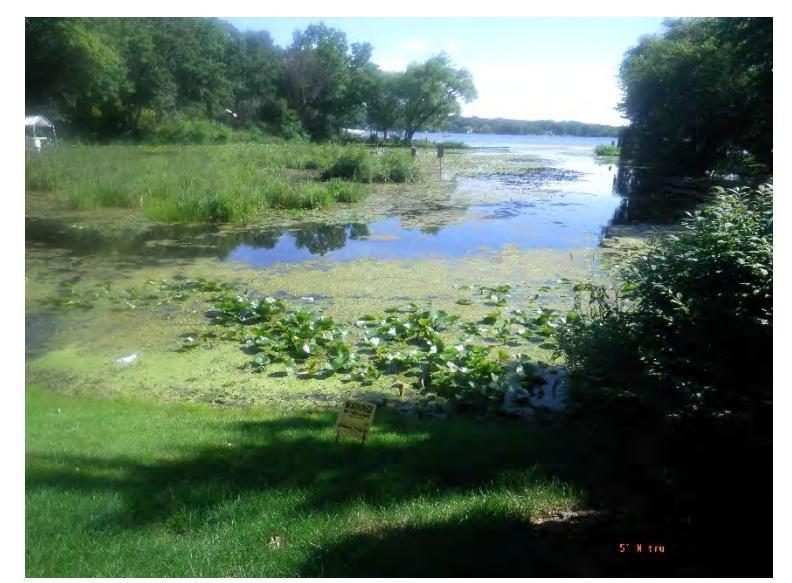
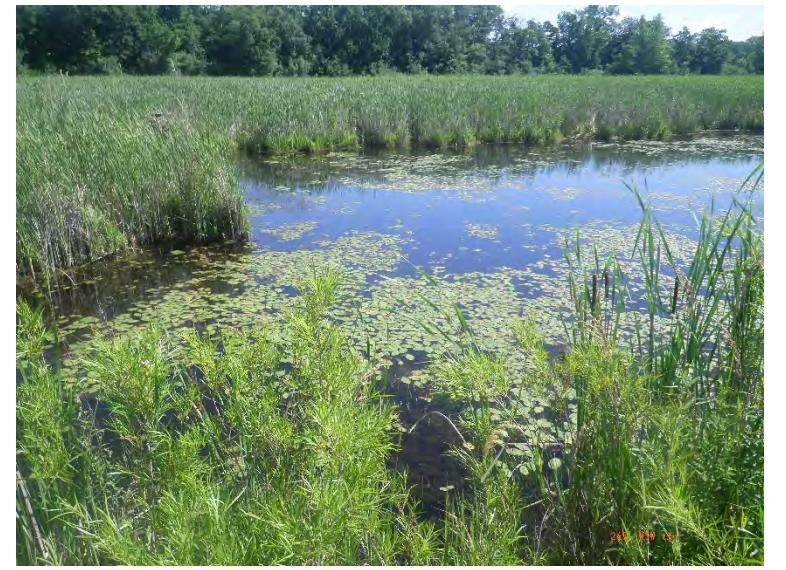
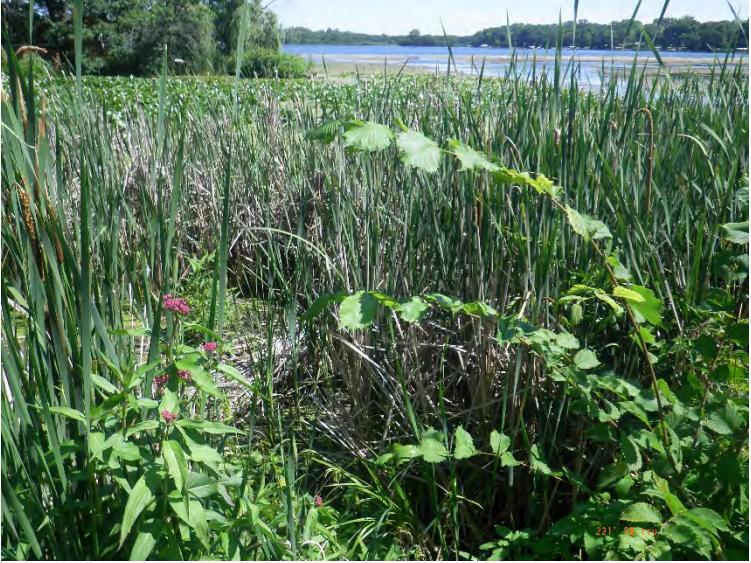
Examples of naturalized vegetation in the emergent zone and upland buffer which provides wildlife habitat and water quality protection.
