Technical Memorandum

To:Commissioners, Black Dog Watershed Management Organization (BDWMO)From:Barr Engineering Co.Subject:2022 Orchard Lake Habitat MonitoringDate:April 12, 2023Project:23190457

This memorandum presents the results of the BDWMO's 2022 habitat monitoring of Orchard Lake.

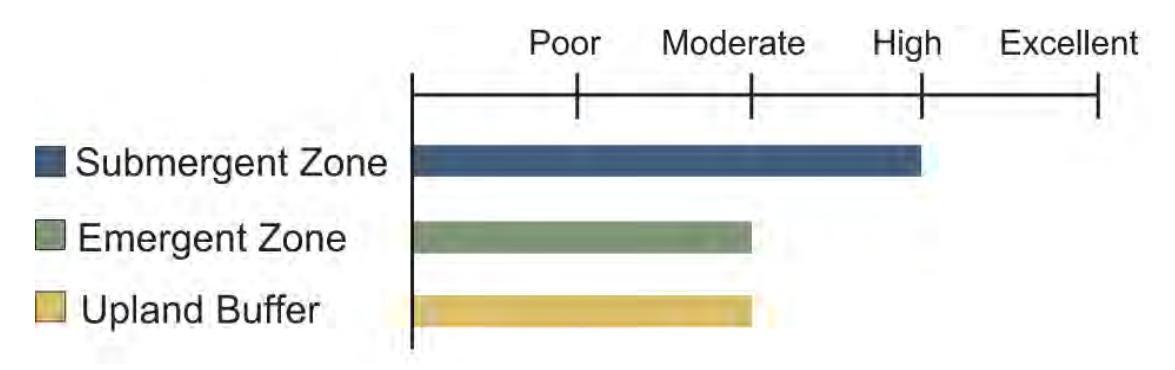
The following schematic diagram shows the overall ratings in 2022 for each vegetation zone within and adjacent to Orchard Lake:

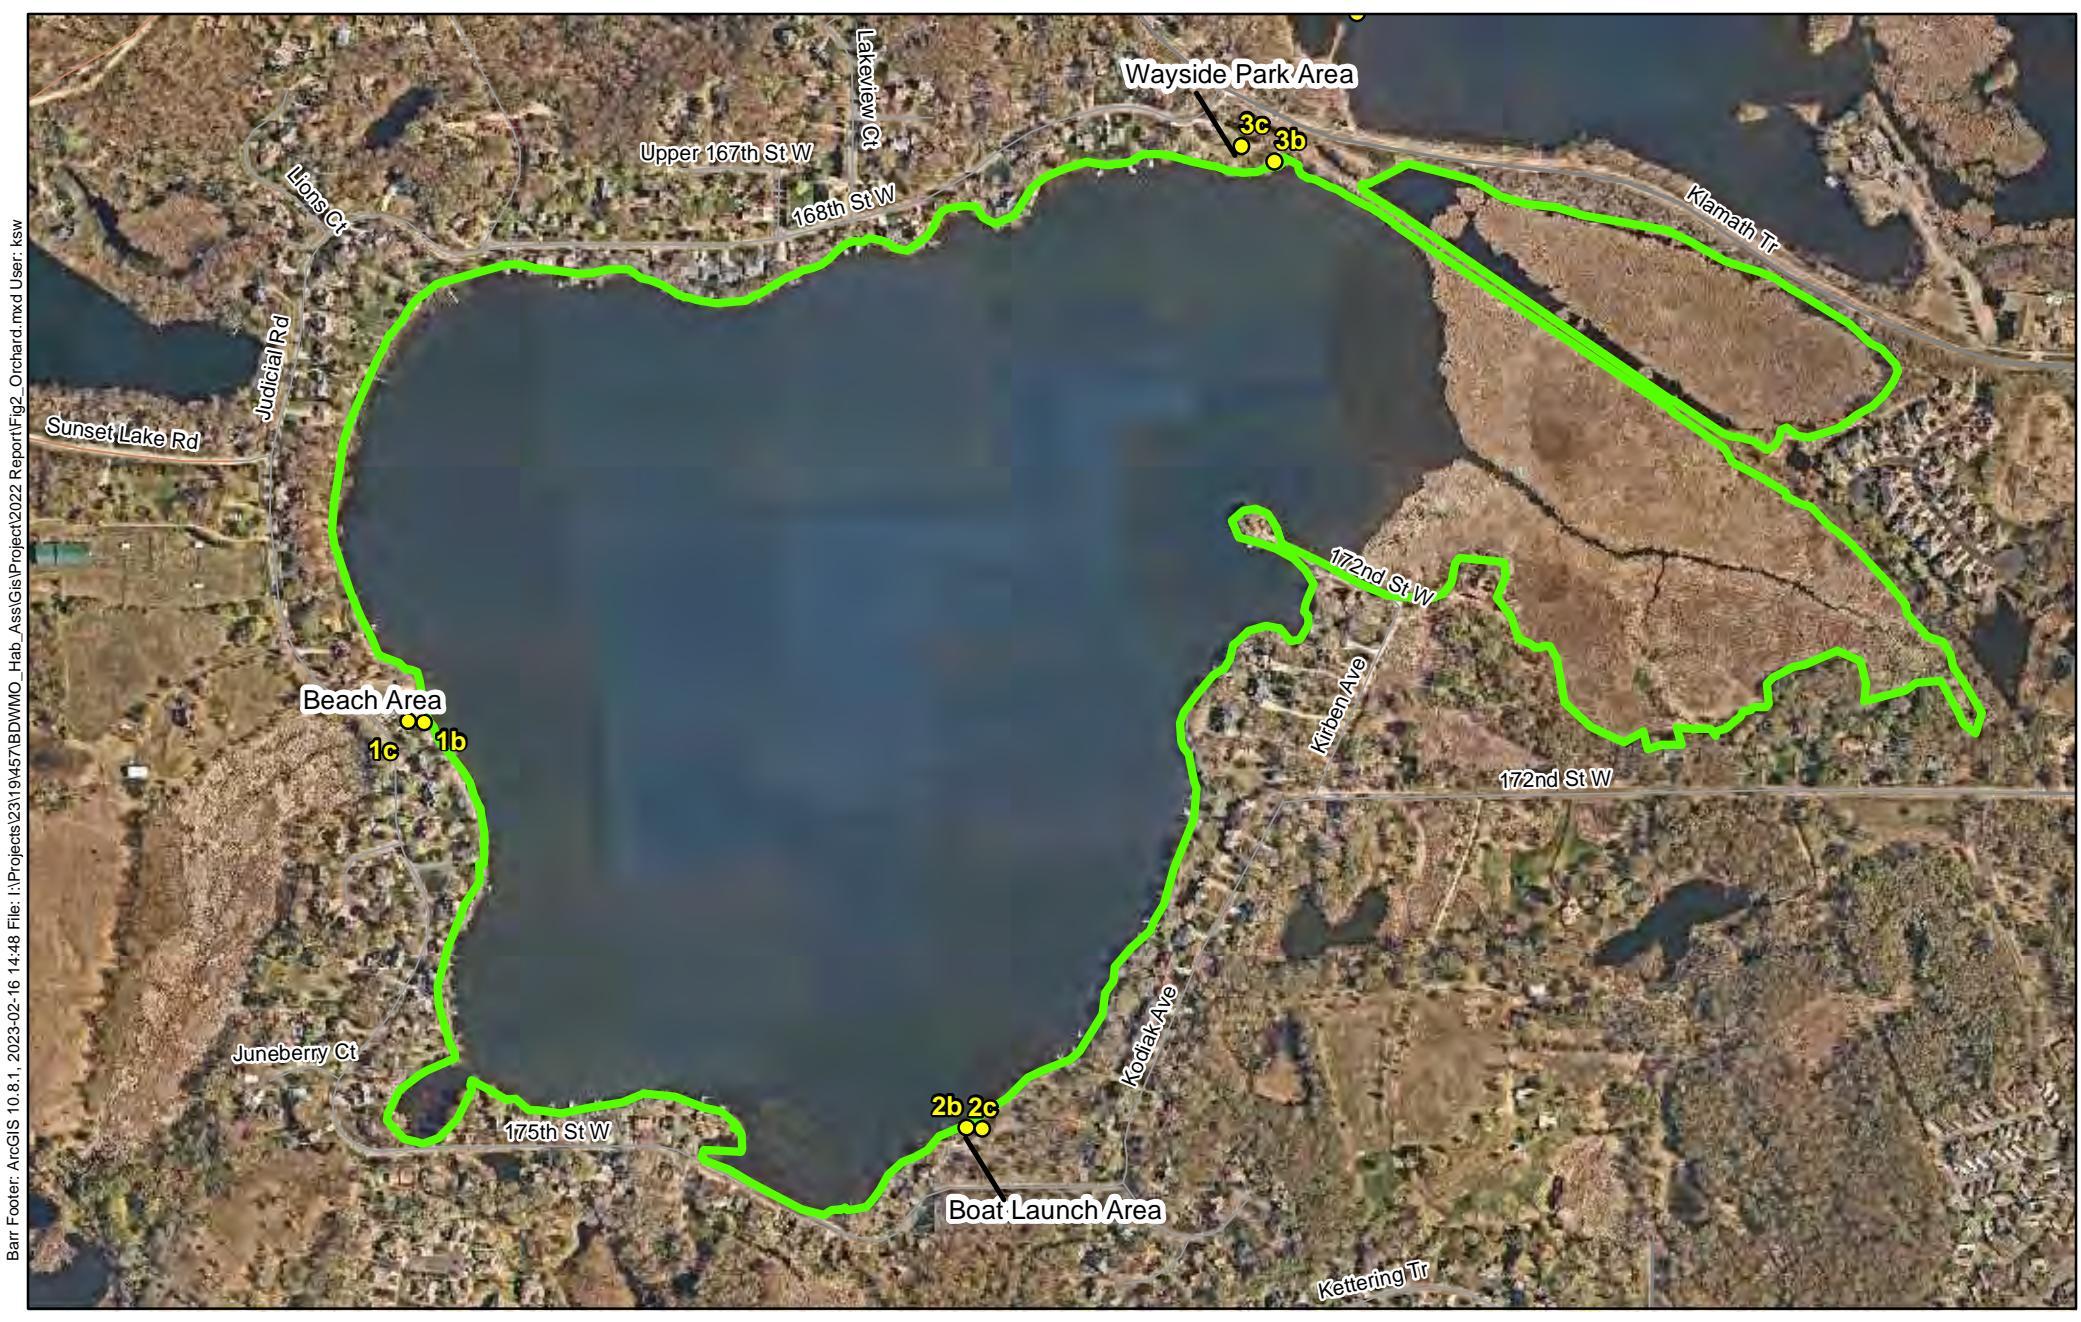
Figure 2

ORCHARD LAKE 2021 AERIAL IMAGERY AND PLOT LOCATIONS Black Dog WMO Lakeville, MN

Orchard Lake is a 243-acre lake located in Lakeville. The lake is used primarily for fishing, but swimming, boating, and aesthetic and wildlife viewing are also popular recreational uses of the lake. There is a public boat access on the south shore, a public beach on the west shore, and a public park on the northeast shore of Orchard Lake. Orchard Lake outlets through the Murphy-Hanrehan Park Reserve to the Credit River. Therefore, Orchard Lake is part of the Credit River hydrologic watershed. **Figure 2** shows the 2021 aerial imagery of Orchard Lake.

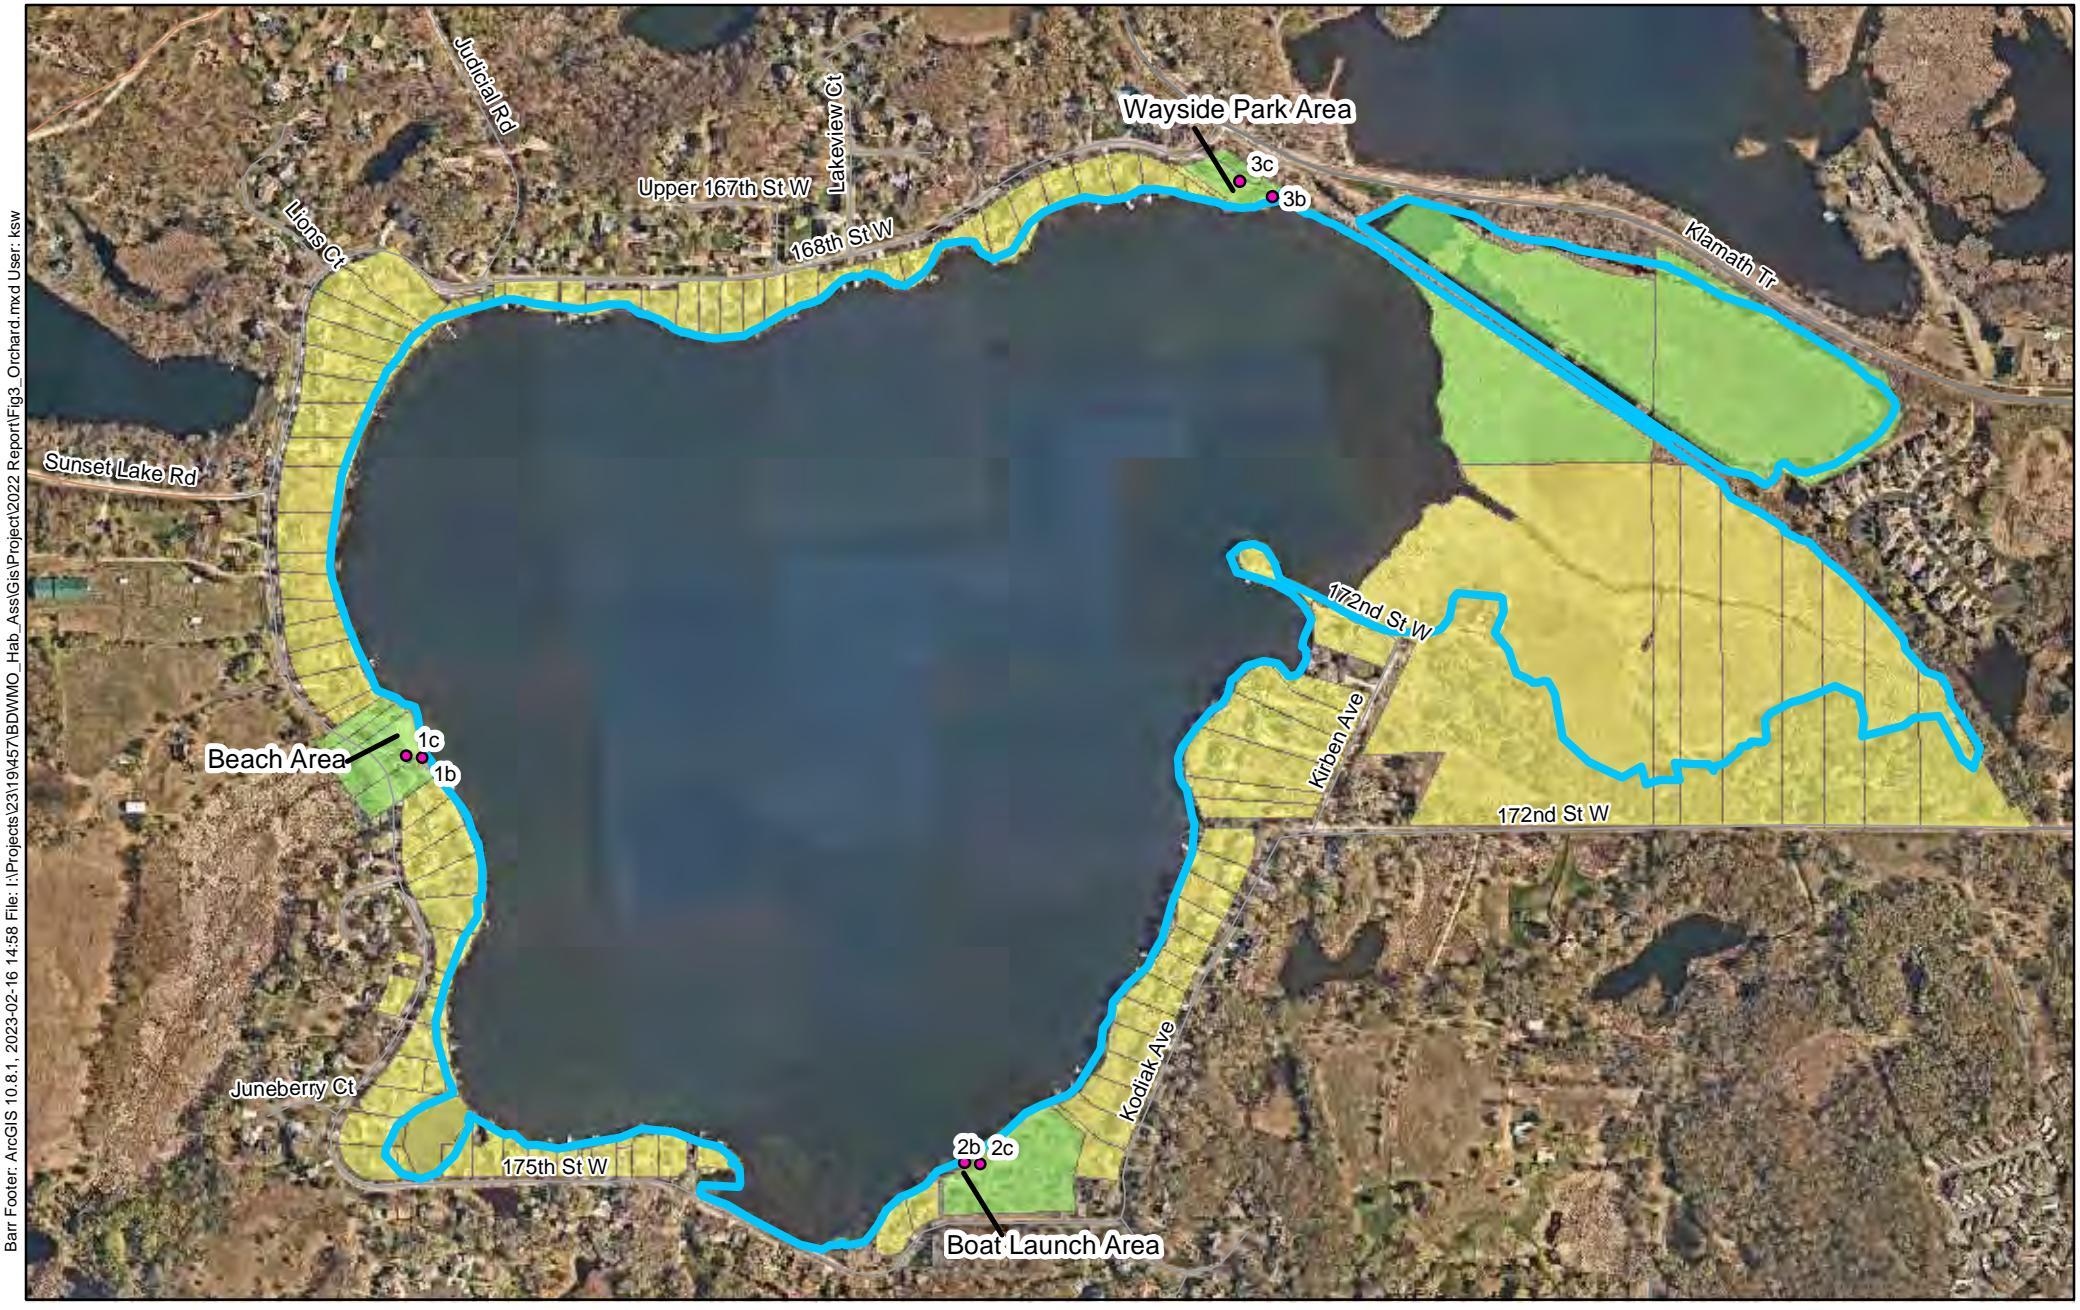
Figure 3

ORCHARD LAKE PLOT LOCATIONS AND PARCEL OWNERSHIP Black Dog WMO Lakeville, MN

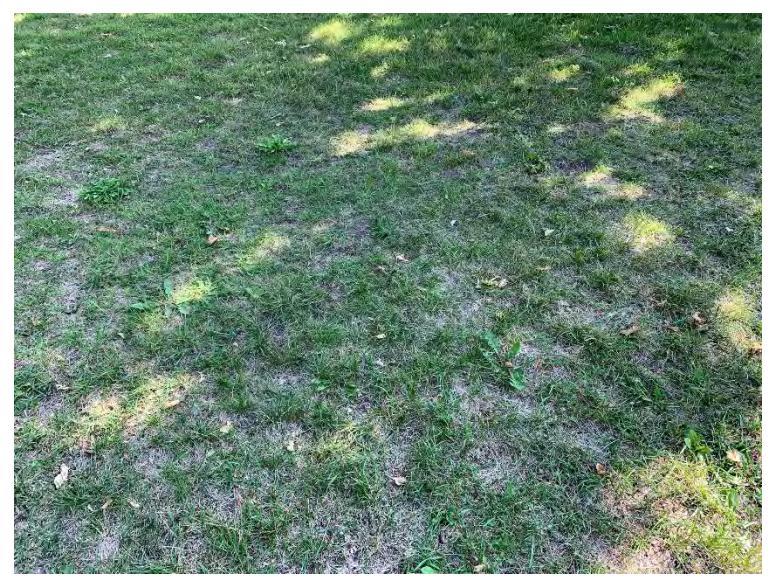
Plot 1C Upland Buffer – beach area - Potential Restoration Area #1

- Remove common buckthorn at beach area, Wayside Park, and boat launch area (see **Potential Restoration Areas #1 and #2**).
 - Remove burdock and reed canary grass in overflow swale structure at beach area (see **Potential Restoration Area #1**)

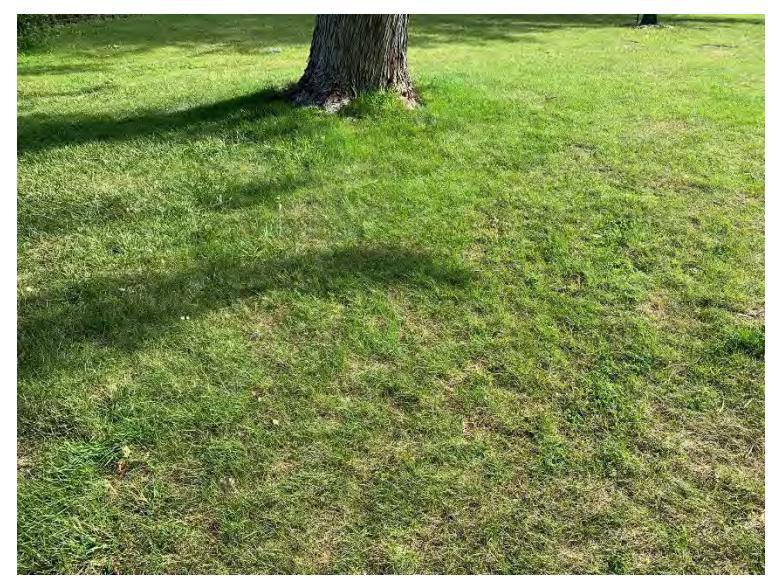
Plot 2C Upland Buffer – boat launch area – Potential Restoration Area #2

- Remove Siberian elm at boat launch area (see Potential Restoration Area #2).
 - Remove Chinese silver grass at boat launch (Potential Restoration Area #2).

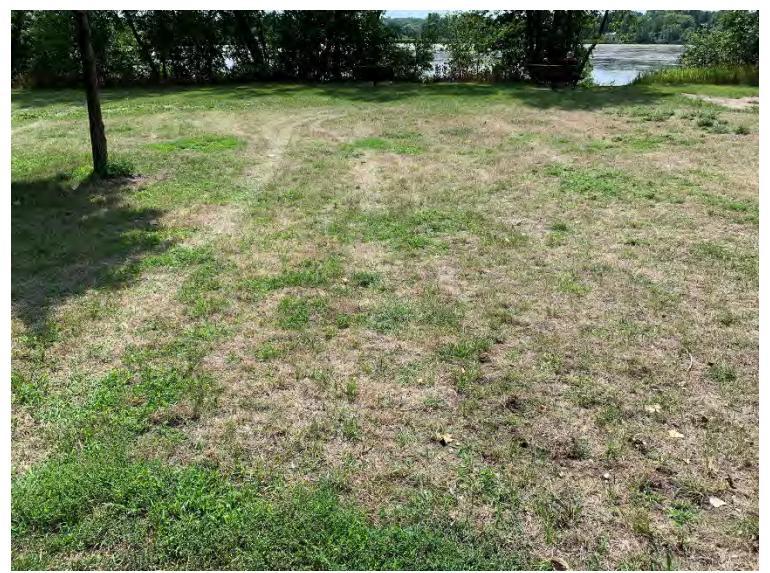
Plot 3C – Upland Buffer – Wayside Park area – Potential Restoration Area #3

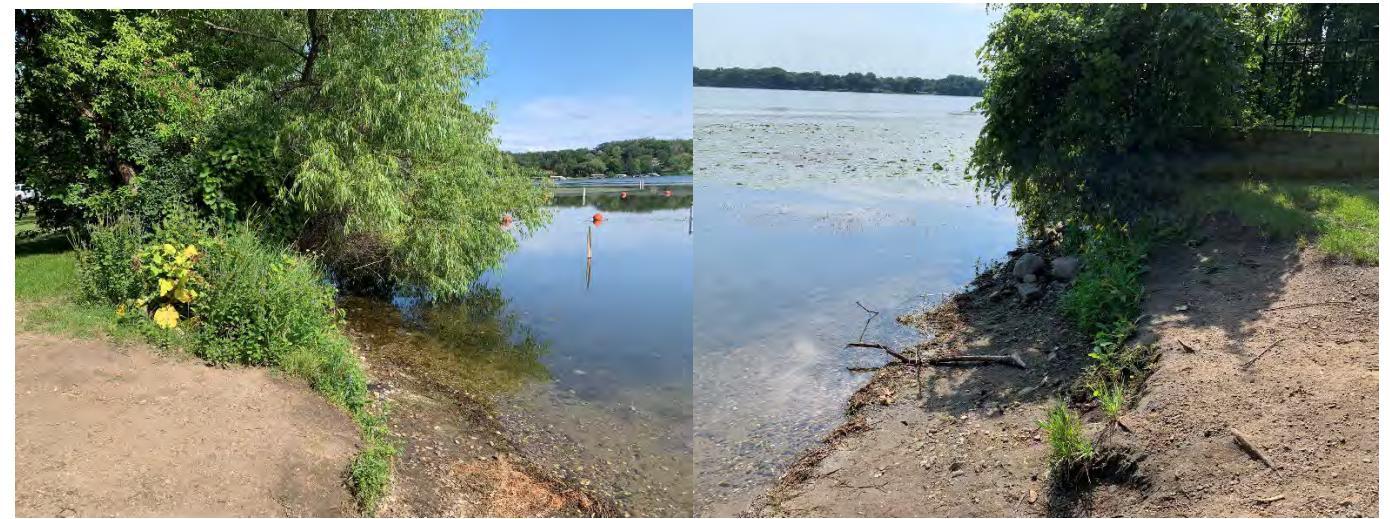
Potential Restoration Area #4 – Beach Area – Dilapidated timber retaining wall was taken out and shoreline restoration attempted but failed. Would need soil improvement to be successful. And/or consider placing stone walkways to establish designated shoreline fishing and viewing areas.

- Improve soil for more successful vegetation establishment south of beach area and/or strategically place stone walkways in locations where shoreline fishing and viewing is common. Directing foot traffic to these stone walkways will allow for vegetation to grow in other surrounding locations, decreasing exposed bare soil.

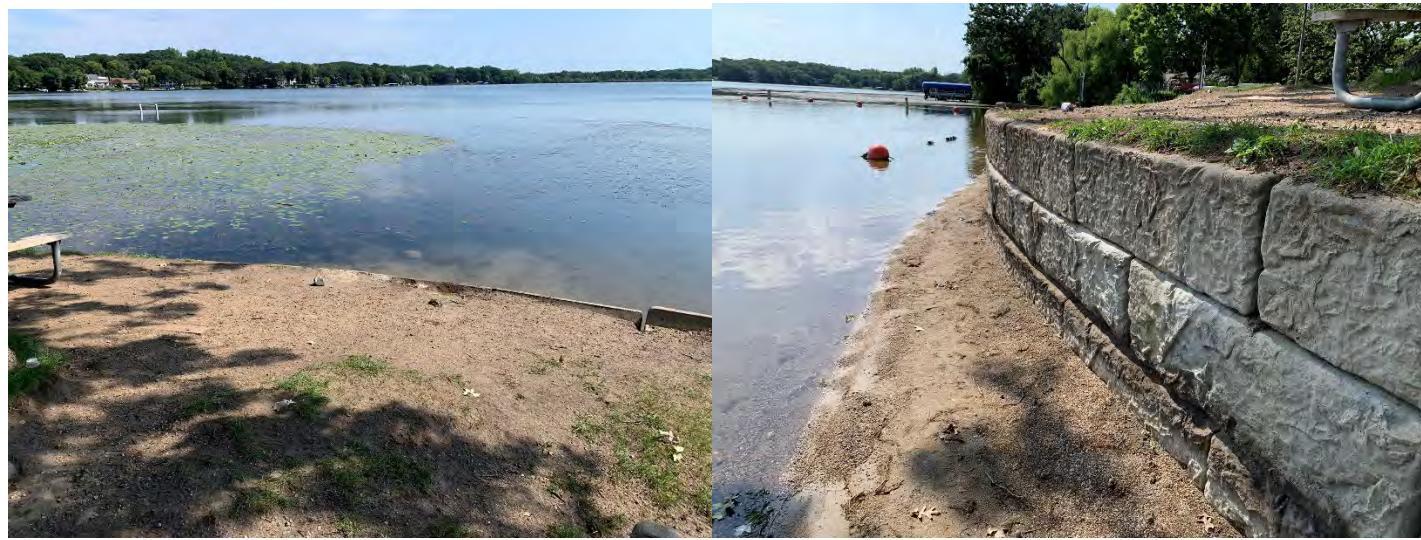
Timber wall was replaced by concrete wall at north end of beach area. Poor vegetation establishment and trash above the concrete.

- Note that maintenance crews may want to treat poison ivy at the beach area and along the paved trail adjacent to Klamath Trail to protect users.
 - Also, note that the beach area lacks recycling and trash containers; trash was evident on the ground.

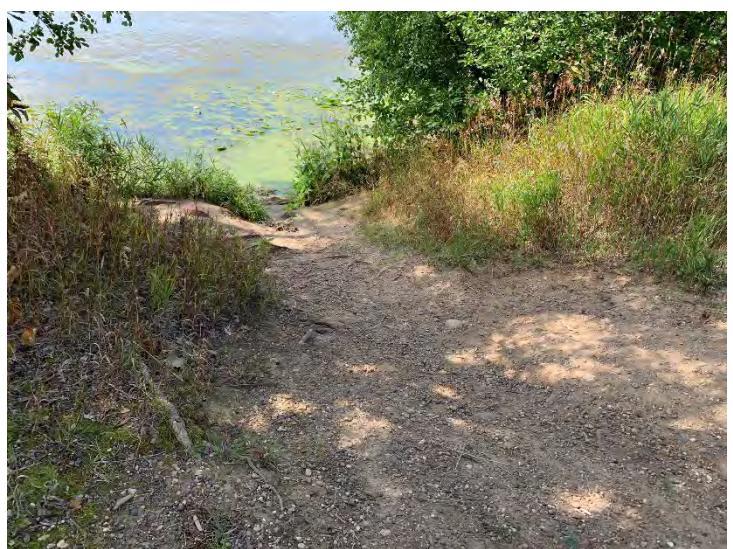
Potential Restoration Area #5 - An established canoe and kayak access at the Wayside Park could help prevent shoreline erosion in this location.

- An established canoe and kayak launch at the Wayside Park could help prevent shoreline erosion along a sloped area with bare soil that is currently being used for canoe and kayak access, and shoreline fishing.

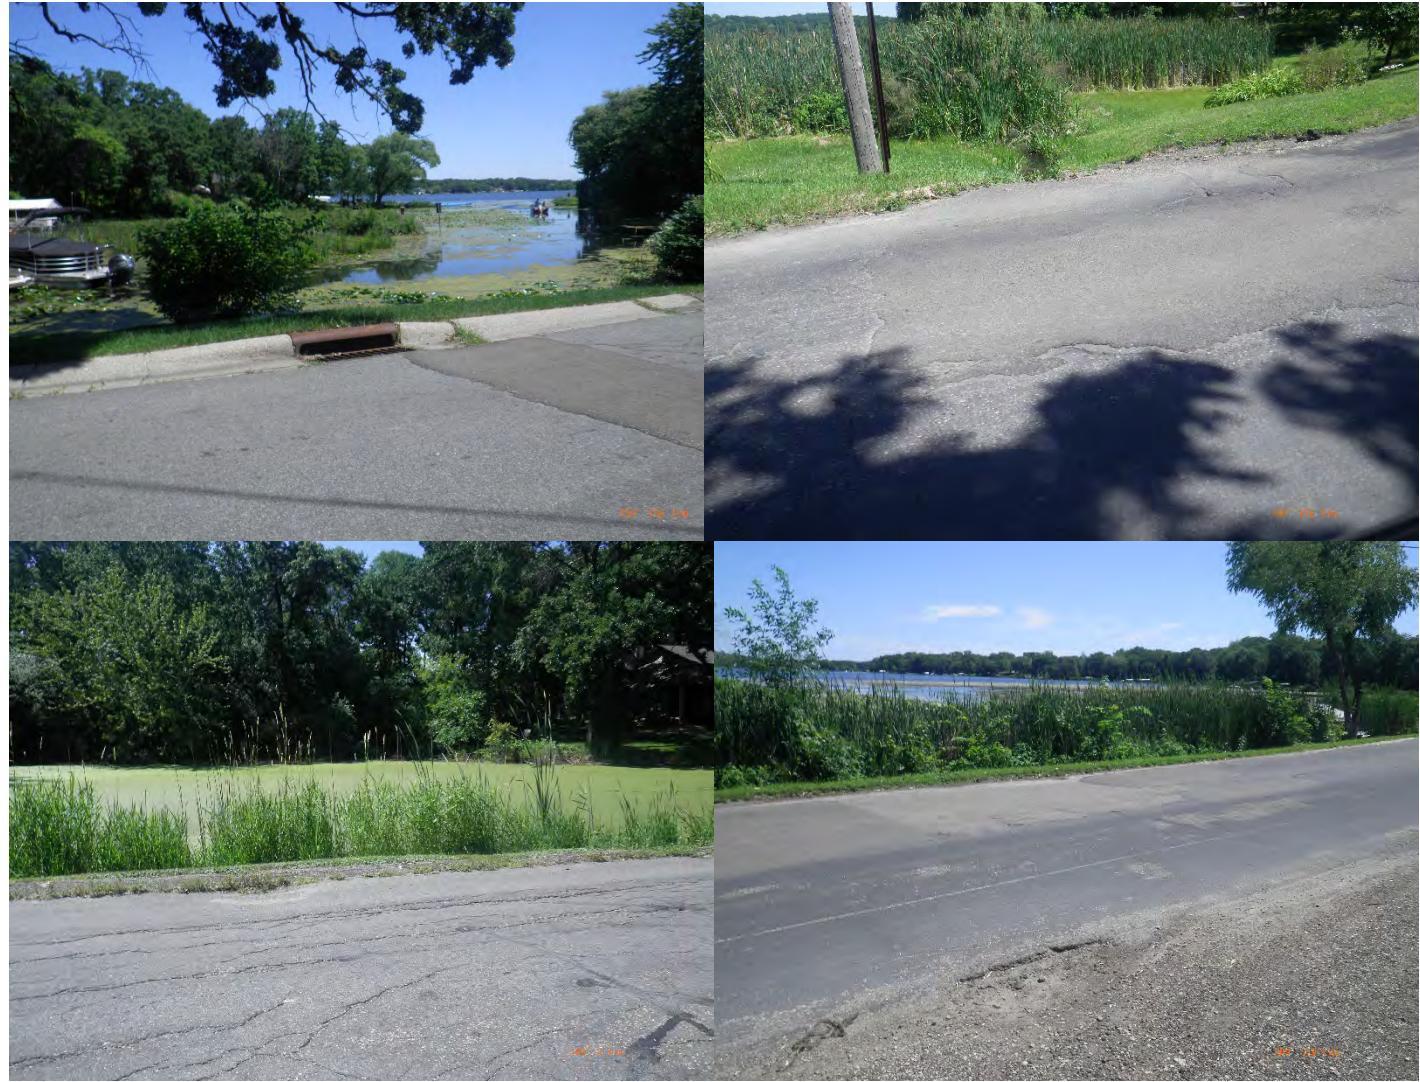
Potential Restoration Area #6 - Stormwater drainage from the road is directed into the lake. A barrier, pre-treatment, and/or naturalized upland buffer could help improve water quality.

- Consider control of non-native invasive cattail in the northeastern portion (see Areas B and C).
- 3. Install a pre-treatment system such as a rain garden, pervious pavement, or sediment trap to collect sediment from impervious surfaces prior to discharge into the lake. A pre-treatment system combined with routine maintenance of sediment clean-out could help to improve lake water quality and prevent algae blooms and degradation of the vegetation community in this area. This project could potentially receive funding assistance from the Dakota County SWCD's Community Conservation Partnership Incentives program (see **Potential Restoration Area #6, as shown in Figure 4 and photos**).

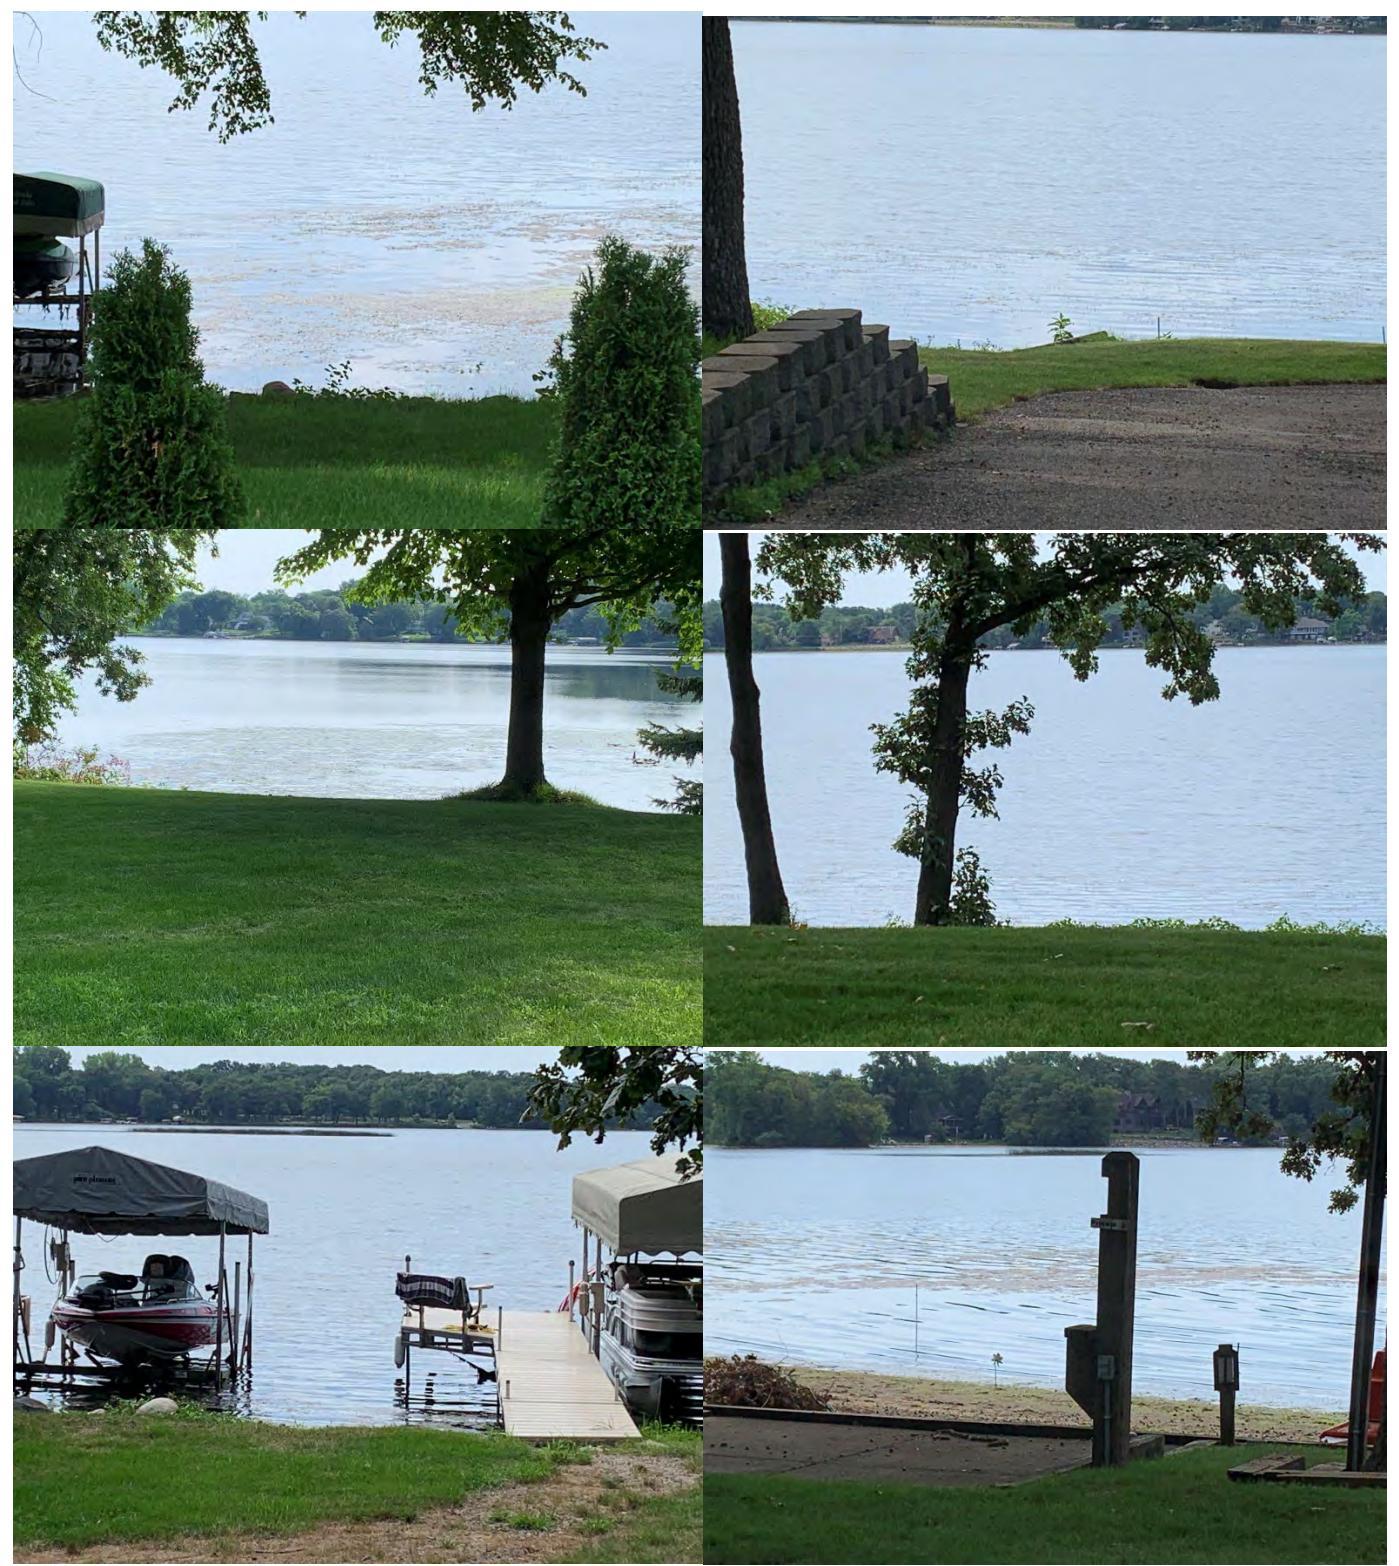
Typical residential shorelines lacking naturalized vegetation in the emergent zone and upland buffer Potential Restoration Area #8 – Nearly All Residential Shoreline properties

- Rather than manicured turf grass, residential shorelines and adjacent upland buffer could be vegetated with native grasses and wildflowers.
- Adjust mowing distance further away from the shoreline on the City of Lakeville properties at Wayside Park and the boat launch area near the east parking lot. The mowed lawn in the Wayside Park has dry and bare patches. This could be seeded with a fescue or a native seed mixture that would tolerate dry conditions better. Maintenance crews could also set the mower at a higher height.

- Providing a wider buffer of native vegetation could help protect water quality, prevent erosion, and improve wildlife habitat, vegetative diversity, and aesthetics, potentially through funding assistance from the Dakota County SWCD Conservation Initiative Funding Program Guidance, assistance and potential funding may be available through the Xerces Society (Pollinator Conservation Program | Xerces Society) and the Minnesota Board of Water and Soil Resources Pollinator Initiative and Lawns to Legumes Program (Pollinator Habitat | MN Board of Water, Soil Resources (state.mn.us) (see Figure 4, Potential Restoration Areas #1 through 3, 7 and 8, and site photos. See Appendix G for examples of improvements.

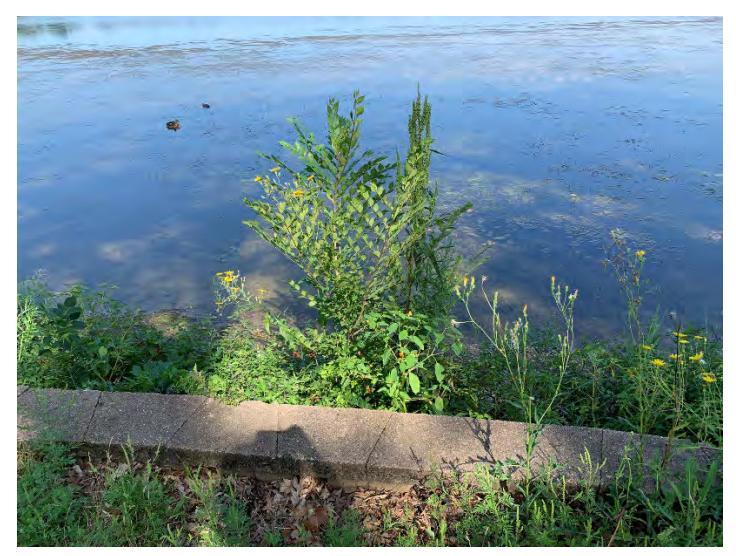
Siberian elm at boat launch area

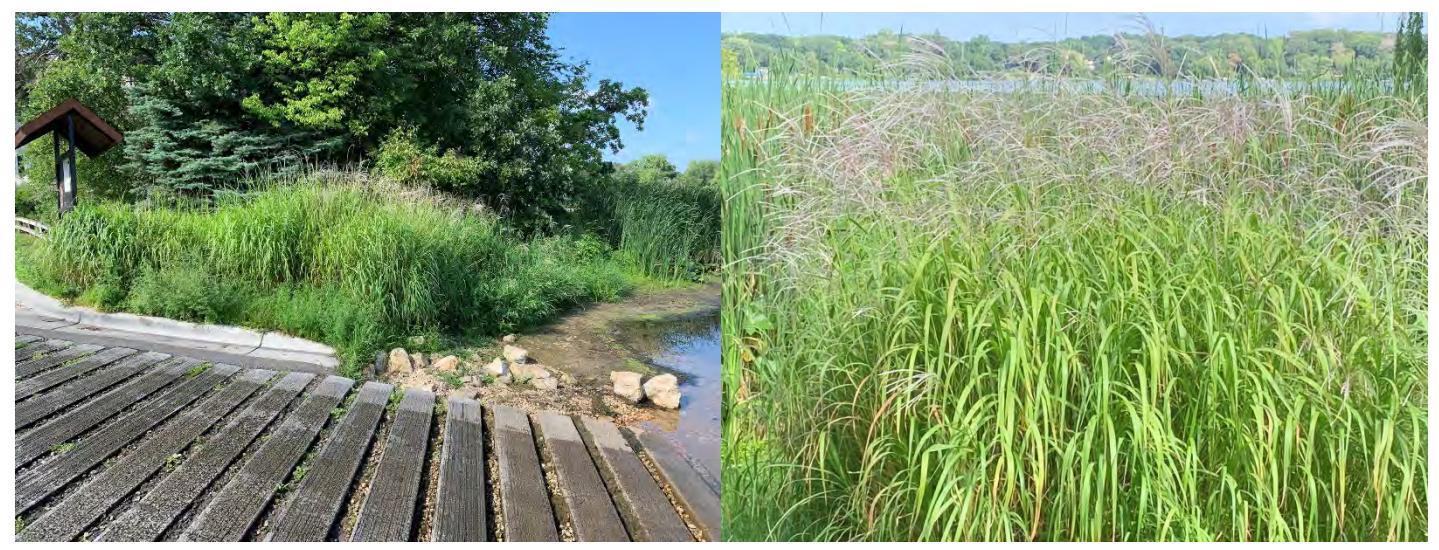
Chinese silver grass at boat launch area

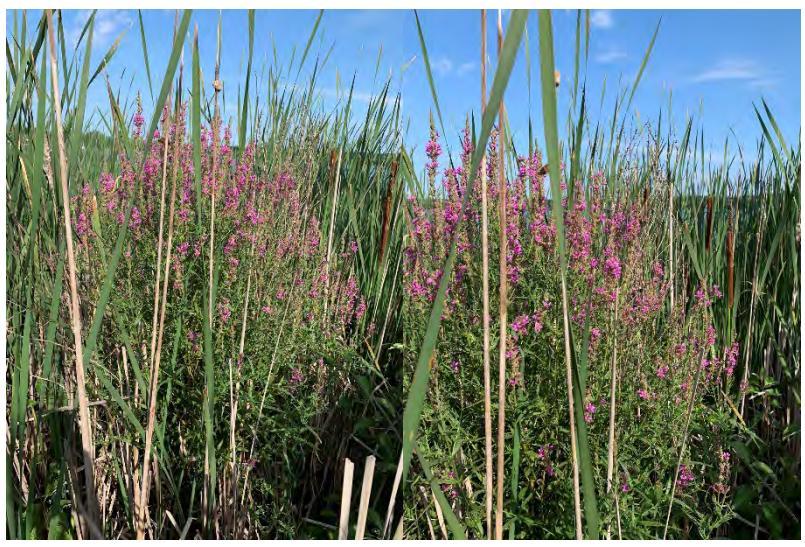
Purple loosestrife at boat launch area

- Based on increases of purple loosestrife observed in recent years, we recommend requesting a status update from the MNDNR (see **Figure 4** for location of abundant purple loosestrife populations).

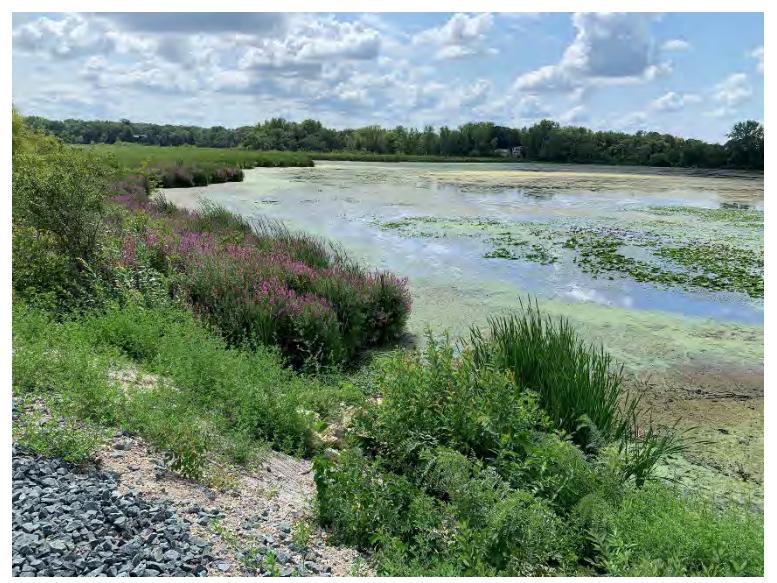
Purple loosestrife in Area C

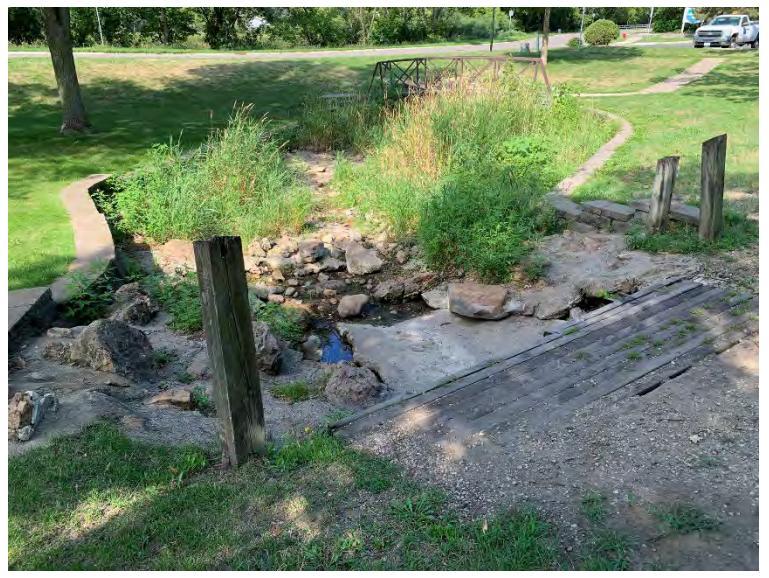
Burdock and reed canary grass in overflow swale at beach area

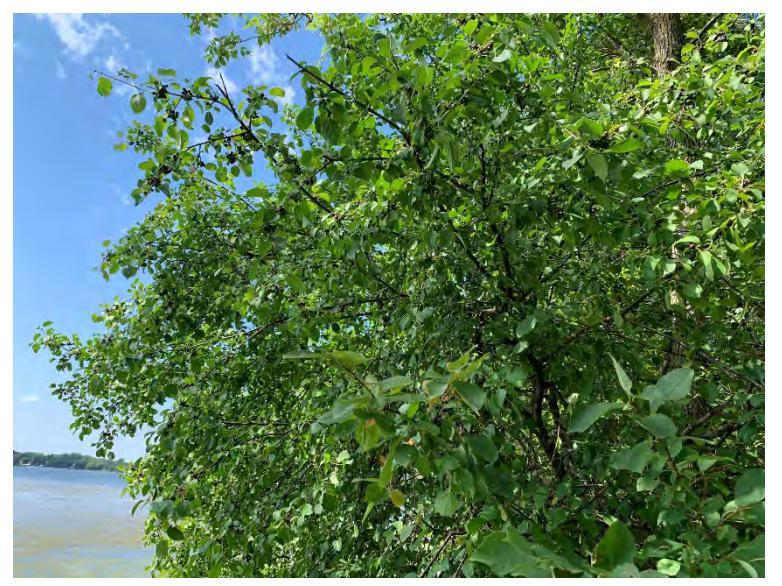
Buckthorn at Wayside Park

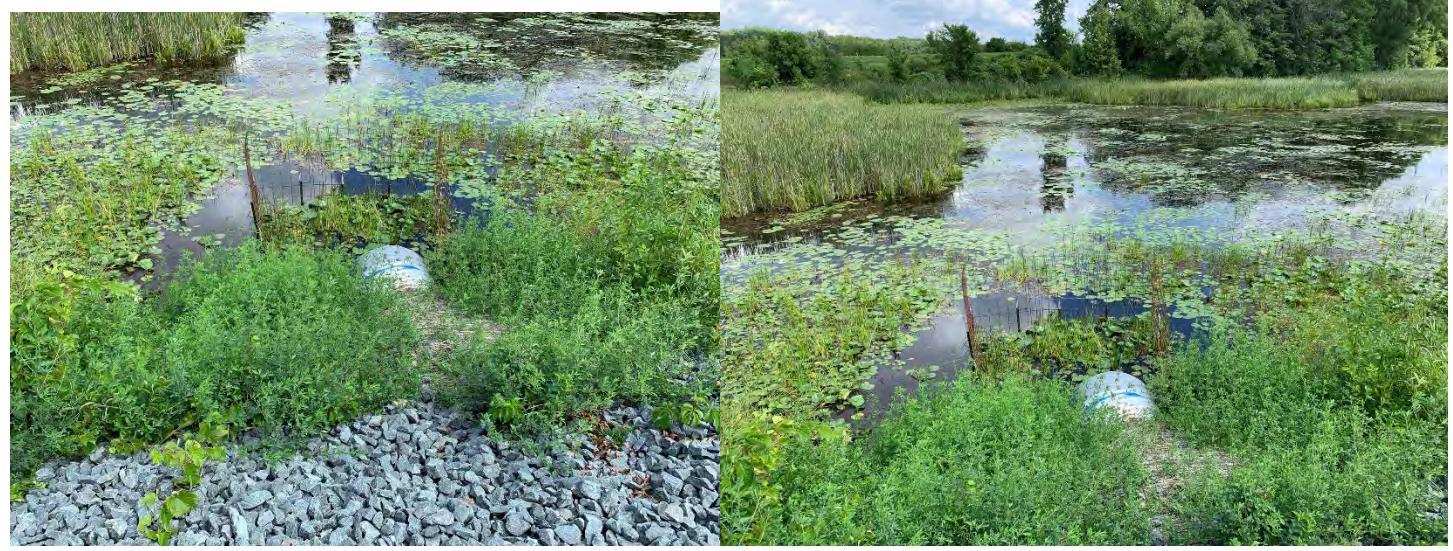
A new culvert under railroad tracks was installed under railroad tracks to maintain flow through of surface hydrology between Areas B and C.

- ✓ The City of Lakeville installed a new culvert under railroad tracks in the northeastern portion of the shoreline to maintain through-flow of surface hydrology within deep marsh habitat.

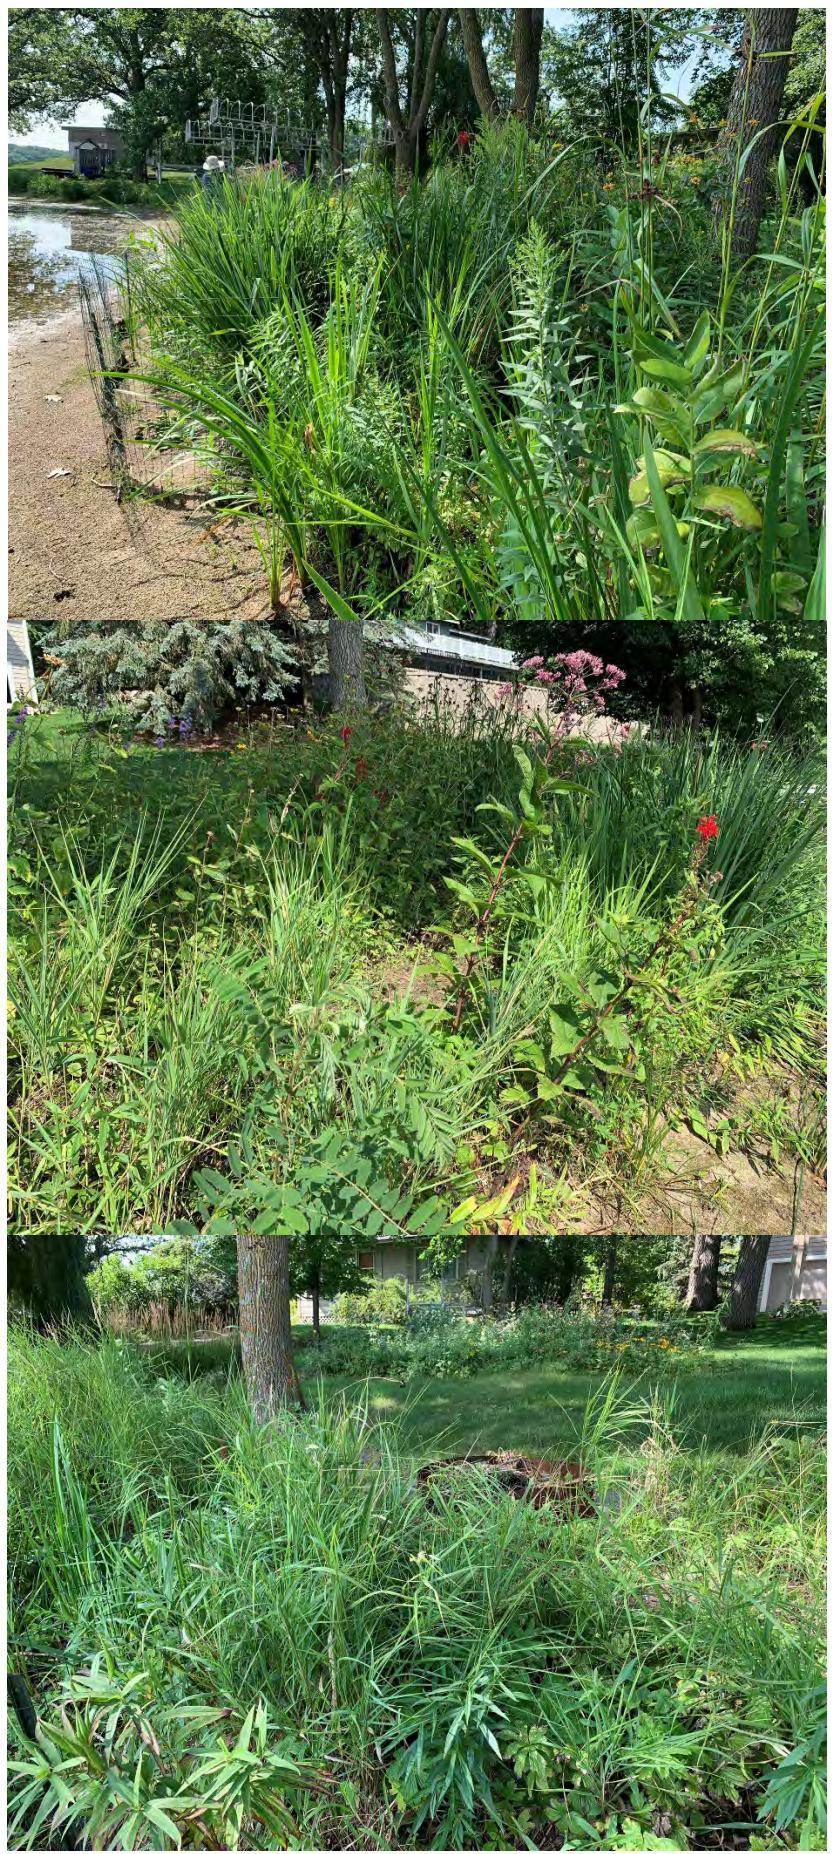
Well maintained successful residential shoreline restoration and raingarden north of beach area

One shoreline restoration located north of the beach area on the western side of the lake, is well maintained by the residential landowner providing aesthetically pleasing shoreline pollinator habitat and erosion protection with dense coverage of native emergent species including bluejoint, sedges, rushes, bulrush, bur-reed, iris, Joe-pye weed (*Eutrochium maculatum*), cardinal flower (*Lobelia cardinalis*), beggarticks (*Bidens*), bugleweed (*Lycopus*), water parsnip (*Sium suave*), Canadian anemone (*Anemone candensis*), sneezeweed (*Helenium autumnale*), and swamp milkweed (*Asclepias incarnata*).
